2015 - 2016 Corvette: Service Bulletin:

#16-NA-014: Delayed Engagement After Sitting

#16-NA-014: Delayed Engagement After Sitting With Engine Off - (Jun 28, 2016)

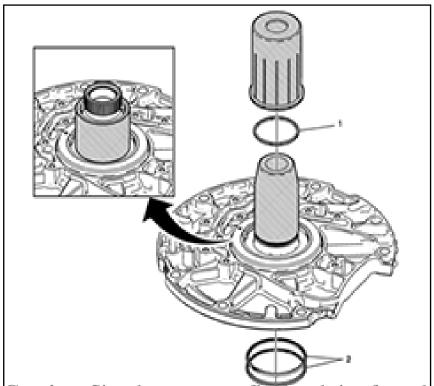
Old stator support asm New stator support asm

Note: The new stator shaft support assembly has a second check ball (1) added (see illustrations).

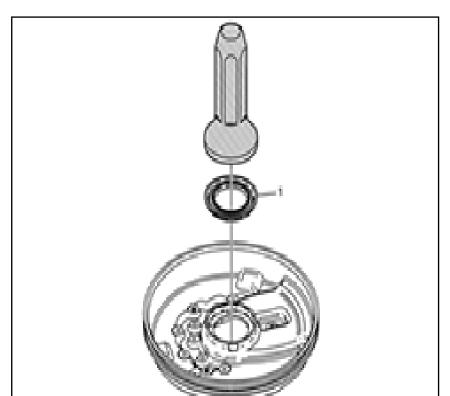
Old cover - 8L90 Only New cover - 8L90 Only

Note: The casting void has been eliminated from the underside of the cover for the 8L90 only (see illustration). The 8L45 is not required.
