1984 - 1985 Corvette: Service Bulletin: Improperly Installed Reverse Idler Shaft Roll Pin

Subject: IMPROPERLY INSTALLED REVERSE IDLER SHAFT ROLL
PIN

Model and Year: 1984-1985 CORVETTE

Bulletin Number: 85-31 - (01/09/1985)

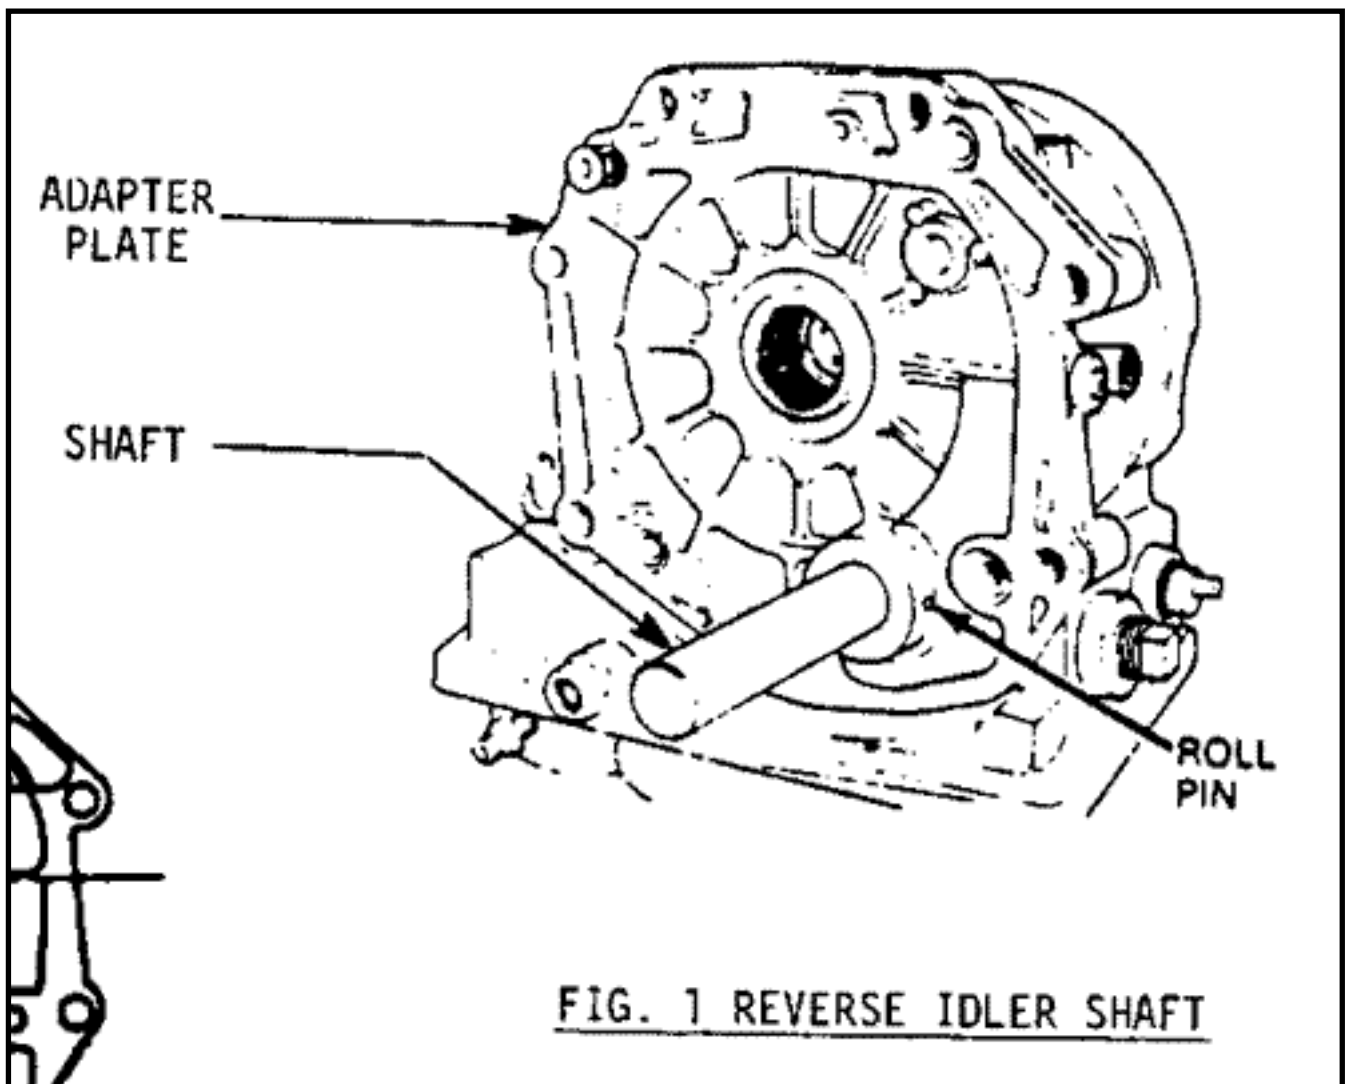
FIG. 1 REVER

Damage to the manual transmission may occur if the roll pin securing the reverse gear idler shaft to adapter plate (Figure 1) is not fully seated to prevent the shaft from spinning and/or backing out. To insure assembly operation results in the shaft securely locked in place, the roll pin has been lengthened from 0.50" to 0.75". When servicing transmissions with the shorter roll pin (0.50"), discard the roll pin and replace with longer roll pin (0.75") maximum.

The recommended procedure for removal and installation of the roll pin is as follows:

A. PIN REMOVAL

1. Insert small punch tool into plate boss hole and carefully drive roll pin into reverse idler shaft (Figure 3).

Driving roll pin too hard may cause to jam and result in shaft binding to adapter plate.

2. Pull reverse idler shaft from adapter plate and remove roll pin from shaft.

B. PIN INSTALLATION

1. Insert reverse idler shaft into adapter plate and align hole in shaft with hole in plate boss.

2. Insert 0.75" roll pin into plate boss hole and, with small punch tool, carefully drive roll pin flush with plate boss (Figure 2).

3. Verify that shaft cannot be pulled from adapter plate.
