1984 - 1985 Corvette: Service Bulletin: Improperly Installed Reverse Idler Shaft Roll Pin

Model and Year: 1984-1985 CORVETTE

Source: Chevrolet Service Bulletin

Bulletin Number: 85-31 - (01/09/1985)

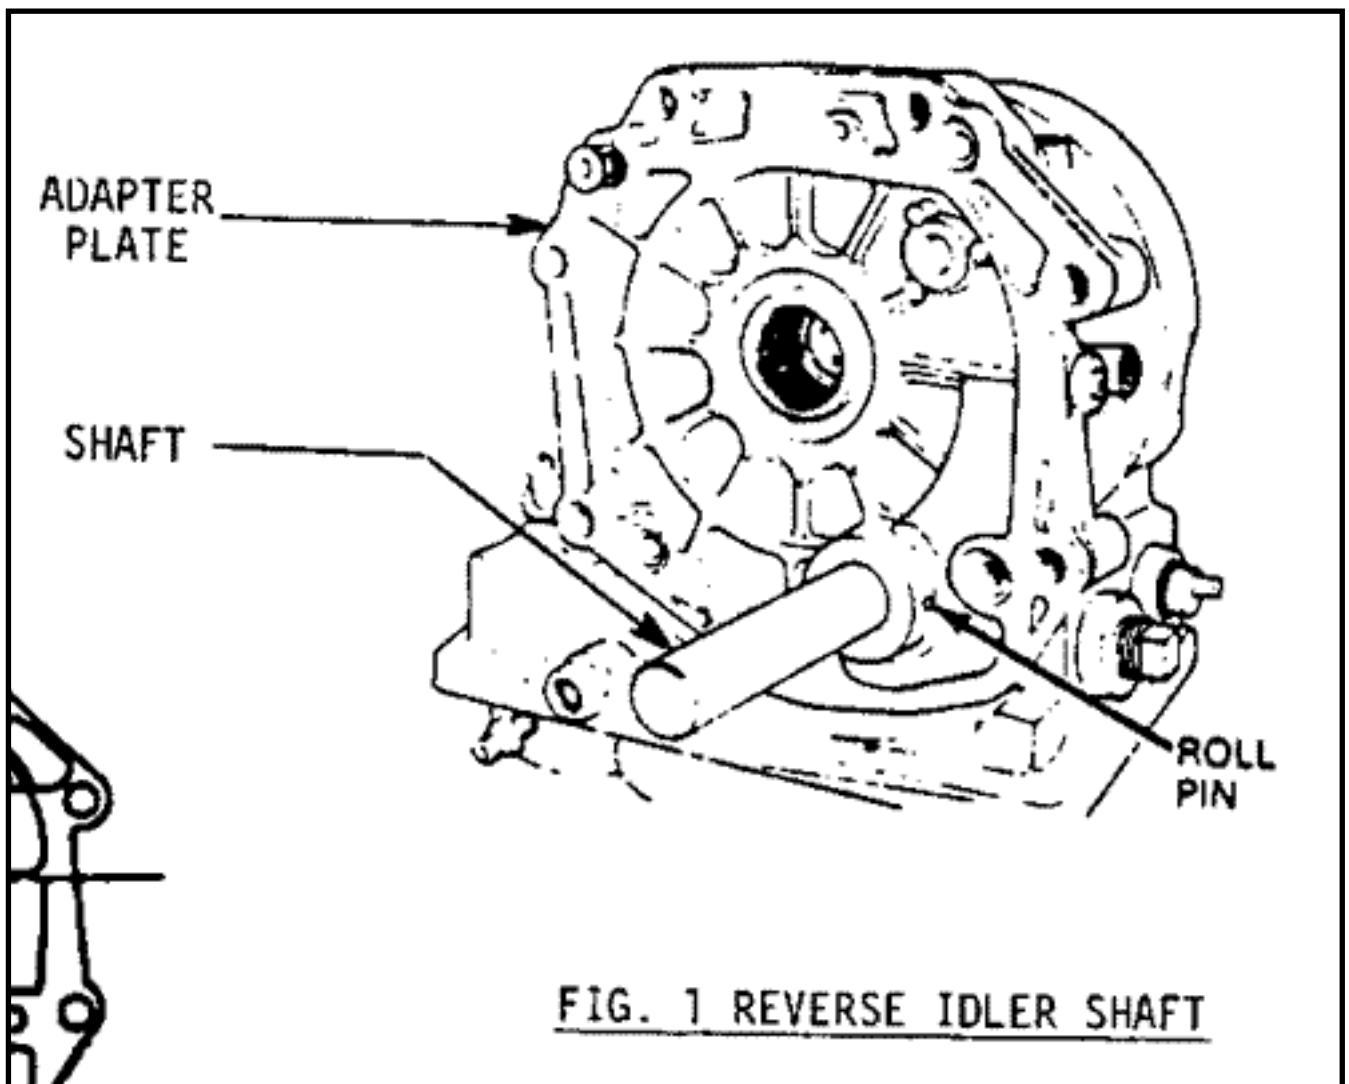
Damage to the manual transmission may occur if the roll pin securing the reverse gear idler shaft to adapter plate (Figure 1) is not fully seated to prevent the shaft from spinning and/or backing out. To insure assembly operation results in the shaft securely locked in place, the roll pin has been lengthened from 0.50" to 0.75". When servicing transmissions with the shorter roll pin (0.50"), discard the roll pin and replace with longer roll pin (0.75") maximum.

The recommended procedure for removal and installation of the roll pin is as follows:

1. Insert reverse idler shaft into adapter plate and align hole in shaft with hole in plate boss.

2. Insert 0.75" roll pin into plate boss hole and, with small punch tool, carefully drive roll pin flush with plate boss (Figure 2).

3. Verify that shaft cannot be pulled from adapter plate.
