1988 - 1990 Corvette: Service Bulletin: Power Steering Shudder / Groan

Subject: POWER STEERING SHUDDER/GROAN INSTALL P/S COOLER & HOSE

Model and Year: 1988-90 CORVETTE WITH 5.7L ENGINE

Bulletin Number: 90-376-3B - (10/25/1990)

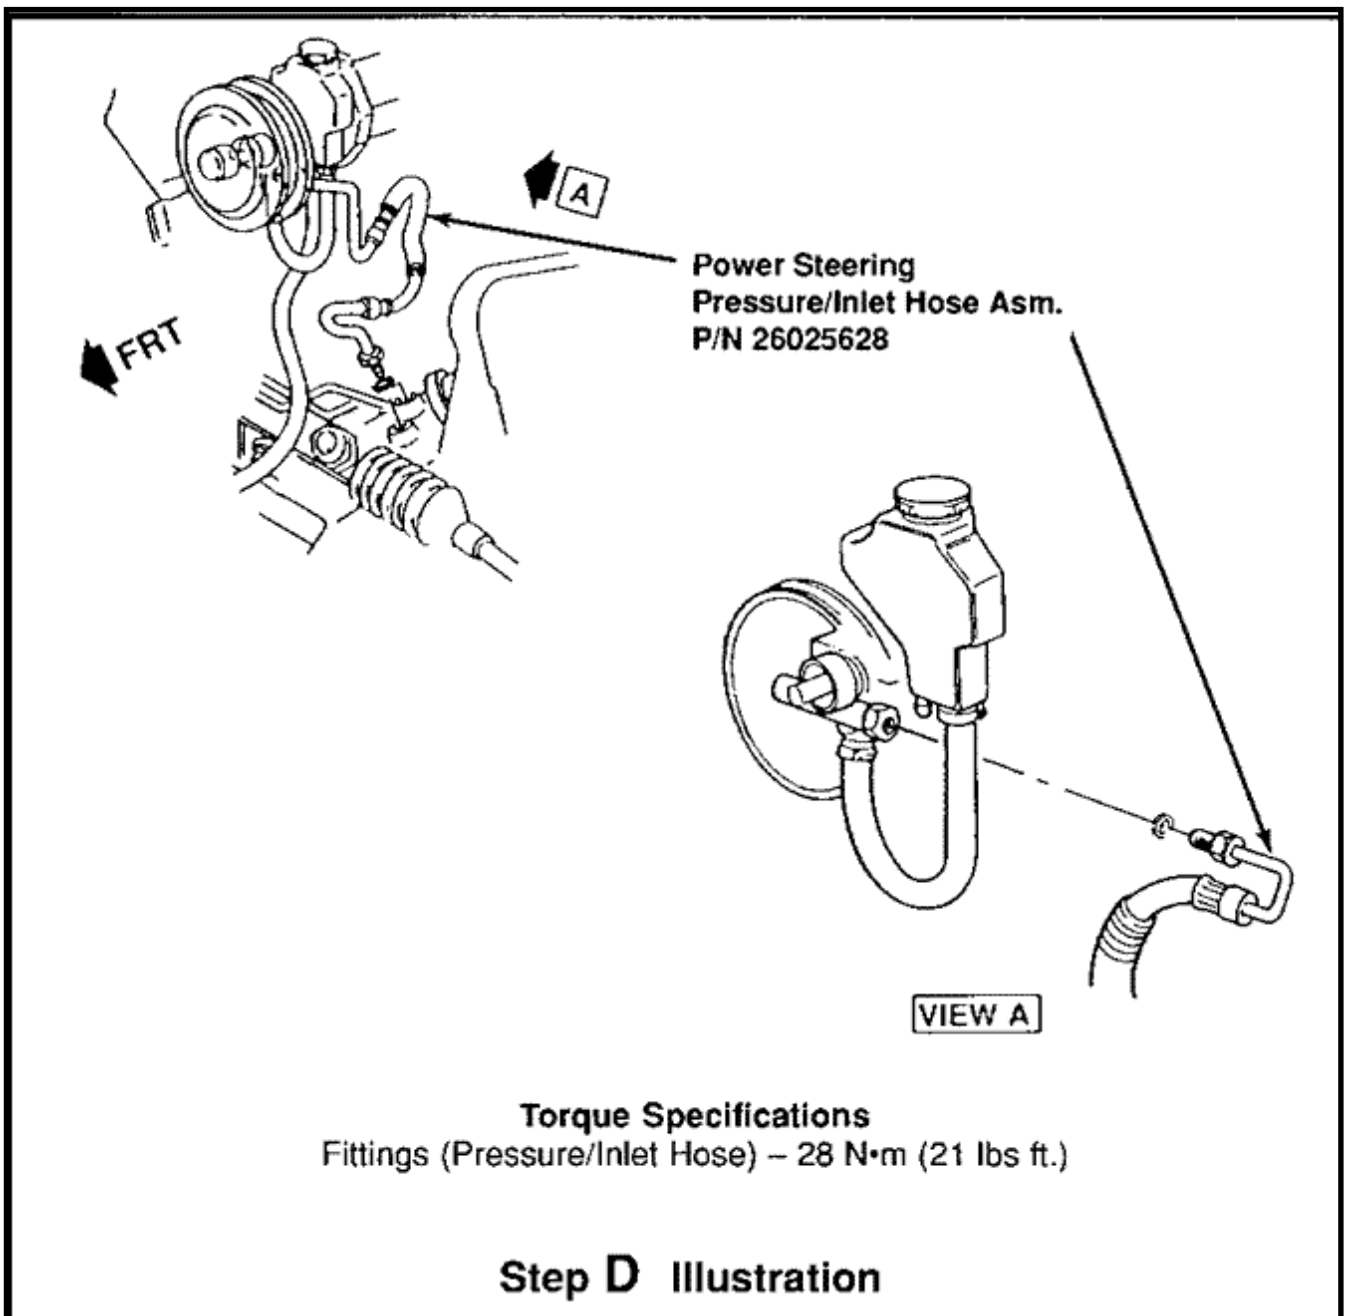
Step C Illustration (1988-89 Vehicles)

Some 1988-90 Y-cars with either L98 or LT5 engines and assembled prior to VIN breakpoint L5115181 or L5802113 respectively, may exhibit a slight power steering related shudder/groan condition. This condition is typically apparent during either static or low speed turning maneuvers and may be perceived by the vehicle operator as a vibration felt in the vehicle's steering wheel.

A combination of power steering pump pressure pulses and engine firing frequency transmitted through the body structure.

- Screws (Cooler/Bracket) – 10 N•m (89 lbs. in.)
- Bolts (Bracket/Frame) – 28 N•m (21 lbs. ft.)
- Fitting (Return/Outlet Hose) – 28 N•m (21 lbs. ft.)
- Clamp (Reservoir Hose) – 2.5 N•m (22 lbs. in.)
