## 1982 - 1991 Corvette: Service Bulletin: Checking Connector Terminal Contact - Metri-Pack

Subject: CHECKING CONNECTOR TERMINAL CONTACT - METRI -

Model and Year: 1982-91 PASSENGER CARS AND TRUCKS

**Bulletin Number:** 91-85-8A - (09/21/1990)

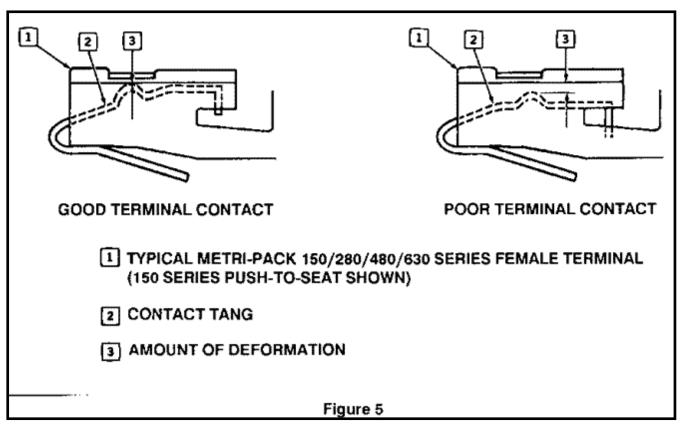
Frequently, a diagnostic chart leads to a step that reads: "Check for poor connection or replace..." Mating terminals must be inspected to assure good terminal contact. A poor connection between the male and female terminal at a connector may be the result of contamination or deformation.

- 1. Separate the connector halves, refer to Terminal Repair Kit J 38125-4 instruction manual.
- 2. Inspect the connector halves for contamination. Contamination will result in a white or green build-up within the connector body or between terminals causing high terminal resistance, intermittent connection or an open circuit. An underhood or underbody connector that shows signs of contamination should be replaced in its entirety, terminals, seals and connector body.

- 3. Using an equivalent male terminal from the Terminal Repair Kit J 38125-2, check the retention force of the female terminal in question by inserting and removing the male terminal to the female terminal in the connector body. Good terminal contact will require a certain amount of force to separate the terminals.

- 4. Using an equivalent female terminal from the Terminal Repair Kit J 38125-2, compare the retention force of this terminal to the female terminal in question by joining and separating the male terminal to the good female terminal, and then joining and separating the male terminal to the female terminal in question. If the retention force is significantly different between the two female terminals, replace the female terminal in question, refer to Terminal Repair Kit J 38125-2.
