Recall Bulletin

PRODUCT SAFETY RECALL

SUBJECT: ELECTRONIC COLUMN LOCK SYSTEM

**MODELS: 1997-2004 CHEVROLET CORVETTE EQUIPPED WITH A MANUAL TRANSMISSION
1997-2000 CHEVROLET CORVETTE EQUIPPED WITH AN AUTOMATIC TRANSMISSION
2001-2004 CHEVROLET CORVETTE EQUIPPED WITH AN AUTOMATIC TRANSMISSION – EUROPEAN EXPORT ONLY**

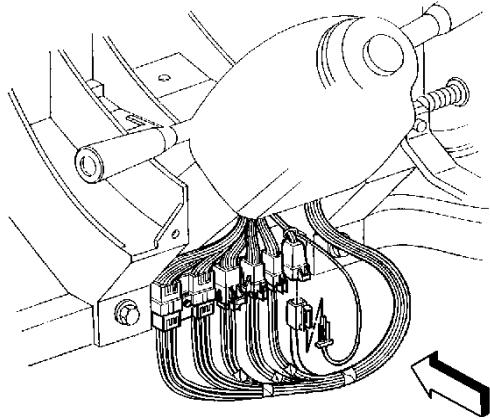
68614

8. Remove the push-on retaining nut from the steering column bracket stud.
9. Release the driver's side lower closeout panel push-in retainers from the IP lower support beam.
10. Insert the IP courtesy lamp assembly up through the opening in the closeout panel.
11. Lower and remove the closeout panel. Release the notch, in the right-hand forward edge of the closeout panel, from the tab on the accelerator pedal bracket.

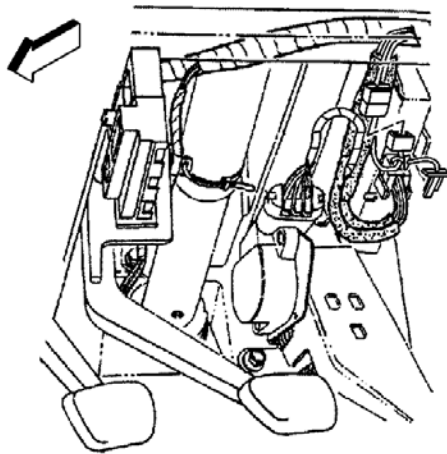
68617

12. Remove the connector position assurance (CPA) from the driver's yellow 2-way air bag connector located at the base of the steering column and disconnect the connector.

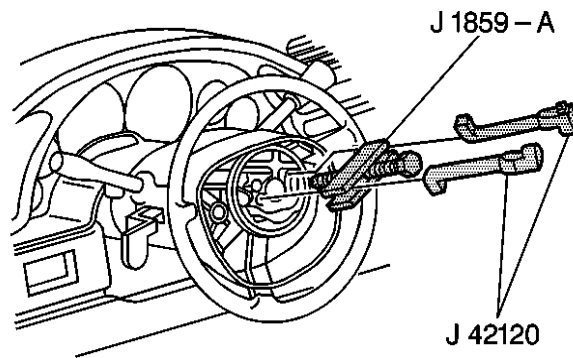
70114

13. Remove the CPA from the passenger yellow 2-way air bag connector, also located at the base of the steering column, and disconnect the connector.
14. Remove the screws attaching the driver's inflator module to the steering wheel (3) and pull the module away from the steering wheel.
15. Disconnect the SIR electrical connector (2) from the backside of the module, the horn wiring harness connector (6) from the steering column, and the ground wire (5) from the steering column. Remove the module.
16. Remove the nut attaching the steering wheel to the column and discard the nut.
