1990 - 1995 Corvette ZR-1: Technical Article: LT5 Secondary Port Operation & Vacuum Diagnosis

LT5 Secondary Port Operation & Vacuum Diagnosis

by Robert Loszewski
Copyright 2001

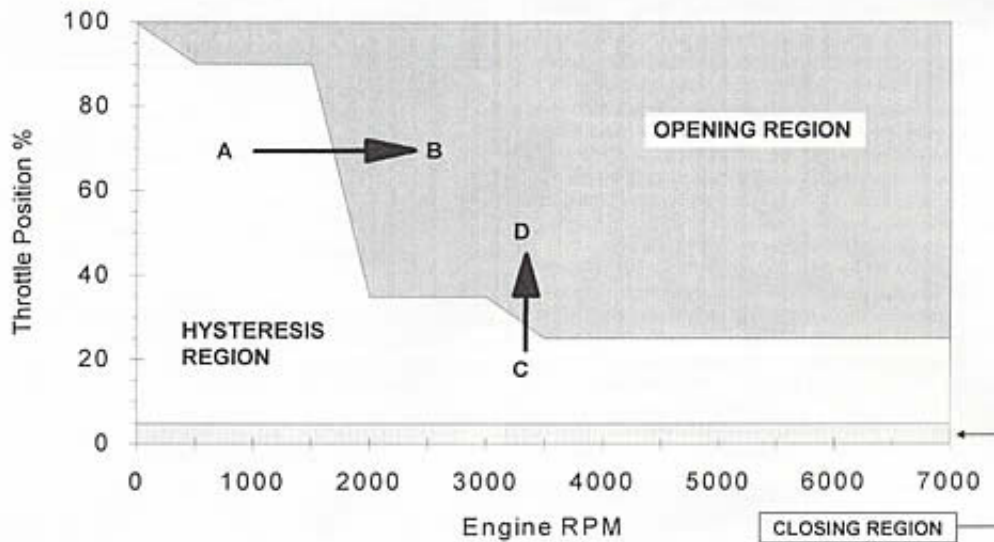
90-92 Model Years

As shown in the diagrams (below), there are three different styles of driving which will operate the port throttles:

1. Ref. line A-B. Constant throttle position with a rising rpm. At the point the arrow corsses into the 'Port Throttle Opening Region' (top left shaded area) the port throttles open and

the secondary injectors start firing.

2. Ref. line C-D. Constant rpm with increasing throttle position - logic as above.
3. Combination of the above: i.e. increasing throttle and rpm - logic as above.

LT5 PORT THROTTLE SWITCHING LOGIC

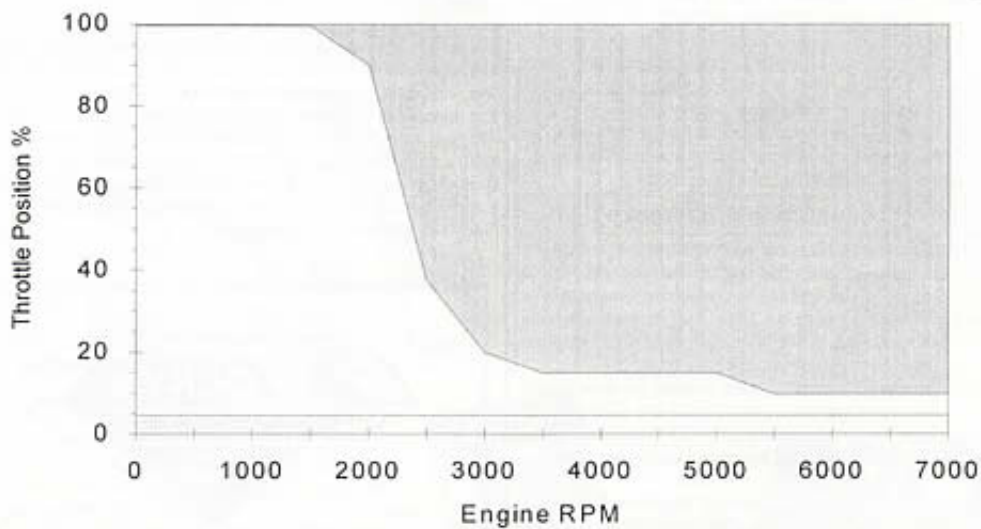
93-95 Model Years

LT5 PORT THROTTLE SWITCHING LOGIC

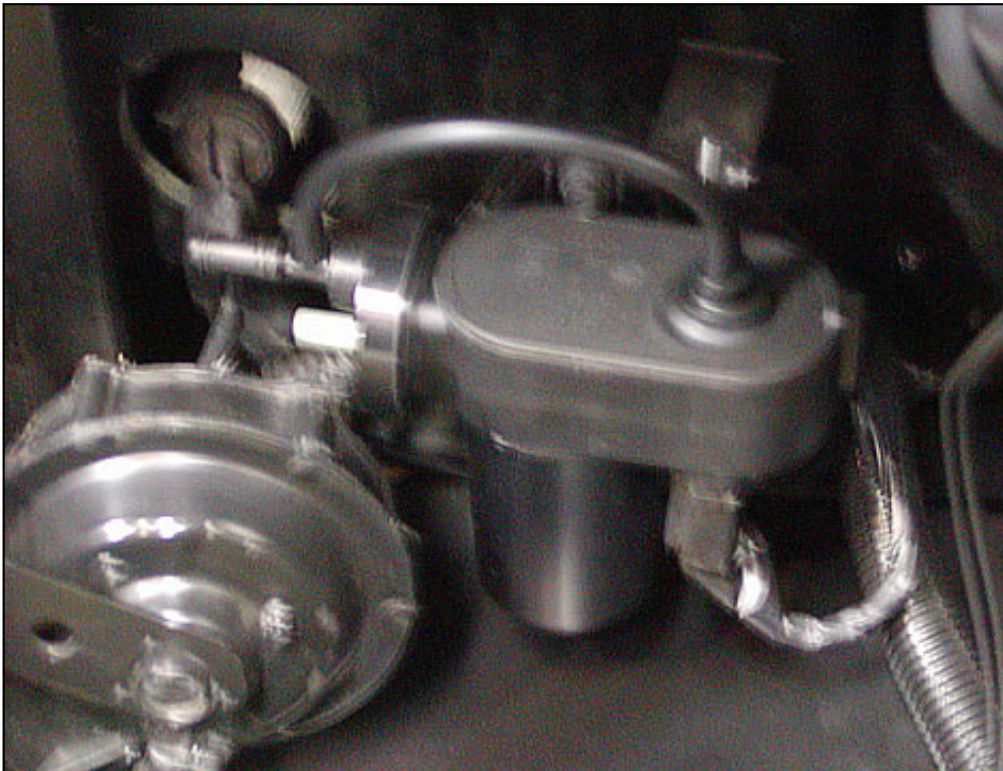
Figure 1 - Secondary Port Vacuum Pump - Part #10098474

The pump is located in front of the coolant reserve tank right underneath the headlight bucket on the passenger side of the engine compartment (see Figure 1 below). The pump should run for 5-10 seconds to prime the system and then turn off.

Unfortunately the quality of this photo is not as good as I'd like but good enough for this example. This is the secondary port vacuum pump located under the passenger side headlight bucket

So what does this pump do? There is a vacuum reservoir located under the plenum. If the vacuum level in the reservoir drops below 41 kPa (12" Hg) while the secondary port throttle valves are open, the pump is turned "on" by a vacuum switch to supplement engine vacuum.

If the pump cycles on and off every few seconds or it runs continuously, chances are, you have a vacuum leak somewhere in the system.

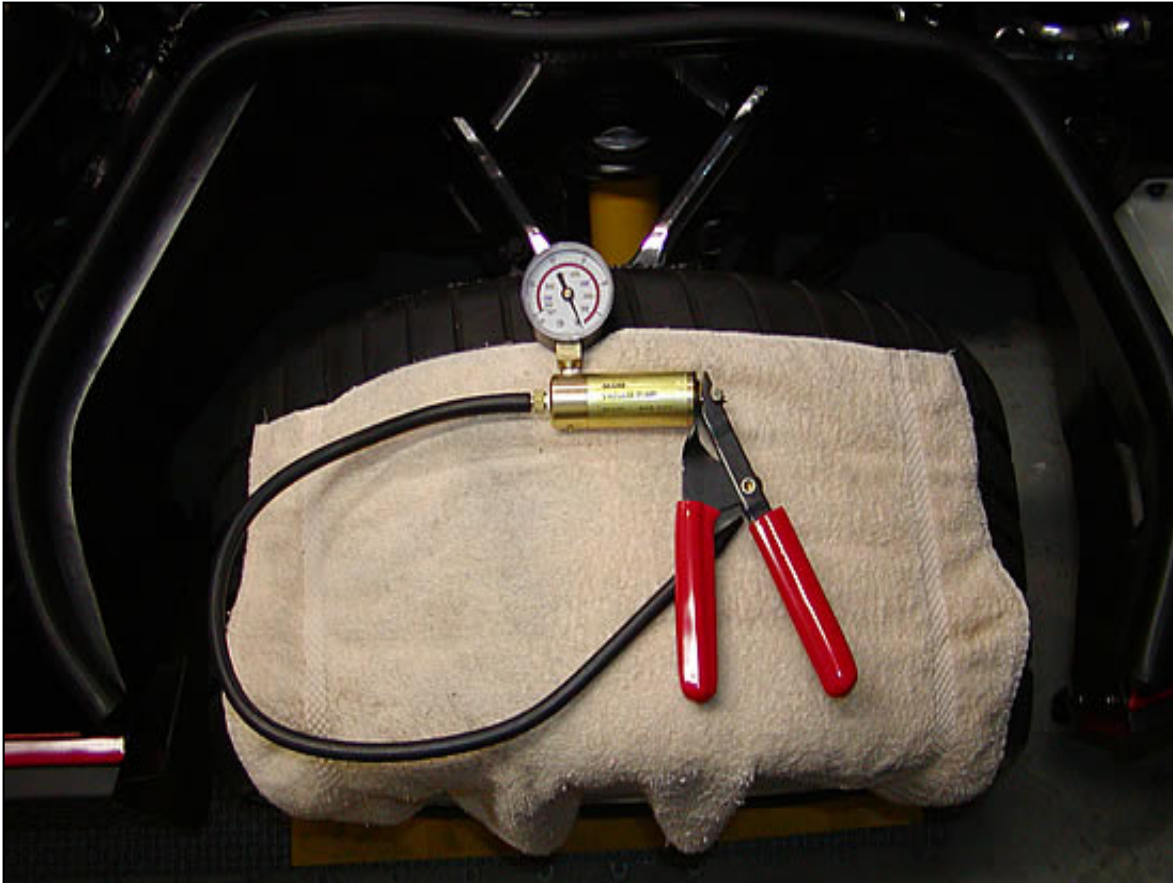
Figure 2 - Handheld Vacuum Pump

To begin, take a ride to your local Sears Automotive Center and purchase a hand held vacuum pump as shown below in Figure 2. This pump is extremely invaluable and will help you to locate the source of the vacuum leak. The pump comes with all necessary hose adapters.

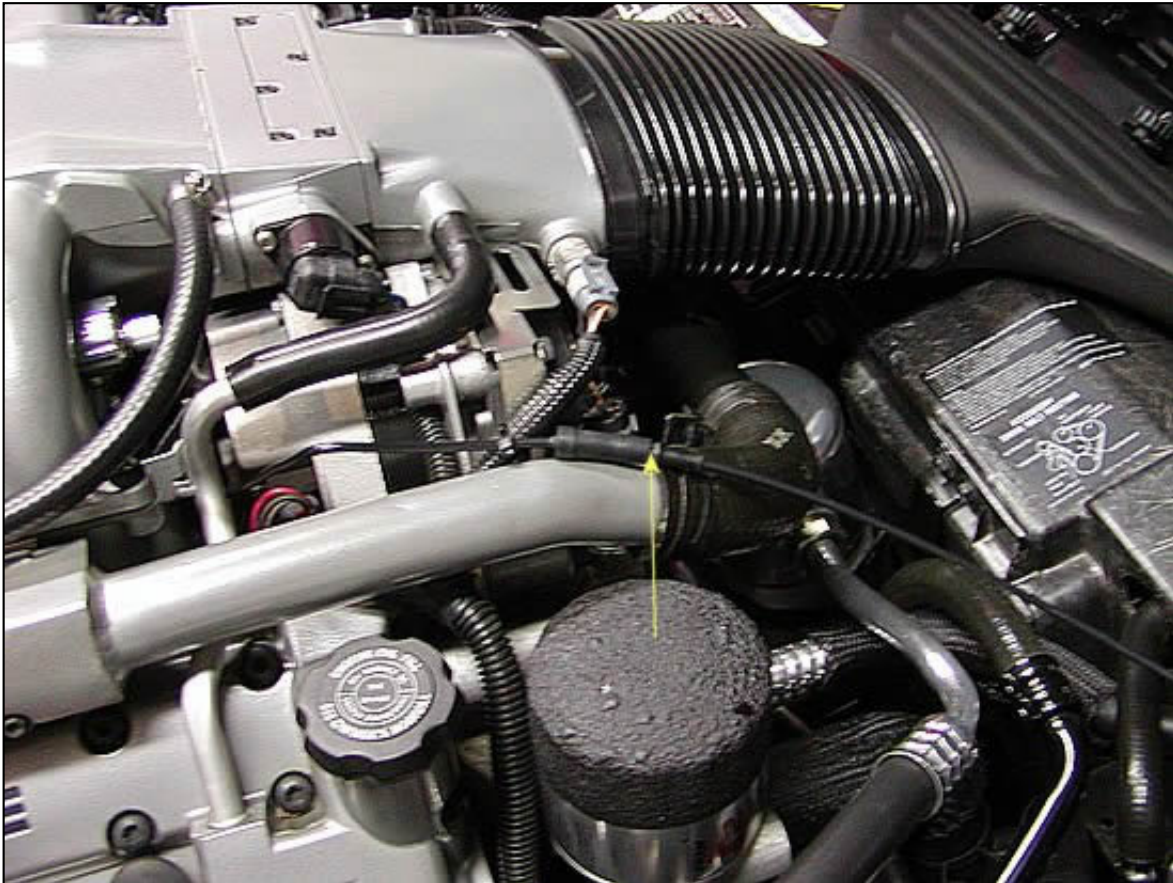
Figure 3 - Vacuum Connection

Figure 3 below shows the vacuum connection between the line going to the pump (right - see pump below) and the left hand vacuum system going underneath the plenum (left).

Disconnect the hose at this connection. At this point, with the engine key in the "On" position, the pump should turn on and run constantly. (Another way of verifying that the pump is operating correctly) Connect your hand held vacuum pump to the line going under the plenum and bring the system up to 10-12 Hg. If the system does not have a leak, the gauge needle will stay at that level. If there is a leak, it will slowly move back to zero. If there is no leak under the plenum, repeat the procedure at the other end of the hose going to the pump to determine if there is a leak on that side of the system.

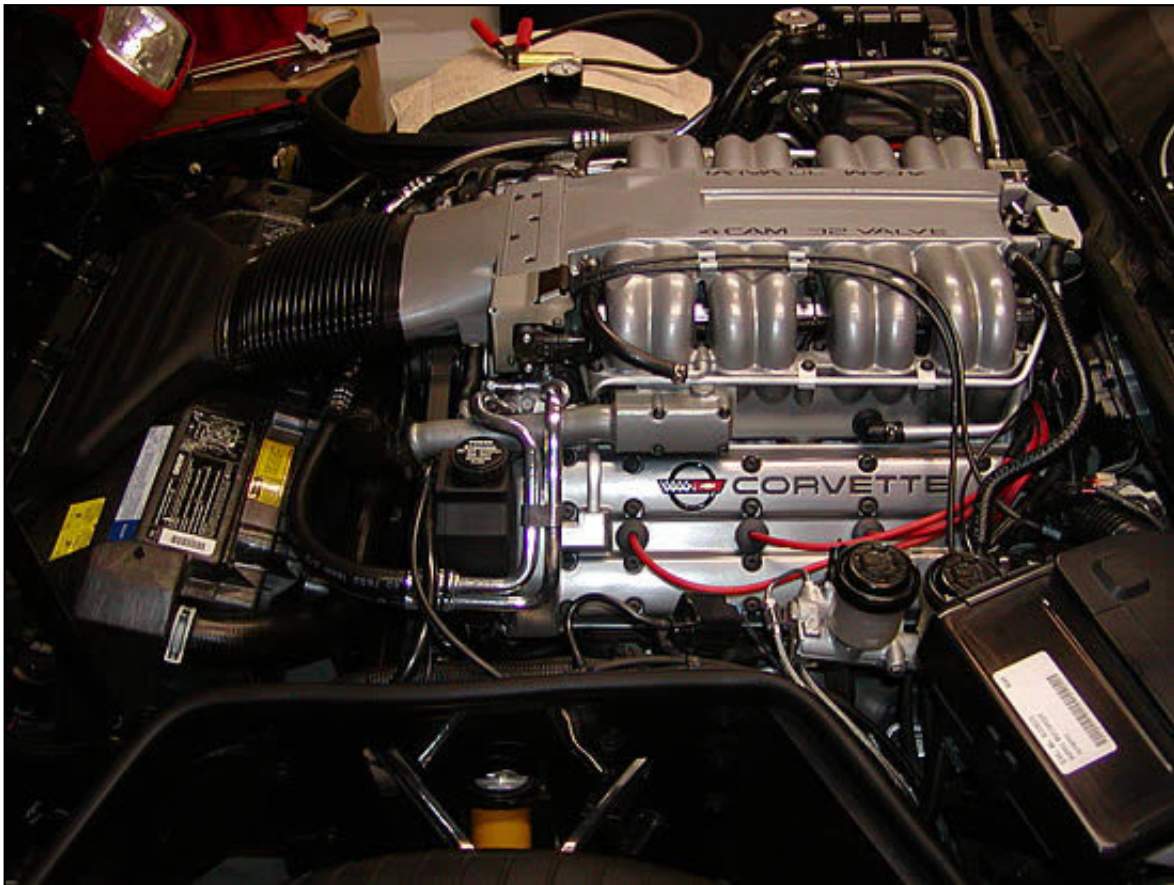
Figure 4 - LT5 Engine Prior to Plenum Removal

To put everything in perspective, below is an LT5 engine with the plenum on (Figure 4 below). With the plenum off, it's a much different picture than what you see here!

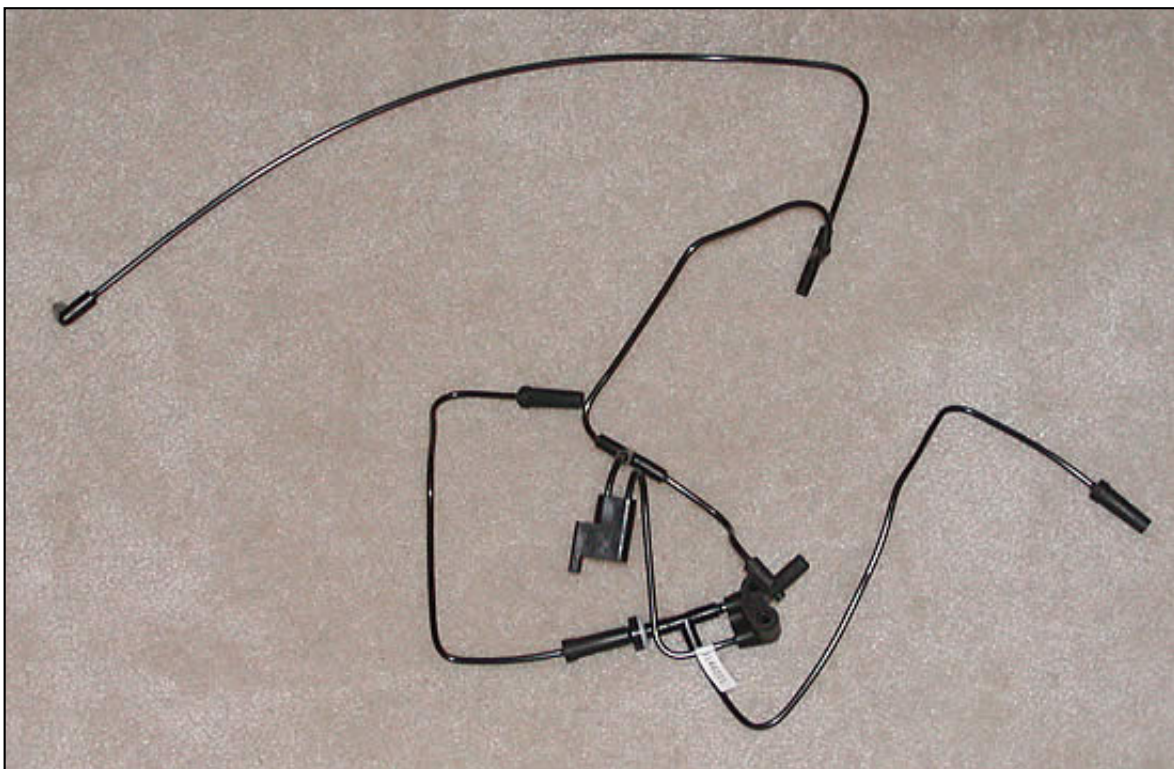
Figure 5 - Secondary Port Vacuum Hose Assembly

In this photo, you can see the entire secondary port vacuum hose assembly (Part #10146221). At

the lower right you can see the connector that is pointed to in the picture above. The upper left hand corner connects to another connector under the ECM.

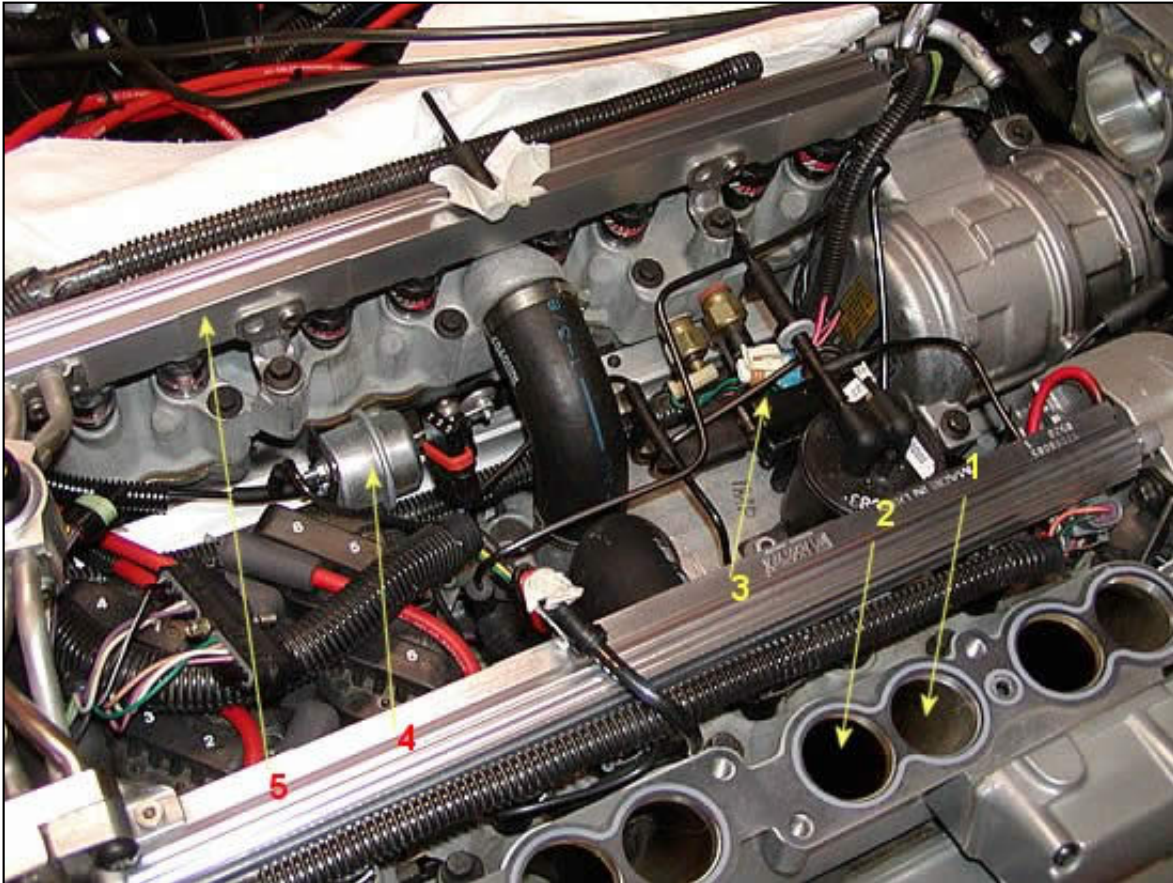
Figure 6A - Plenum Removed

1. Primary Port
2. Secondary Port
3. Secondary Port Control Solenoid
4. Secondary Port Vacuum Actuator (Part #1996743) (just to the right, you can see the metal arm and attachment going to the injector housing)
5. Fuel Rail Assembly with injectors inserted into the Injector Housing

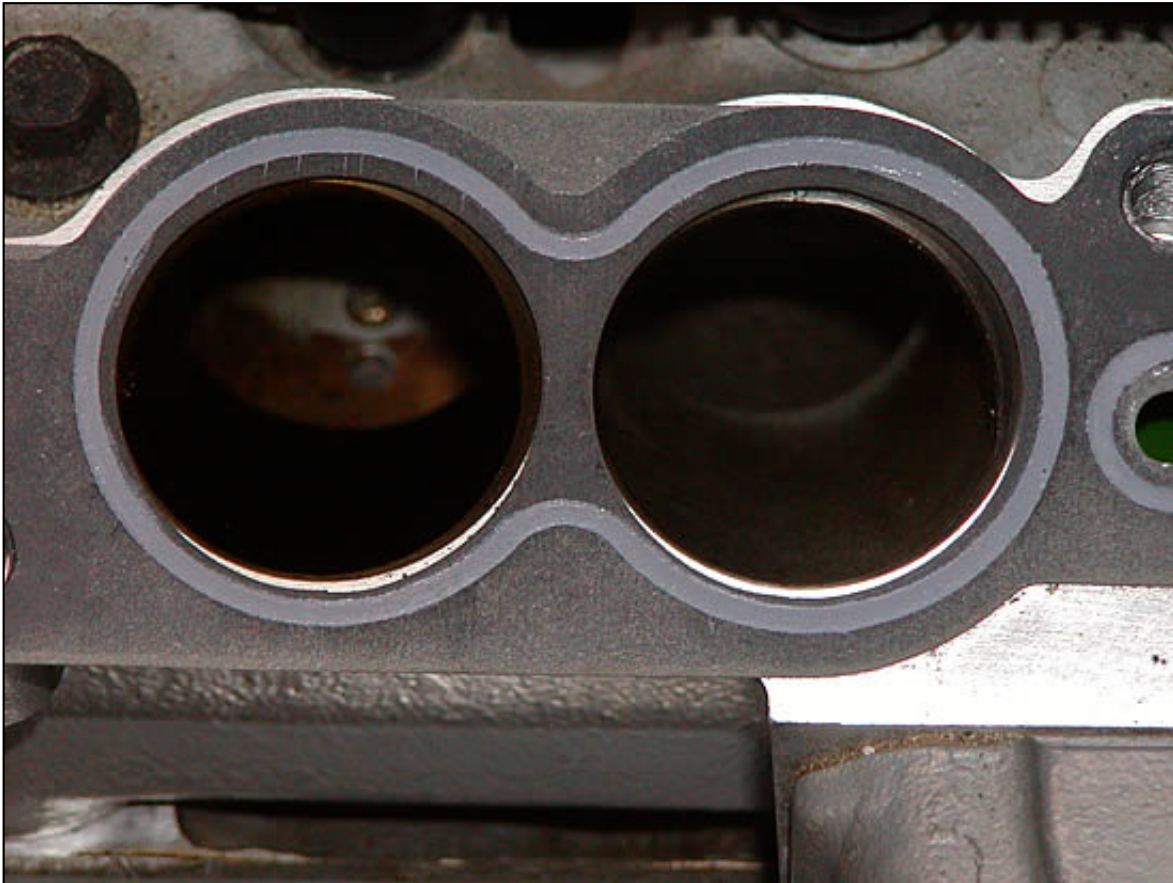
Figure 6B is a closeup view of a primary and secondary port. The primary port is on the right and the secondary port is on the left. You can see the butterfly valve inside the secondary port.

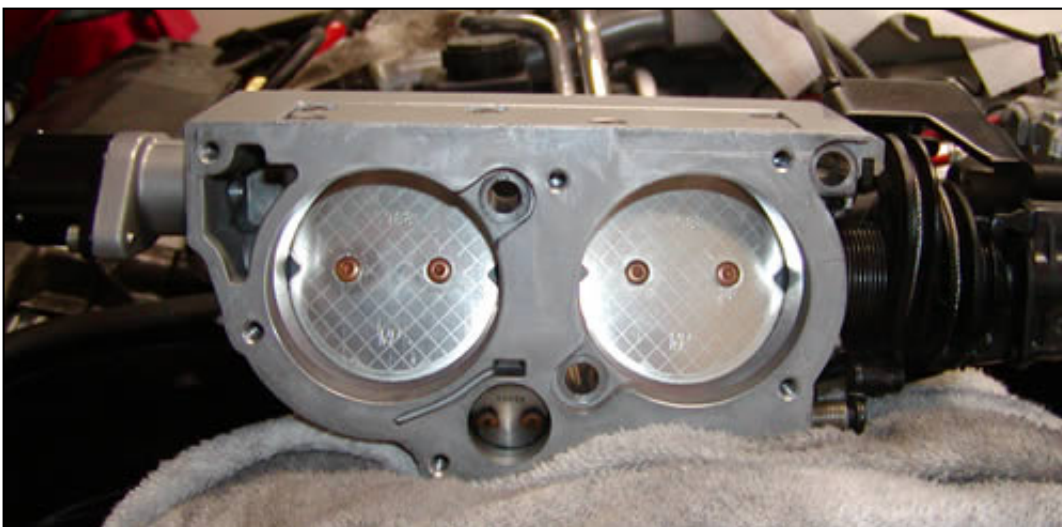
Figure 7- LT5 Throttle Body

In the center of the throttle body, at the bottom, you see the primary throttle valve which is 22 mm (0.87 in.) in diameter. Above are the two larger secondary valves which are 59 mm (2.32 in.).

The secondary throttle valves begin opening when the primary valve is 80% open and are completely open at full throttle.

"The primary throttle valve is operational when the vehicle speeds are less than approximately 113 km/h (70 mph) (level terrain cruise). The secondary throttle valves are opened at approximately 80 degrees of primary throttle opening."

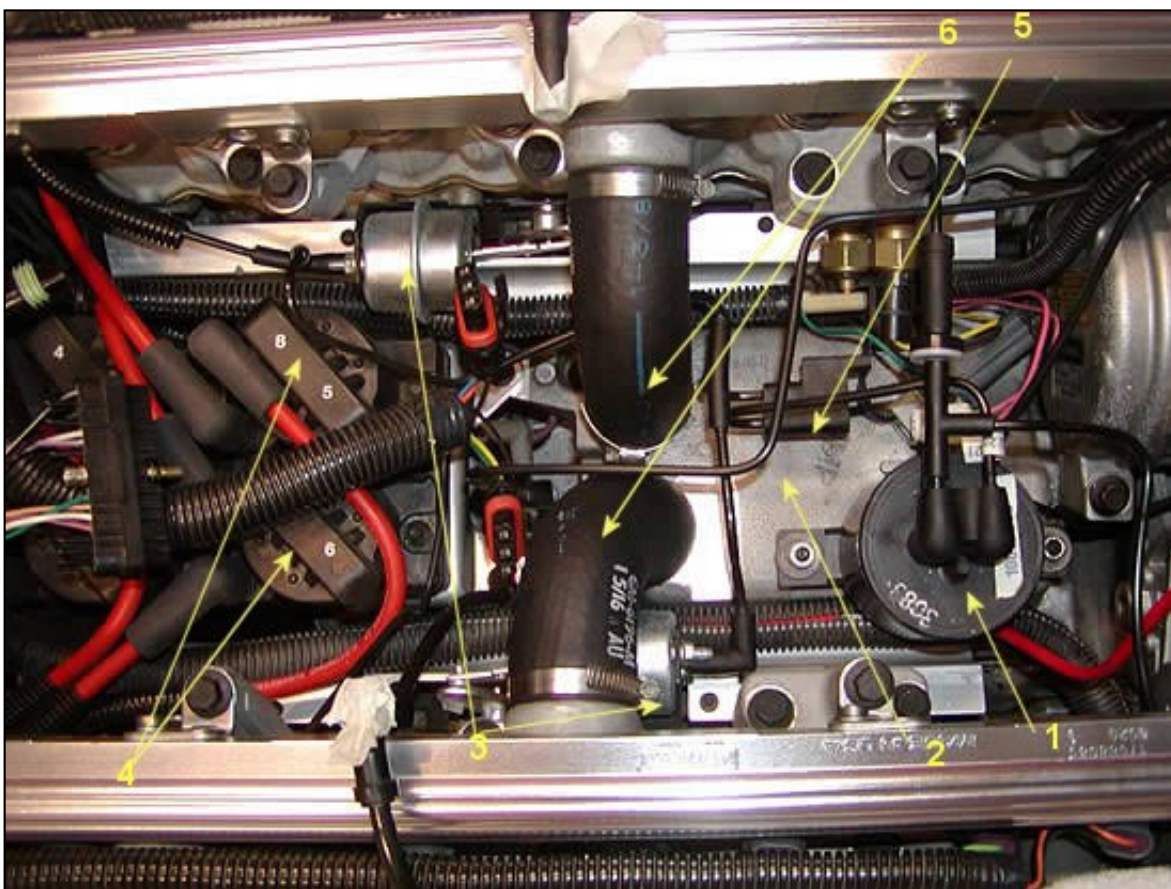
Figure 8 - Top View, Plenum Removed

1. Secondary Port Vacuum Reservoir (Part #10067563)
2. Crankcase Ventilation Cover
3. Secondary Port Vacuum Actuators (Part #1996743)
4. Ignition Coil Packs (starter is underneath them)
5. Vacuum connector which plugs into the Secondary Port Vacuum Solenoid
6. Crankcase Breather Hoses (Part #s 10110908, 10110907)

In this picture you can see the top of the Crankcase Ventilation Cover. For those of you with 1990 ZR-1s, this is a common area of oil seepage. The cover bolts were not torqued properly from the factory and can loosen up over time. If you notice the top of your engine V is damp with oil,

chances are, this is the source. It's a good idea to replace the Crankcase Breather Gasket underneath (Part #10168682) and retorque the bolts.

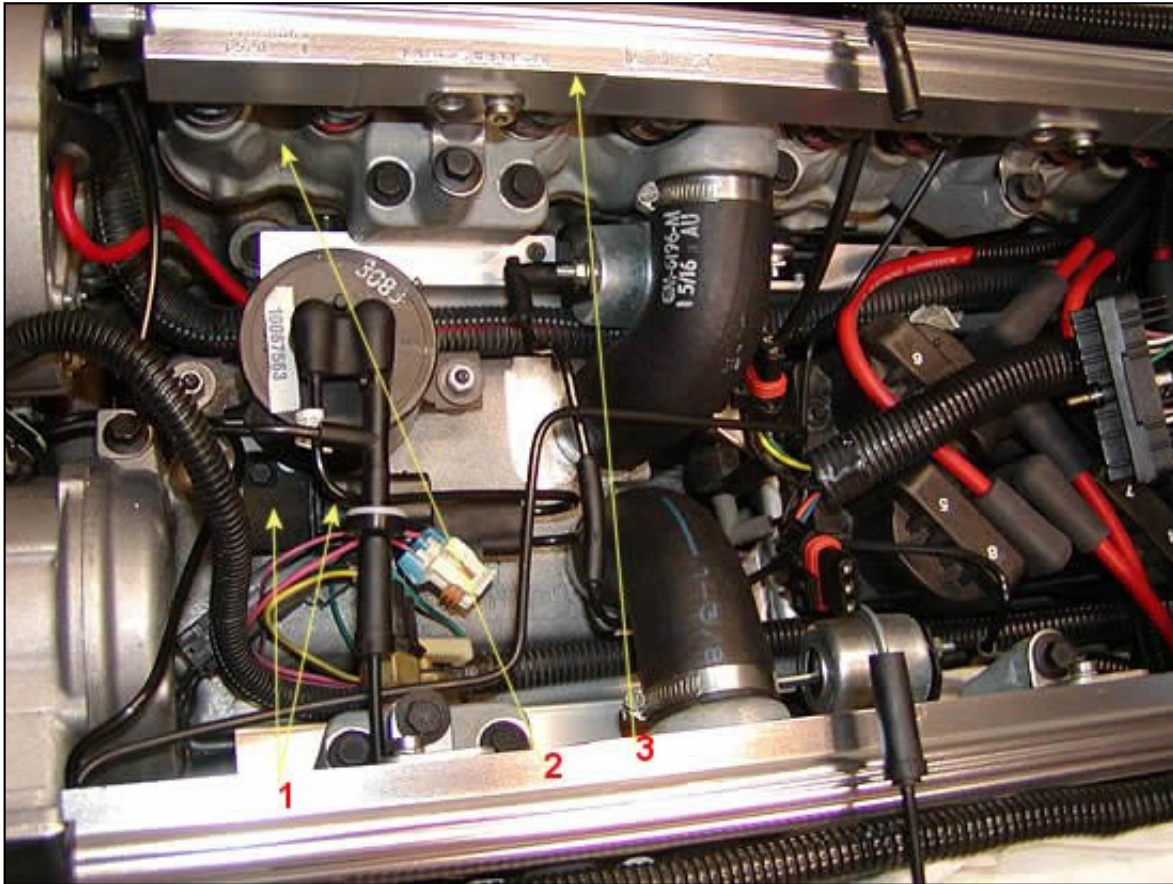
1. Vacuum Solenoid with conical air filter (Part #1997222), Conical Air Filter Part #: 10159525
2. Injector Housing
3. Fuel Rail

Figure 9 is a different angle taken from the driver's side of the engine looking down at the vacuum solenoid.
