# N202315731 Wheel Casting with Exposed Porosity on Extra Set of Wheels

Release Date: March 2021 Revision: 00

Condition	Certain 2020 model year Chevrolet Corvette vehicles may have a condition where exposed porosity in wheel castings are larger than allowed and do not meet internal GM requirements. Vehicles in this field action are to have two sets of wheels inspected. The wheels on the vehicle are inspected under N202315730 and the extra wheels are inspected under this field action.
Correction	Dealers are to inspect the wheels and replace if necessary.

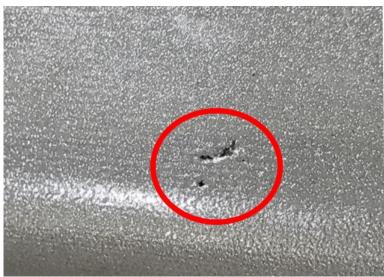
### Rim:

The following photos show examples of the porosity condition covered by this bulletin.

3. If any of the above conditions are found, initiate the Pre-Repair Authorization (PRA) process for a wheel replacement authorization:
