# 1970 Corvette: Service News: Front Fender Side Louver Replacement

**Subject:** Front Fender Side Louver Replacement

**Model and Year:** 1970 Corvette

**Source:** Chevrolet Service News

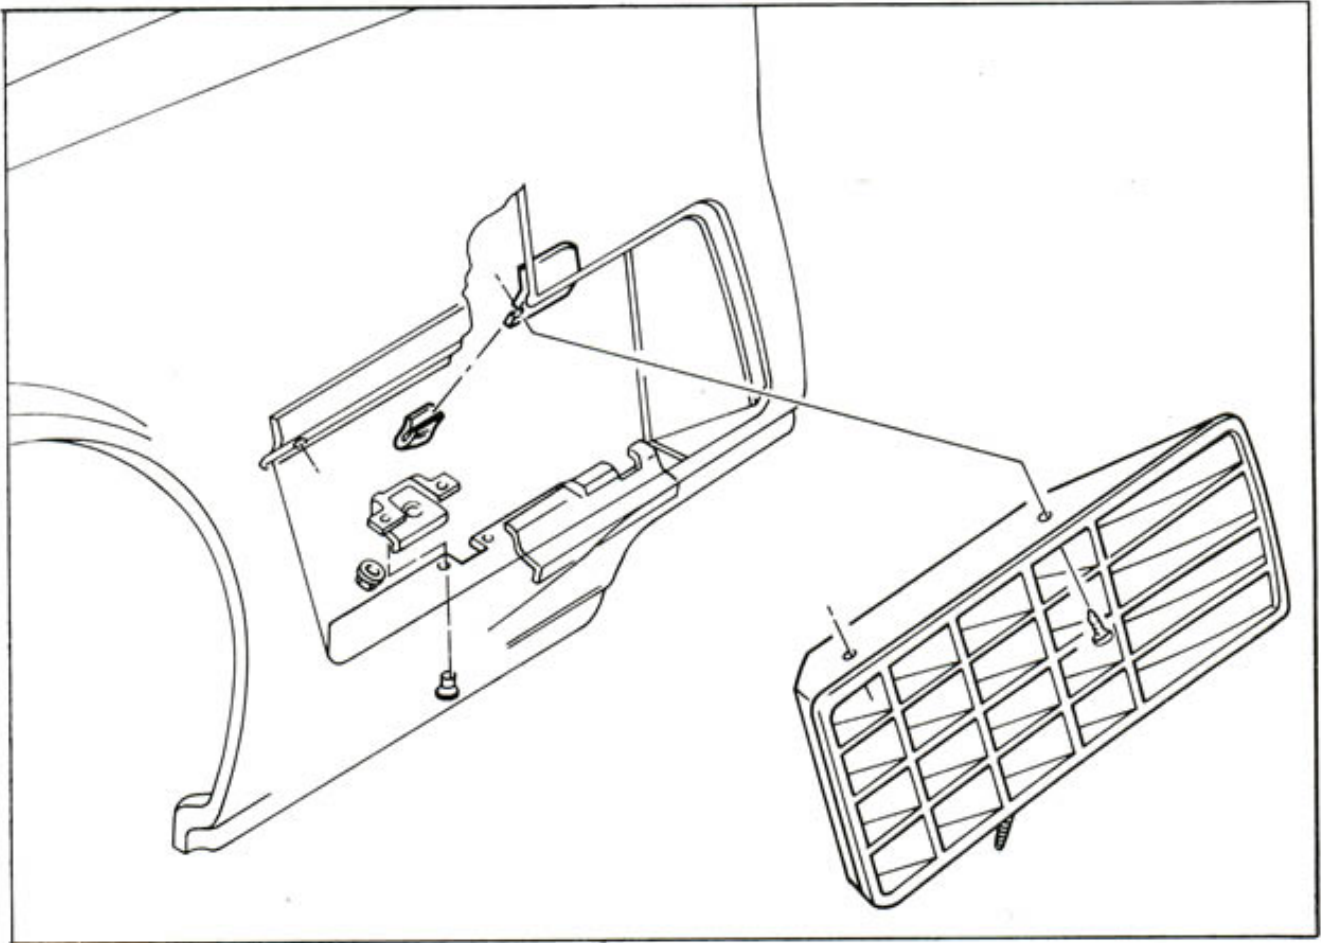
**Figure 1—Fender Side Louver**

1. Reach up beneath the front fender lower edge and remove a locknut threaded on a stud fastened to the bottom of the louver.
2. From the outside, remove (2) screws driven through the upper edge of the louver.
3. Gently lift the louver up and off the fender.
4. Reverse Steps 1-3 for installation.
