2014 - 2016 Corvette: Service Bulletin: #16-NA-170: Brake Pulsation and/or Vibration During Brake Apply

#16-NA-170: Brake Pulsation and/or Vibration During Brake Apply - (July 20, 2016)

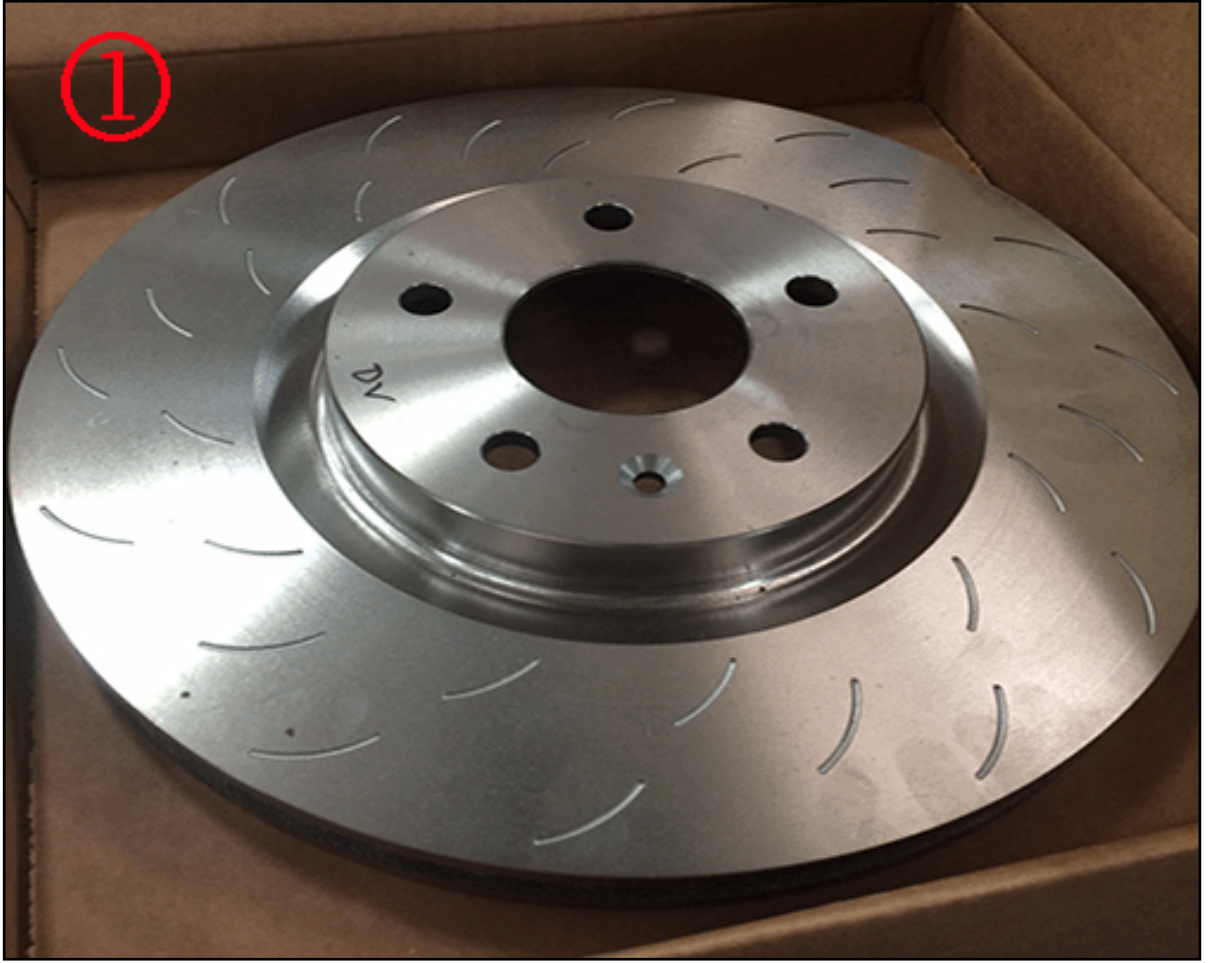
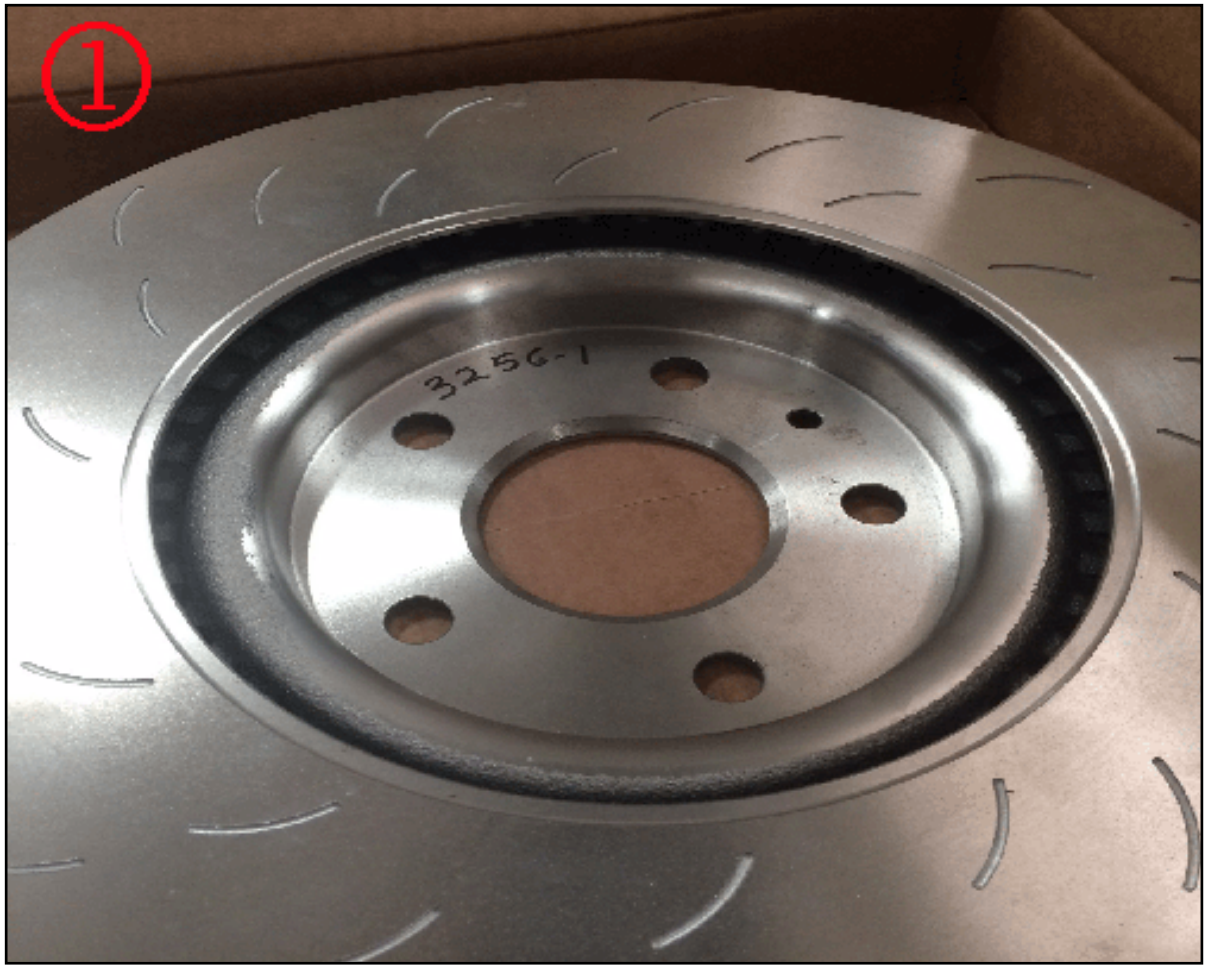
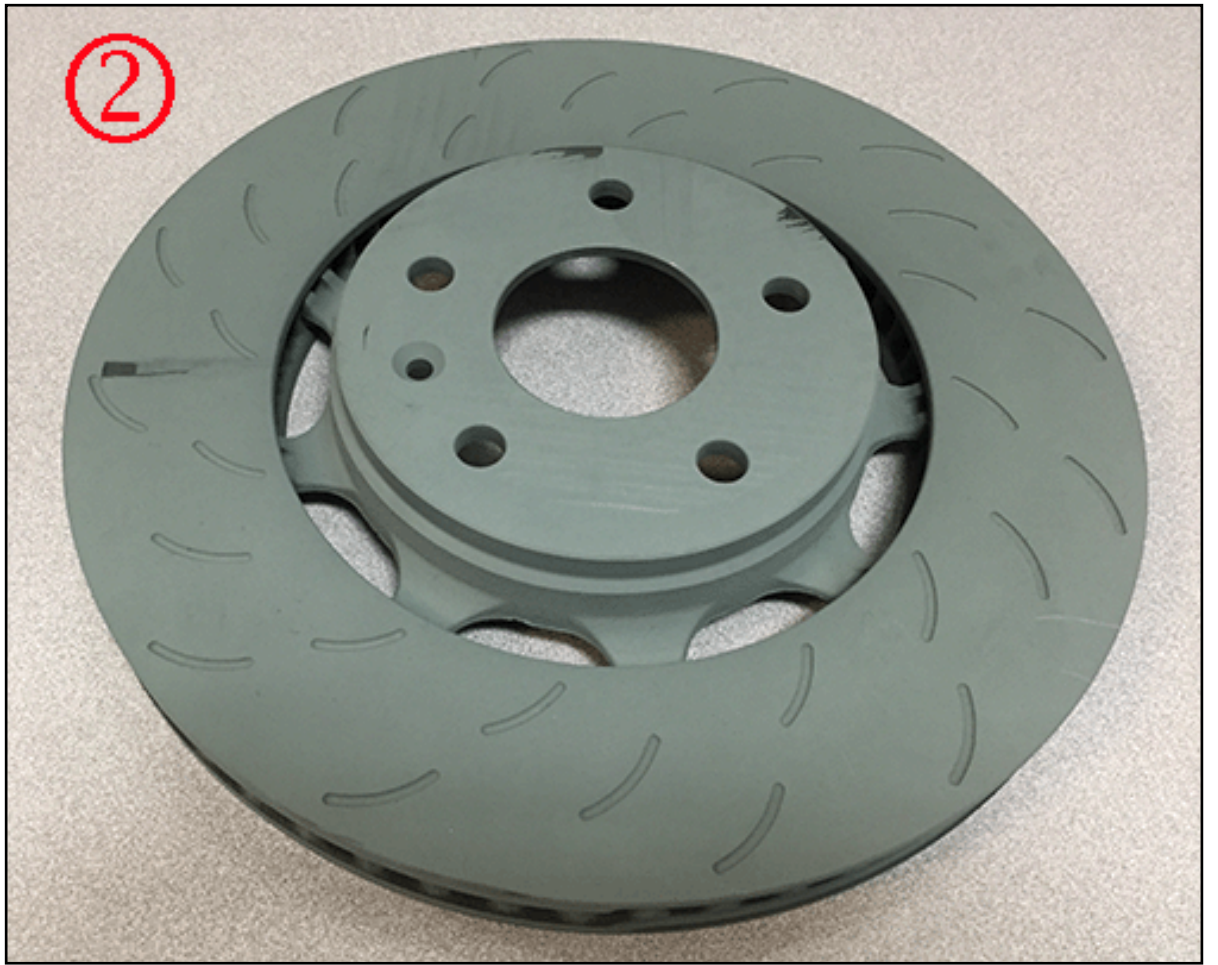
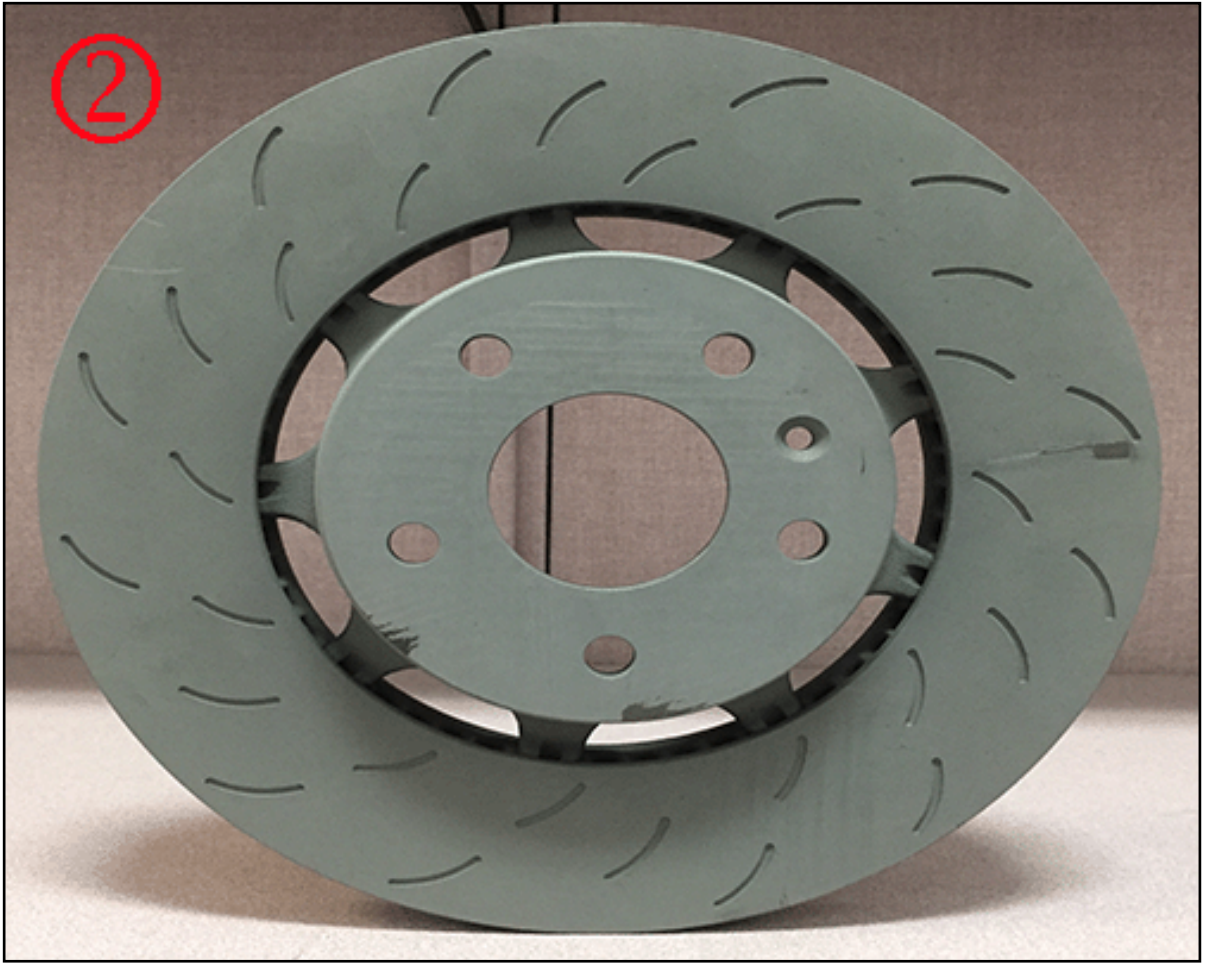
①

Customer may also comment they hear a rattle noise from the wheel area. The noise may go away when the brakes are lightly applied. This condition may be due to excessive lateral runout (LRO) or interation between the inner top hat section to the rotor ring.

- For front rotors and vehicles built prior to May 31, 2016, replace old two piece design (2) with new one piece design (1).
- For rear rotors and vehicles built prior to July 23, 2015, replace old two piece design (2) with new one piece design (1).

Important: The rotors *MUST* be replaced as a pair due to a design change.

Refer to *Brake Rotor Assembled Lateral Runout Correction* and *Front and Rear Brake Rotor Replacement-Both Sides* in SI.
