2014 - 2016 Corvette: Service Bulletin: #16-NA-170: Brake Pulsation and/or Vibration During Brake Apply

#16-NA-170: Brake Pulsation and/or Vibration During Brake Apply - (July 20, 2016)

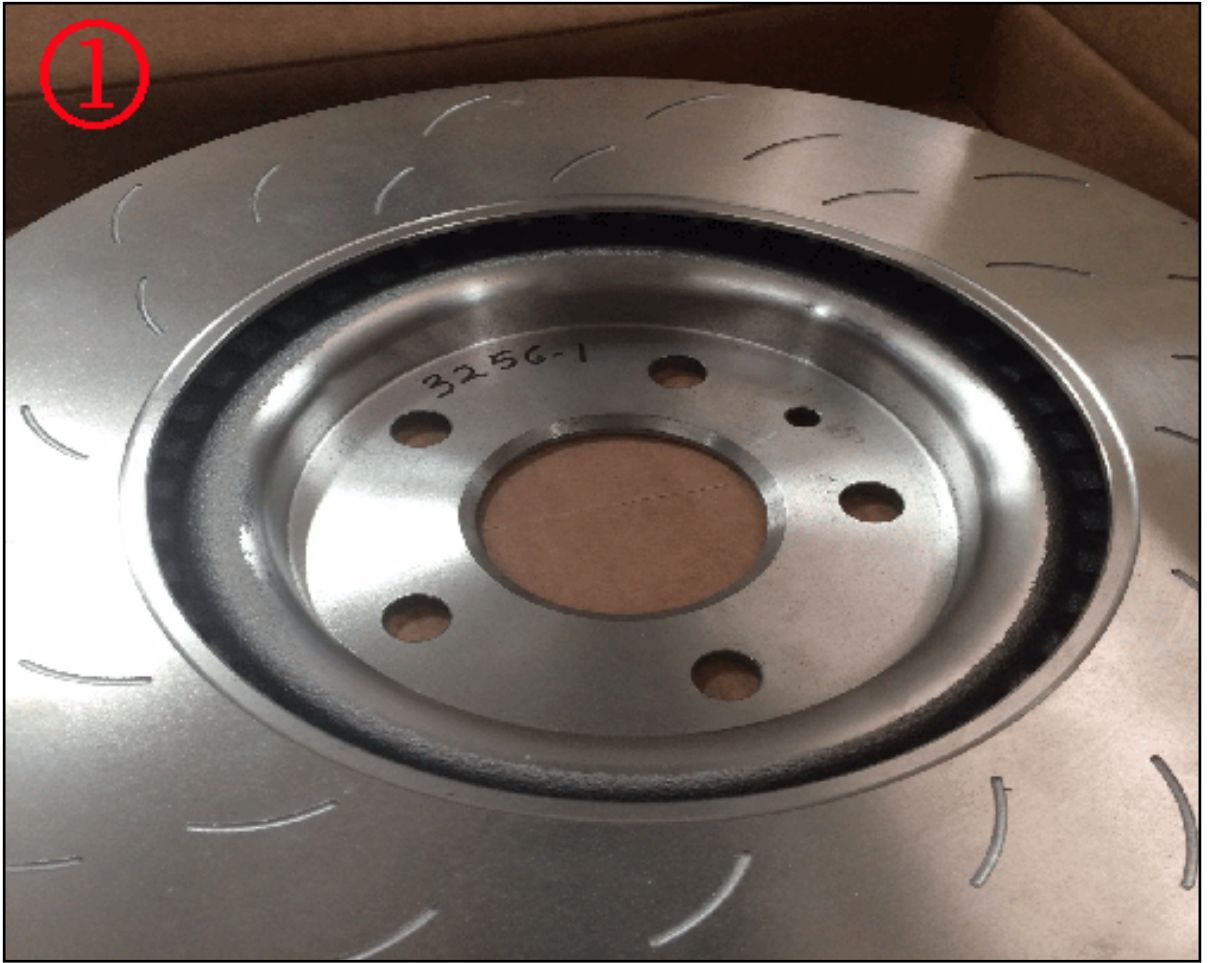
①

Customer may also comment they hear a rattle noise from the wheel area. The noise may go away when the brakes are lightly applied. This condition may be due to excessive lateral runout (LRO) or interation between the inner top hat section to the rotor ring.

- For front rotors and vehicles built prior to May 31, 2016, replace old two piece design (2) with new one piece design (1).
- For rear rotors and vehicles built prior to July 23, 2015, replace old two piece design (2) with new one piece design (1).

Important: The rotors *MUST* be replaced as a pair due to a design change.
