**2015 - 2017 Corvette Z06: Service Bulletin:  
 #PIP5395B: Ticking Rattle Or Buzz Noise Heard  
 The Best In The Passenger Compartment - (Mar  
 20, 2017)**

**#PIP5395B: Ticking Rattle Or Buzz Noise Heard The Best  
 In The Passenger Compartment - (Mar 20, 2017)**

This PI was superseded to update Recommendation/Instructions. Please discard PIP5395A.

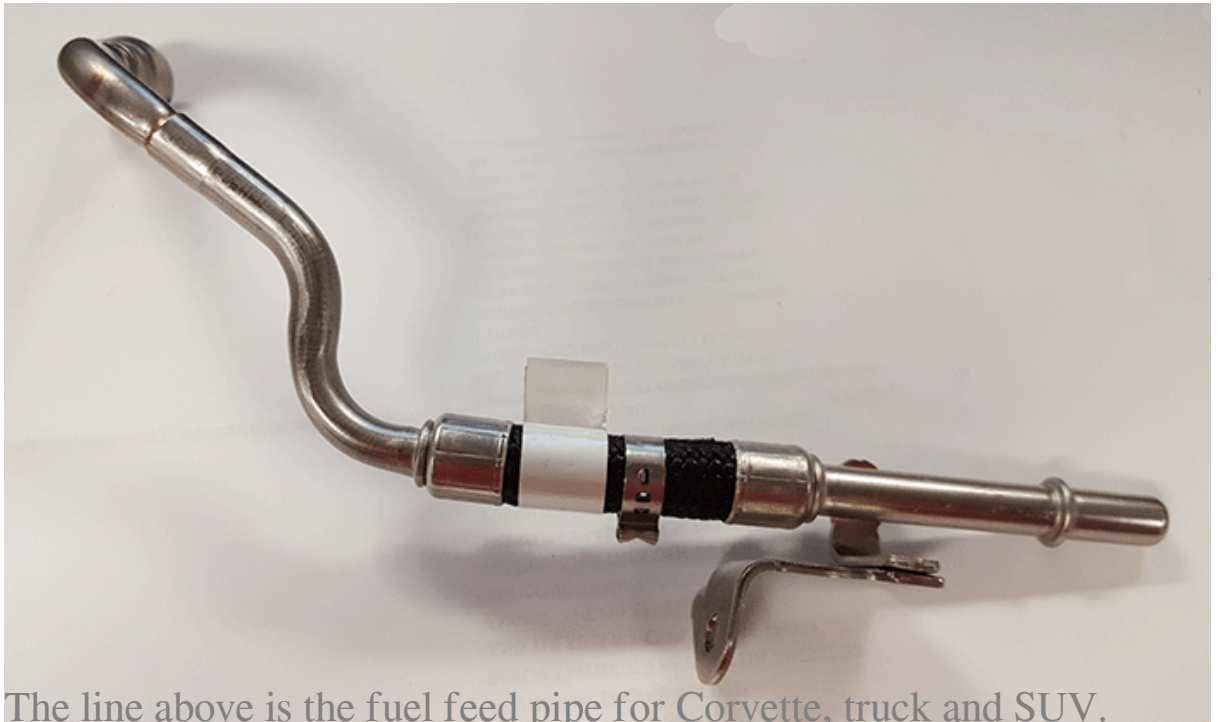
The line above is the fuel feed pipe for Corvette, truck and SUV.

This line connects the chassis fuel line to the high pressure fuel pump.

The fuel feed line between the high pressure fuel pump and chassis fuel line could be the cause allowing high pressure pulsation back to the low side of the fuel system. There is not a good way to test the check valve, the line will need to be replaced.

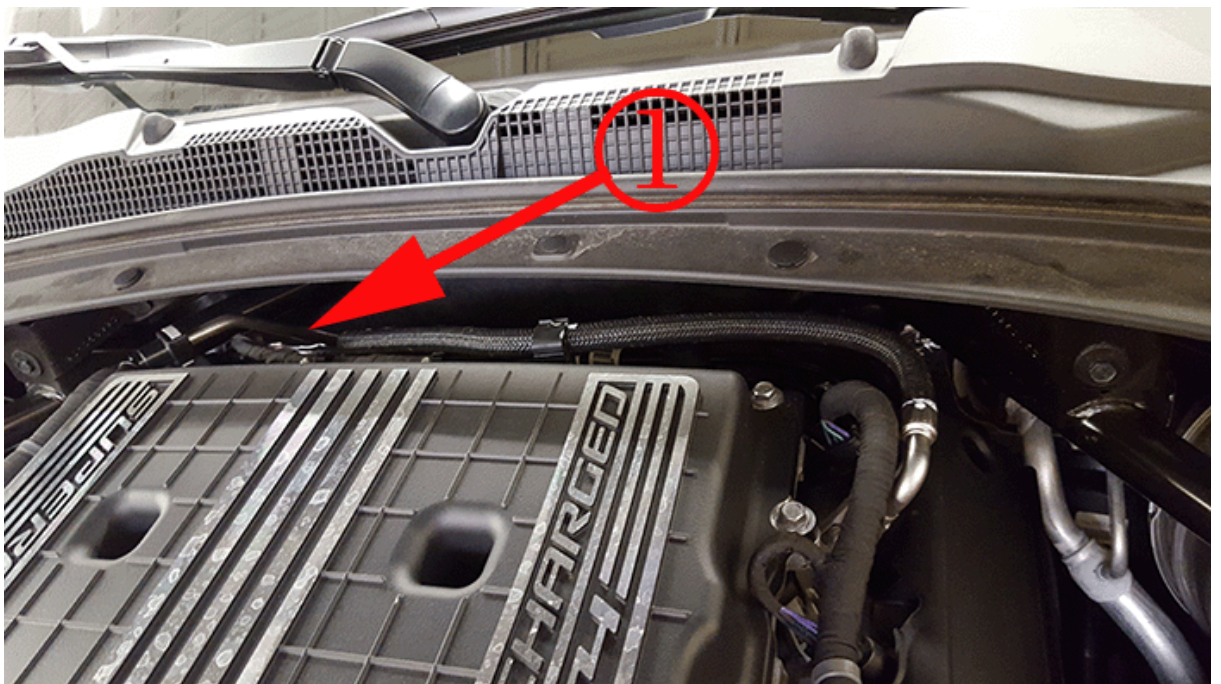
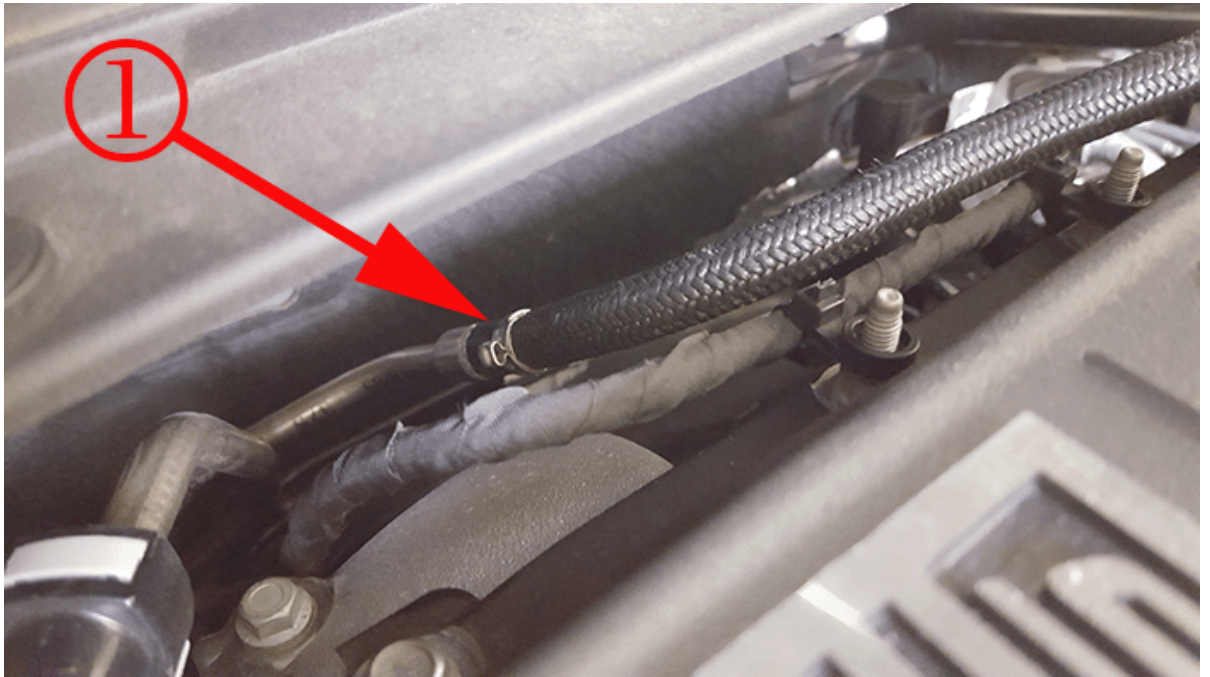
These pictures above shows the chassis fuel feed pipe for the LT4 supercharged ZL1 Camaro.

On LT1 Camaro and LT4 CTS-V this line would have a jumper line with quick disconnects at both ends.

One end will connect to the chassis line and the other to the high pressure pump feed line.
