# 1966 Corvette: Product Data Book: Radiator Grille Supports

**Subject:** Radiator Grille Supports

**Model and Year:** 1966 Corvette

**Source:** Technical Service Department - Product Data Book

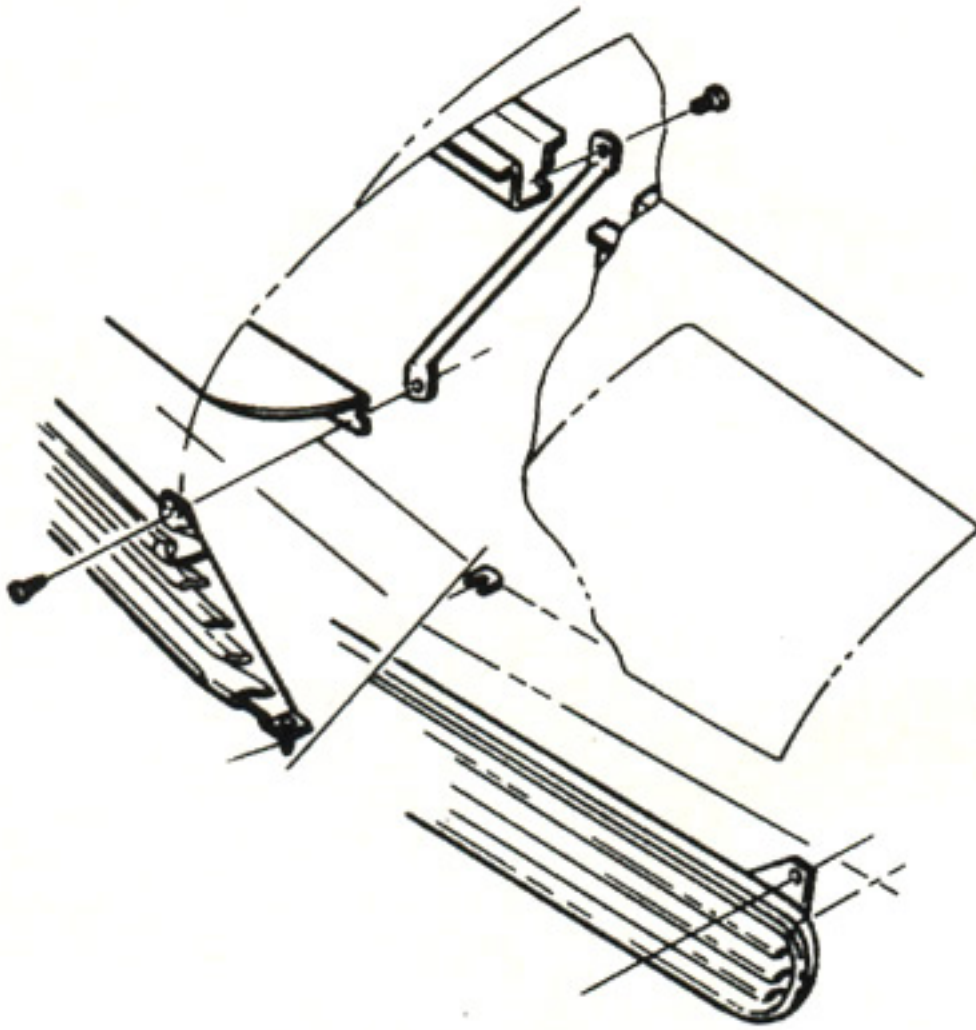
**FIGURE 1**

When 1966 Corvettes are driven on rough surface roads, there is a possibility the outer grille supports may break at the body attaching locations.

In production, starting with serial #S115499, the radiator grille supports are of an improved design and a radiator support rod has been added at the center. This is similar to 1965 production.

If outer grille support breakage is encountered on vehicles built prior to serial #S115499, install radiator grille supports, Part No. 3897389, and center radiator support rod, Part No. 3897387. (fig. 1).
