# 2014 - 2020 Corvette: Service Bulletin: #17-NA-271: Clicking Noise from Front Wheels While Turning at Slow Speeds

## #17-NA-271: Clicking Noise from Front Wheels While Turning at Slow Speeds - (Oct 13, 2020)

**Subject:** Clicking Noise from Front  
Wheels While Turning at Slow  
Speeds

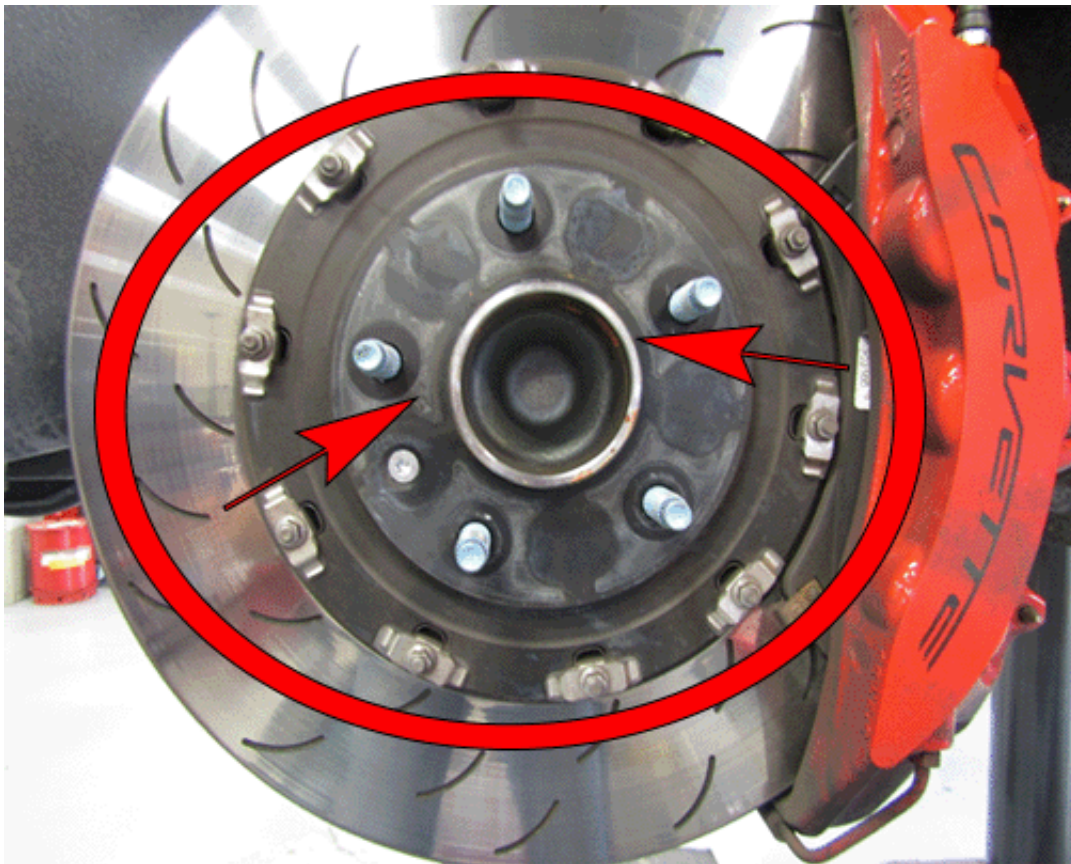
- Clean the wheel mounting surface of the brake rotors, or sometimes referred to as the brake rotor top hats, as follows:

- Using 3M red Scotch-Brite 7447 pad or equivalent with approved brake cleaner (ex. Part number 19370705 (U.S.), 88901247 (Canada)), wipe the wheel mounting surface of the rotor (brake rotor top hat) and the wheel pilot at the center of the

rotor, removing any residual grey or black material that has accumulated on the rotors.

**Note:** All cleaning must be done by hand. *DO NOT* use pneumatic or power tools.
