1984 - 2021 Corvette: Service Bulletin: #PI0754D: Rear and Side Tempered Glass Spots (Quench Marks) - (Nov 6, 2020)

#PI0754D: Rear and Side Tempered Glass Spots (Quench Marks) - (Nov 6, 2020)

Subject: Rear and Side Tempered Glass Spots (Quench Marks)
Models: 2021 and Prior GM Passenger Cars and Trucks
Attention: This PI also applies to any of the above models that may be Export from N

This PI has been revised to add the 2020-2021 Model Years. Please discard PI0754C.

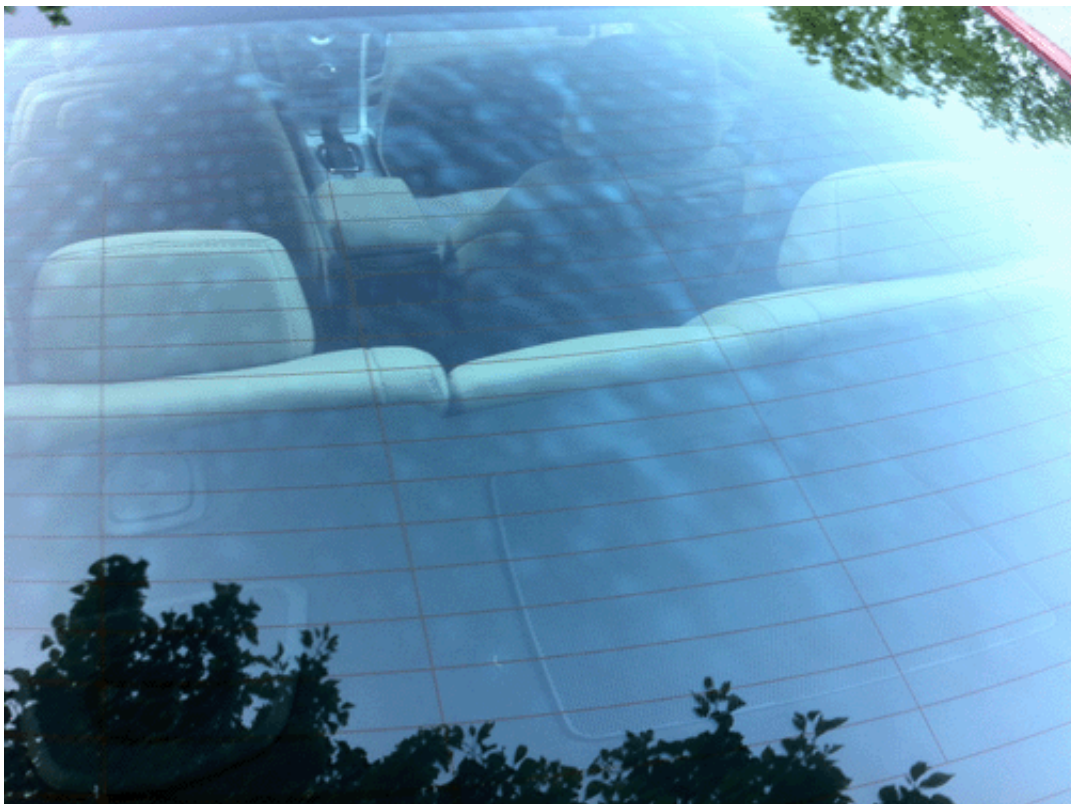
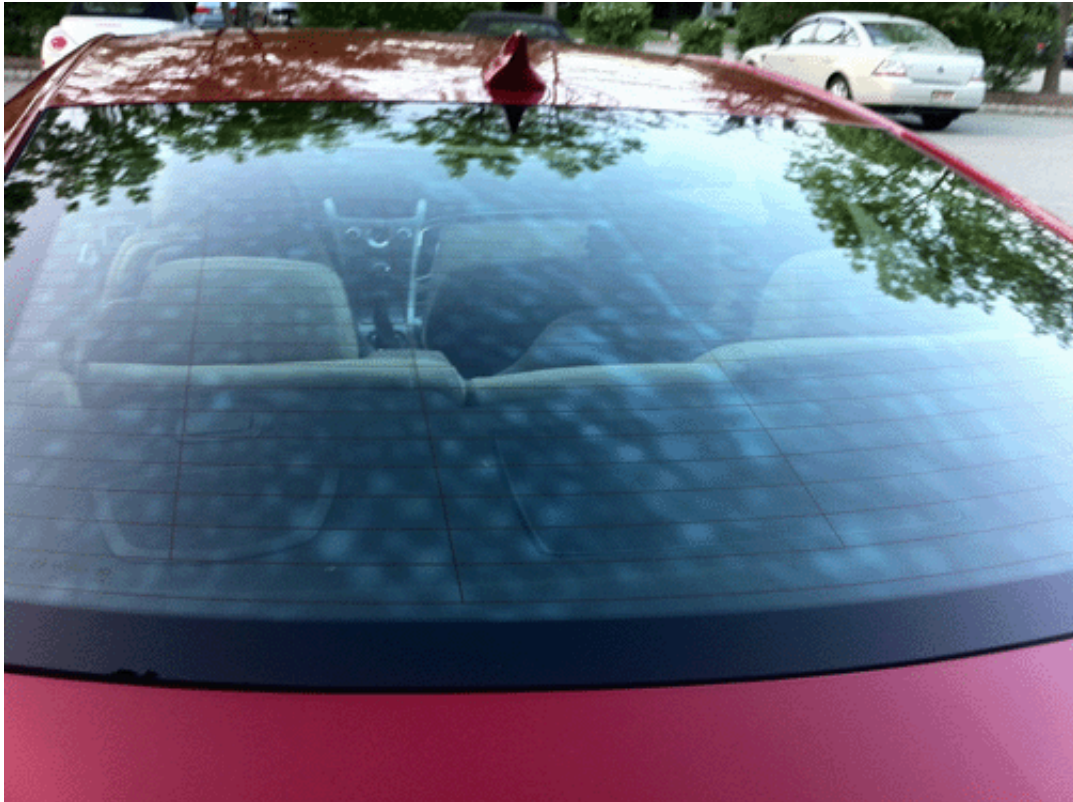
Some customers may comment on spots showing on the rear and side windows when the vehicle is in the sunlight. When wearing polarized glasses/sunglasses, these spots may be more magnified.

The spots are due to the manufacturing process and are “quench marks” in the glass. Quench marks are an unintentional side effect of the tempering process.

Technicians should explain to the customer that this is a normal condition and part of the manufacturing process for tempered glass. Do not replace the window(s) for this condition.

Note: This will not be seen on front windshields or laminated side glass.
