1984 - 2021 Corvette: Service Bulletin: #PI0754D: Rear and Side Tempered Glass Spots (Quench Marks) - (Nov 6, 2020)

Subject: Rear and Side Tempered Glass Spots (Quench Marks)

Models: 2021 and Prior GM Passenger Cars and Trucks

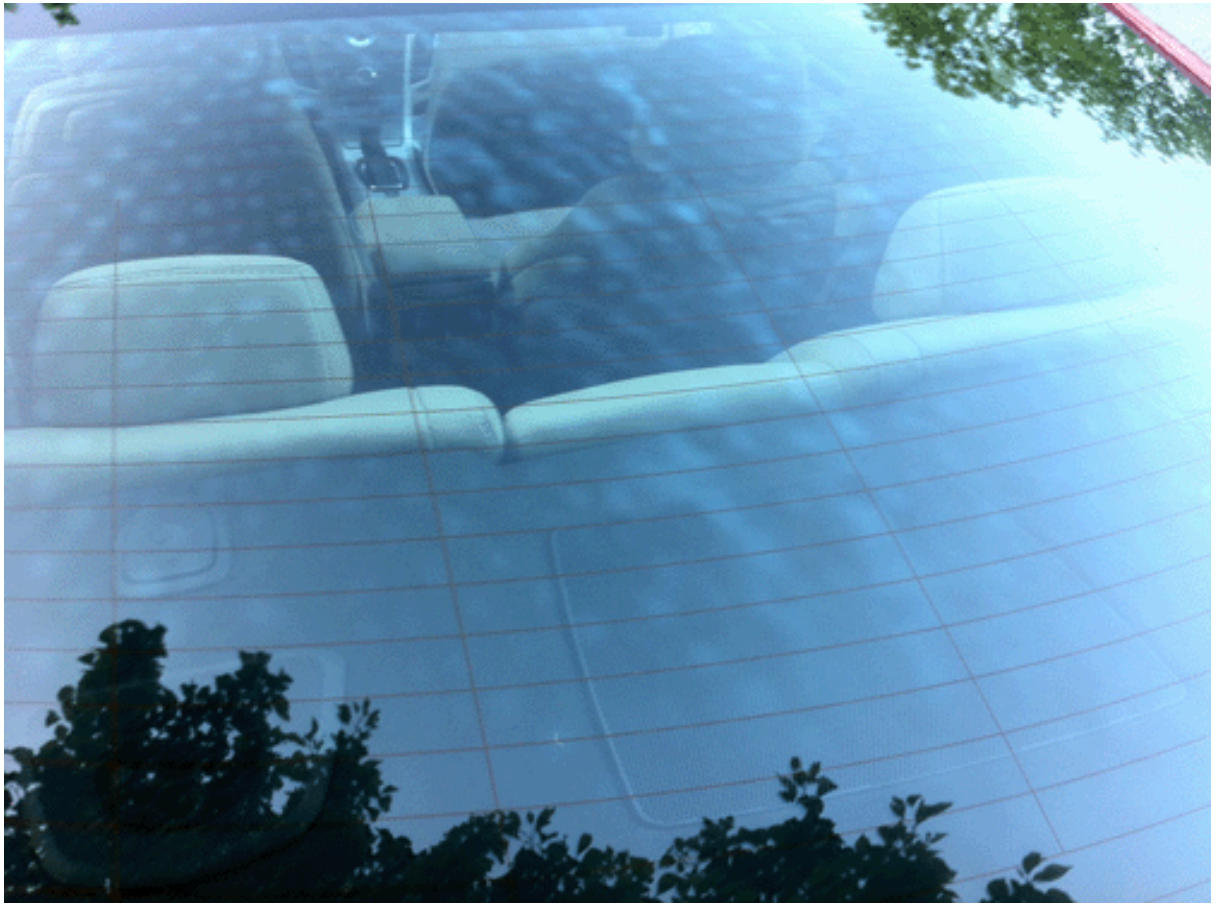
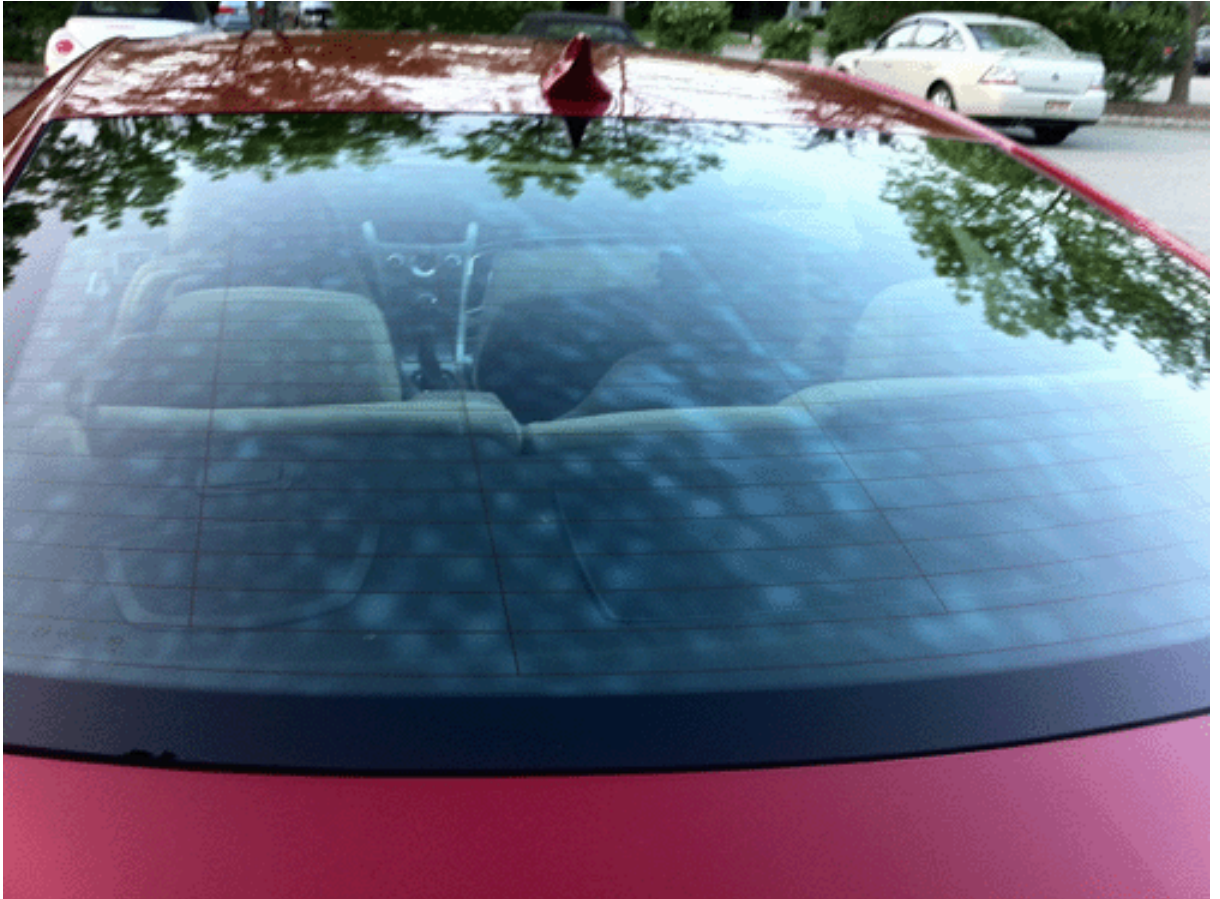
Some customers may comment on spots showing on the rear and side windows when the vehicle is in the sunlight. When wearing polarized glasses/sunglasses, these spots may be more magnified.

The spots are due to the manufacturing process and are “quench marks” in the glass. Quench marks are an unintentional side effect of the tempering process.

Technicians should explain to the customer that this is a normal condition and part of the manufacturing process for tempered glass. Do not replace the window(s) for this condition.

Note: This will not be seen on front windshields or laminated side glass.
