1984 - 2021 Corvette: Service Bulletin: #PI0754D: Rear and Side Tempered Glass Spots (Quench Marks) - (Nov 6, 2020)

Subject: Rear and Side Tempered Glass Spots (Quench Marks)

Models: 2021 and Prior GM Passenger Cars and Trucks

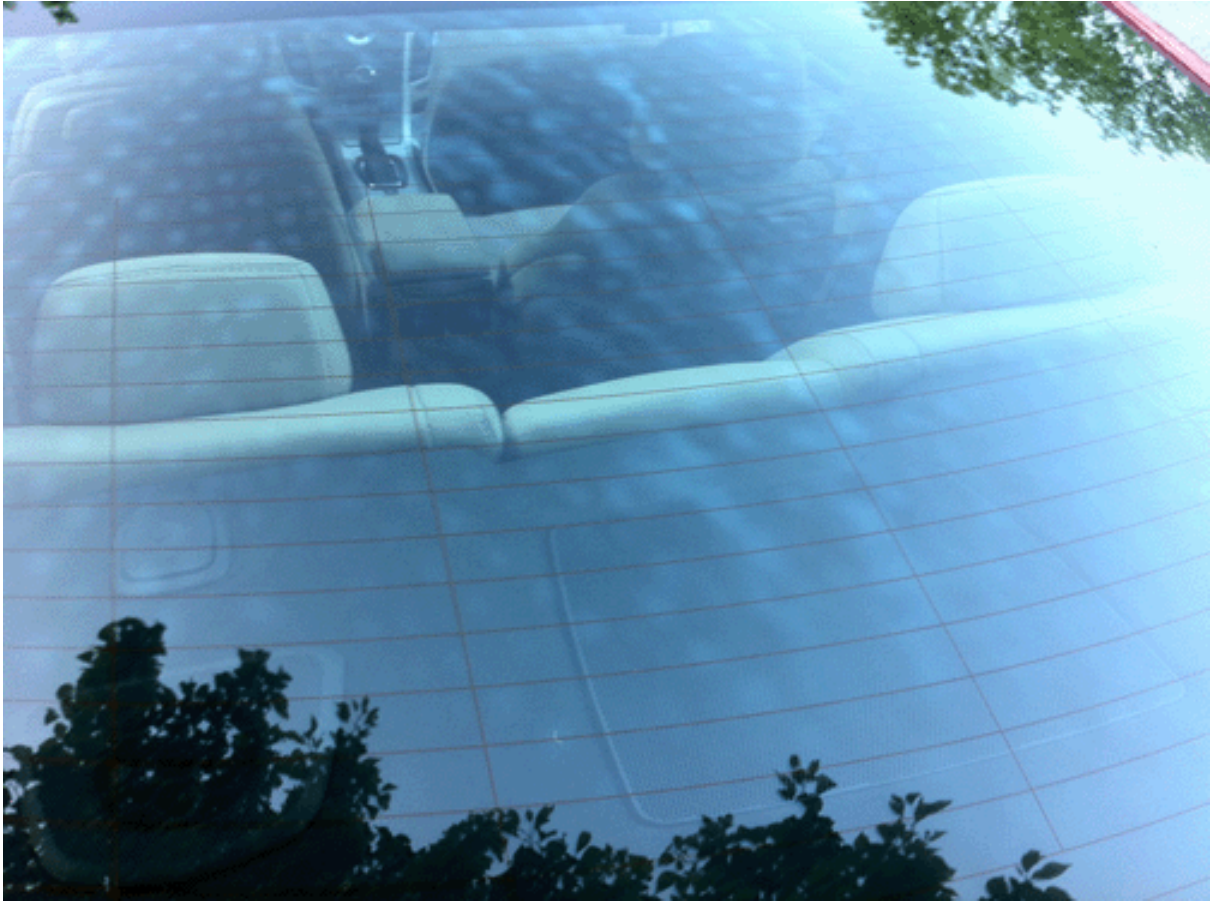
Some customers may comment on spots showing on the rear and side windows when the vehicle is in the sunlight. When wearing polarized glasses/sunglasses, these spots may be more magnified.

The spots are due to the manufacturing process and are “quench marks” in the glass. Quench marks are an unintentional side effect of the tempering process.

Technicians should explain to the customer that this is a normal condition and part of the manufacturing process for tempered glass. Do not replace the window(s) for this condition.
