2020 - 2021 Corvette: Service Bulletin: #PIC6429: Addressing Customer Concerns on Brake Noises - (Jan 20, 2021)

#PIC6429: Addressing Customer Concerns on Brake Noises - (Jan 20, 2021)

Subject:		Addressing Customer Concerns on Brake Noises					
Brand:	Model:	Model Year:		VIN:		Engine:	Transmission:
		from	to	from	to		
Chevrolet	Corvette	2020	2021	All	All	All	All

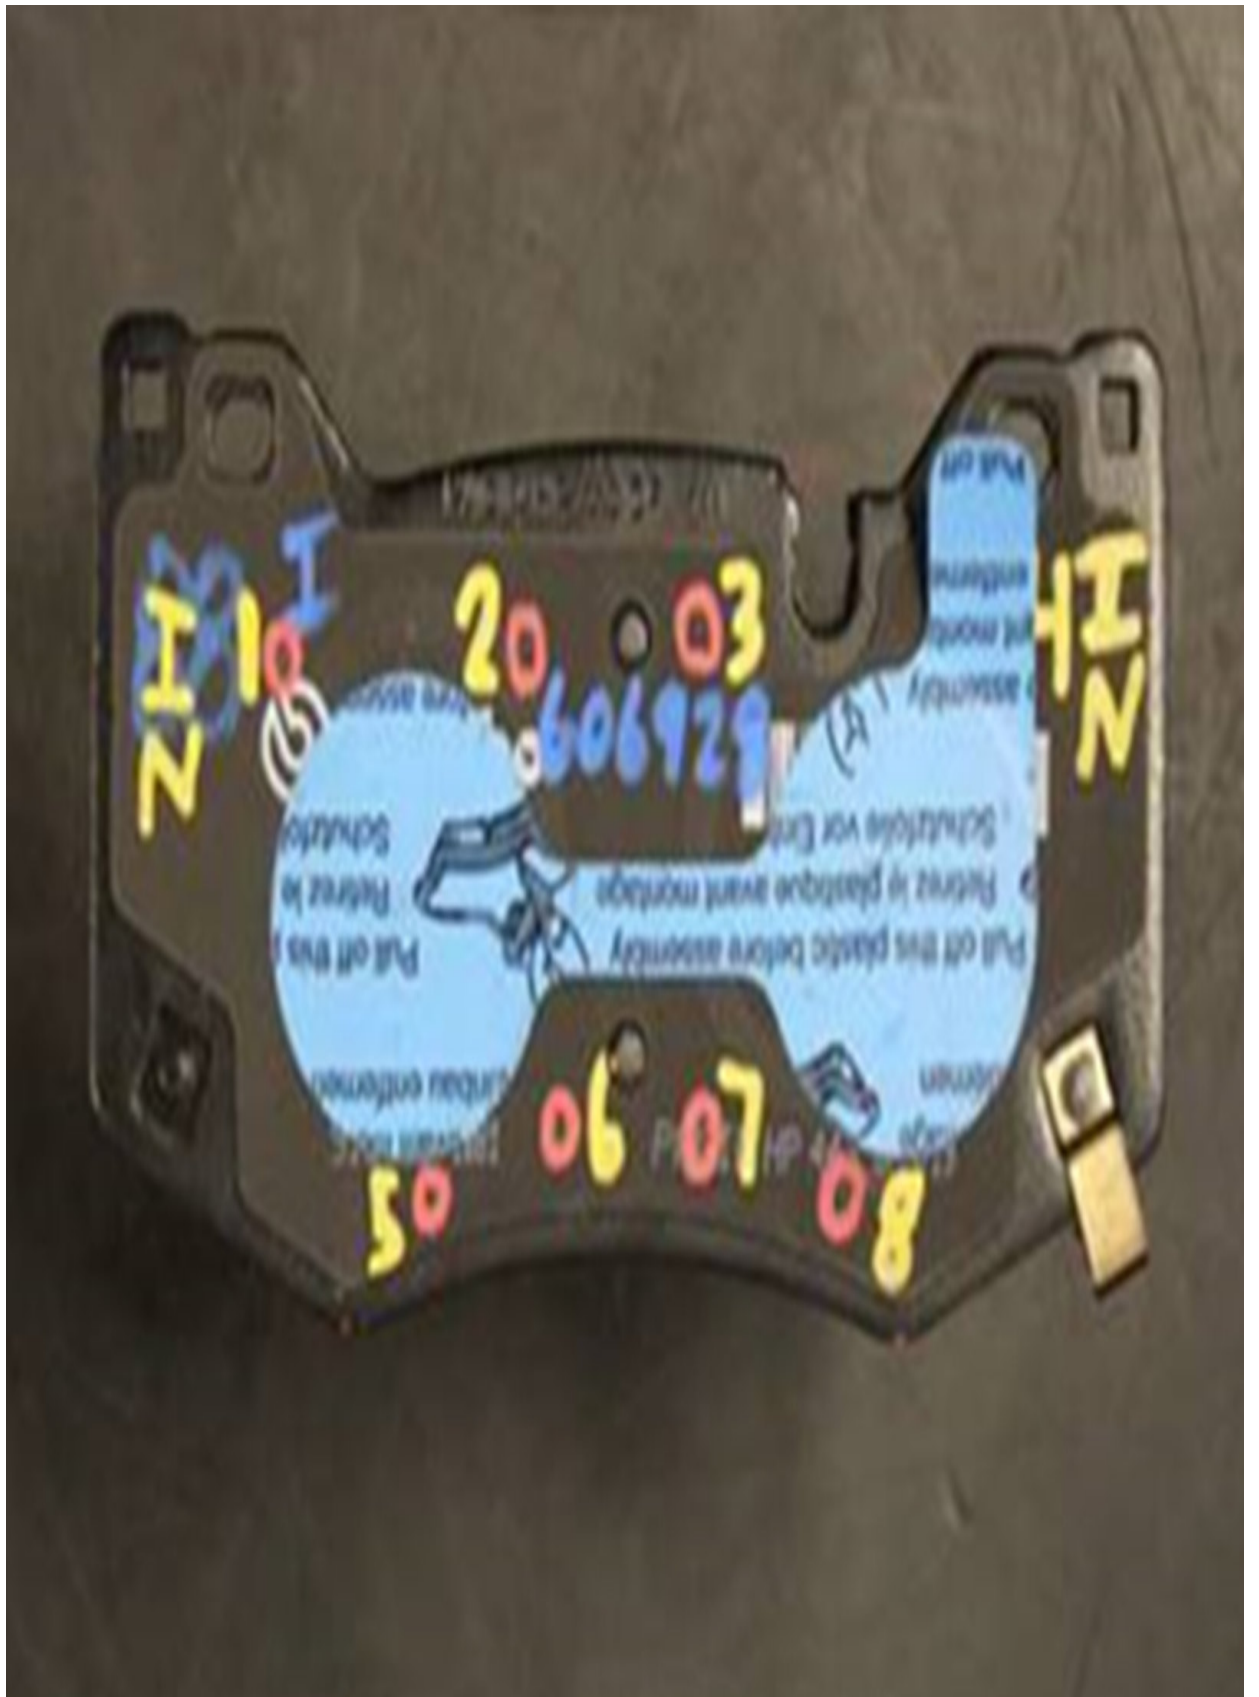
If the customer describes a brake noise coming from the vehicle, perform bulletin 17-NA-040 as described. When removing the front brake pads on a Z51-equipped vehicle, the servicing technician should notice that there is a piece of double-sided tape that secures the front brake pads firmly to the caliper pistons. See the photo below as an example. The blue area is this peel-and-stick double sided tape.

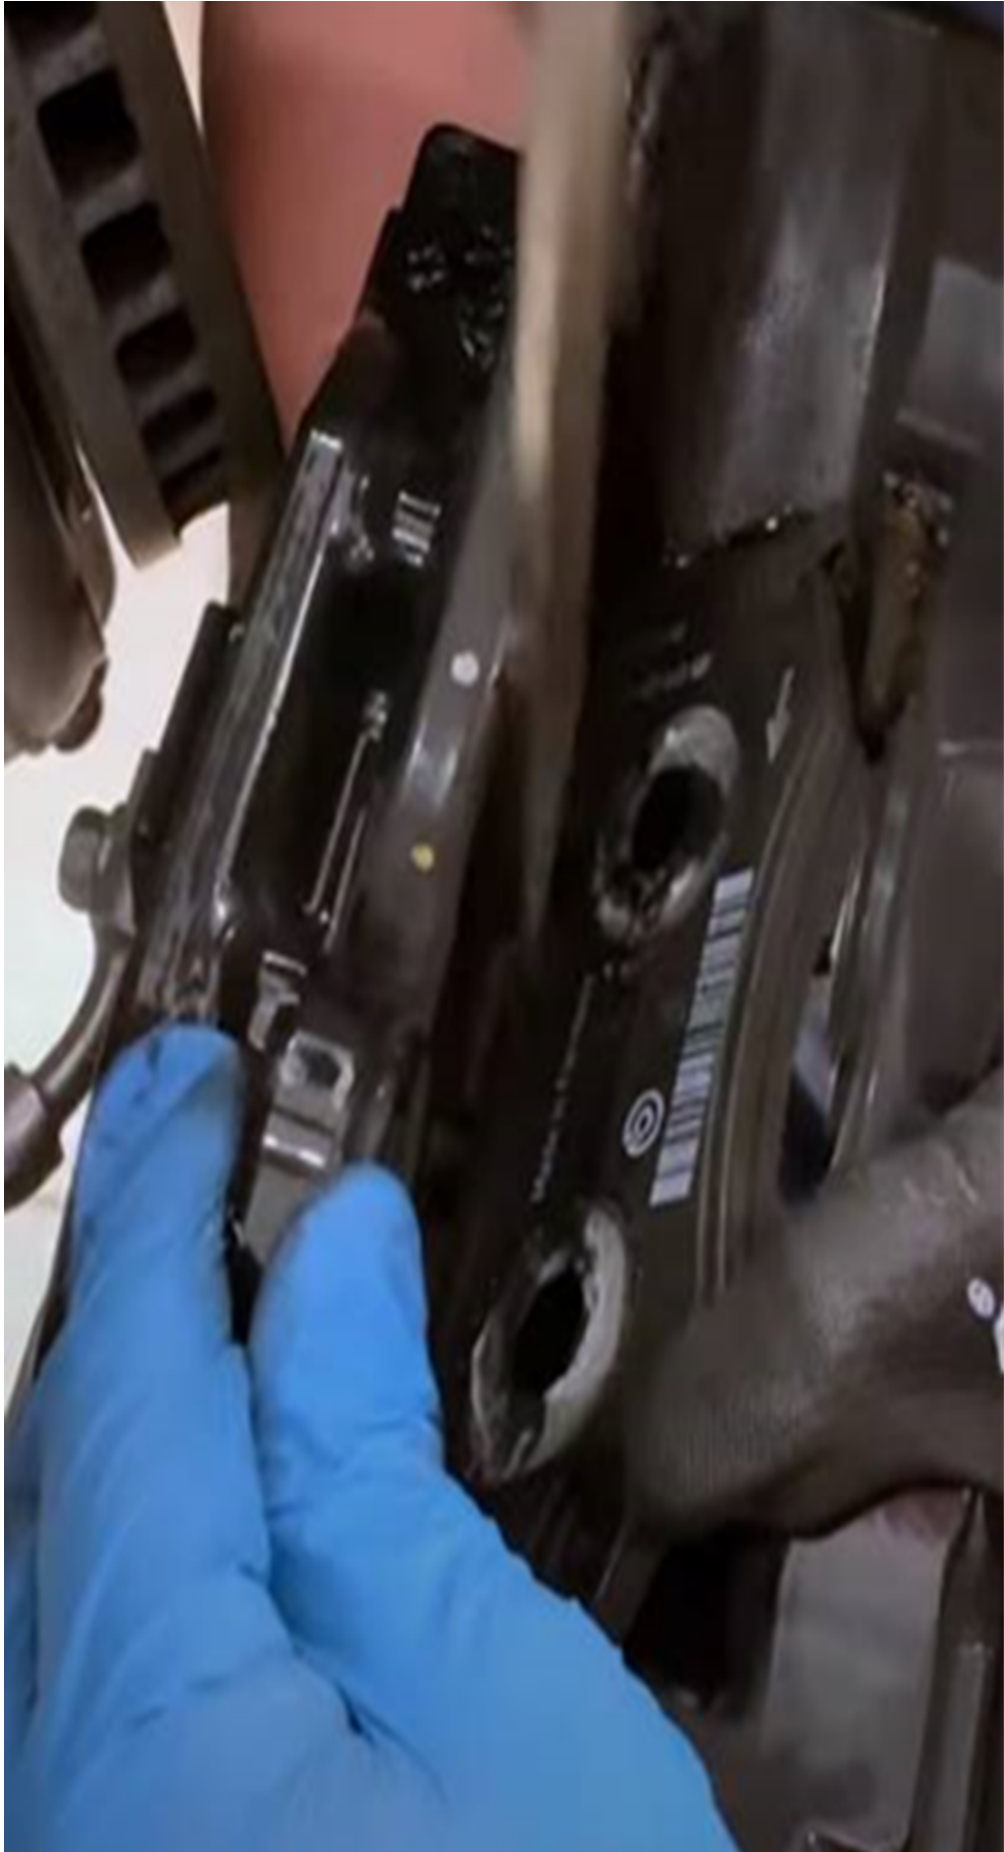
To apply the paste correctly, the pads must be removed from the calipers. See the photo below for an example of what the front brake pads look like once they have been separated from the caliper pistons.

This is normal when the front pads have been removed. When this has been done, remove as much of the remaining tape residue as possible. Then, apply the copper paste as directed in the bulletin. Once the copper paste has been applied correctly to the front brake pads, simply reinstall them into the calipers. There is no need to replace the front brake pads during this service because of the double-sided tape.

Important: At this point in reassembly, many technicians have a tendency to want to chamfer the edges of the brake pads slightly, in the hopes that this will eliminate or prevent future noises from occurring. This is not something that should be done, despite any direction to the contrary. "Taking the edge off" or chamfering the brake pads will not provide any noise benefit to the customer and it may actually create other issues with the brake system.
