2020 - 2021 Corvette: Service Bulletin: #PIC6429: Addressing Customer Concerns on Brake Noises - (Jan 20, 2021)

Subject: Addressing Customer Concerns on
Brake Noises

Brand:	Model:	Model Year:	VIN:	Engine:	Transmission:
		from to	from to		
Chevrolet	Corvette	2020 - 2021	All	All	All

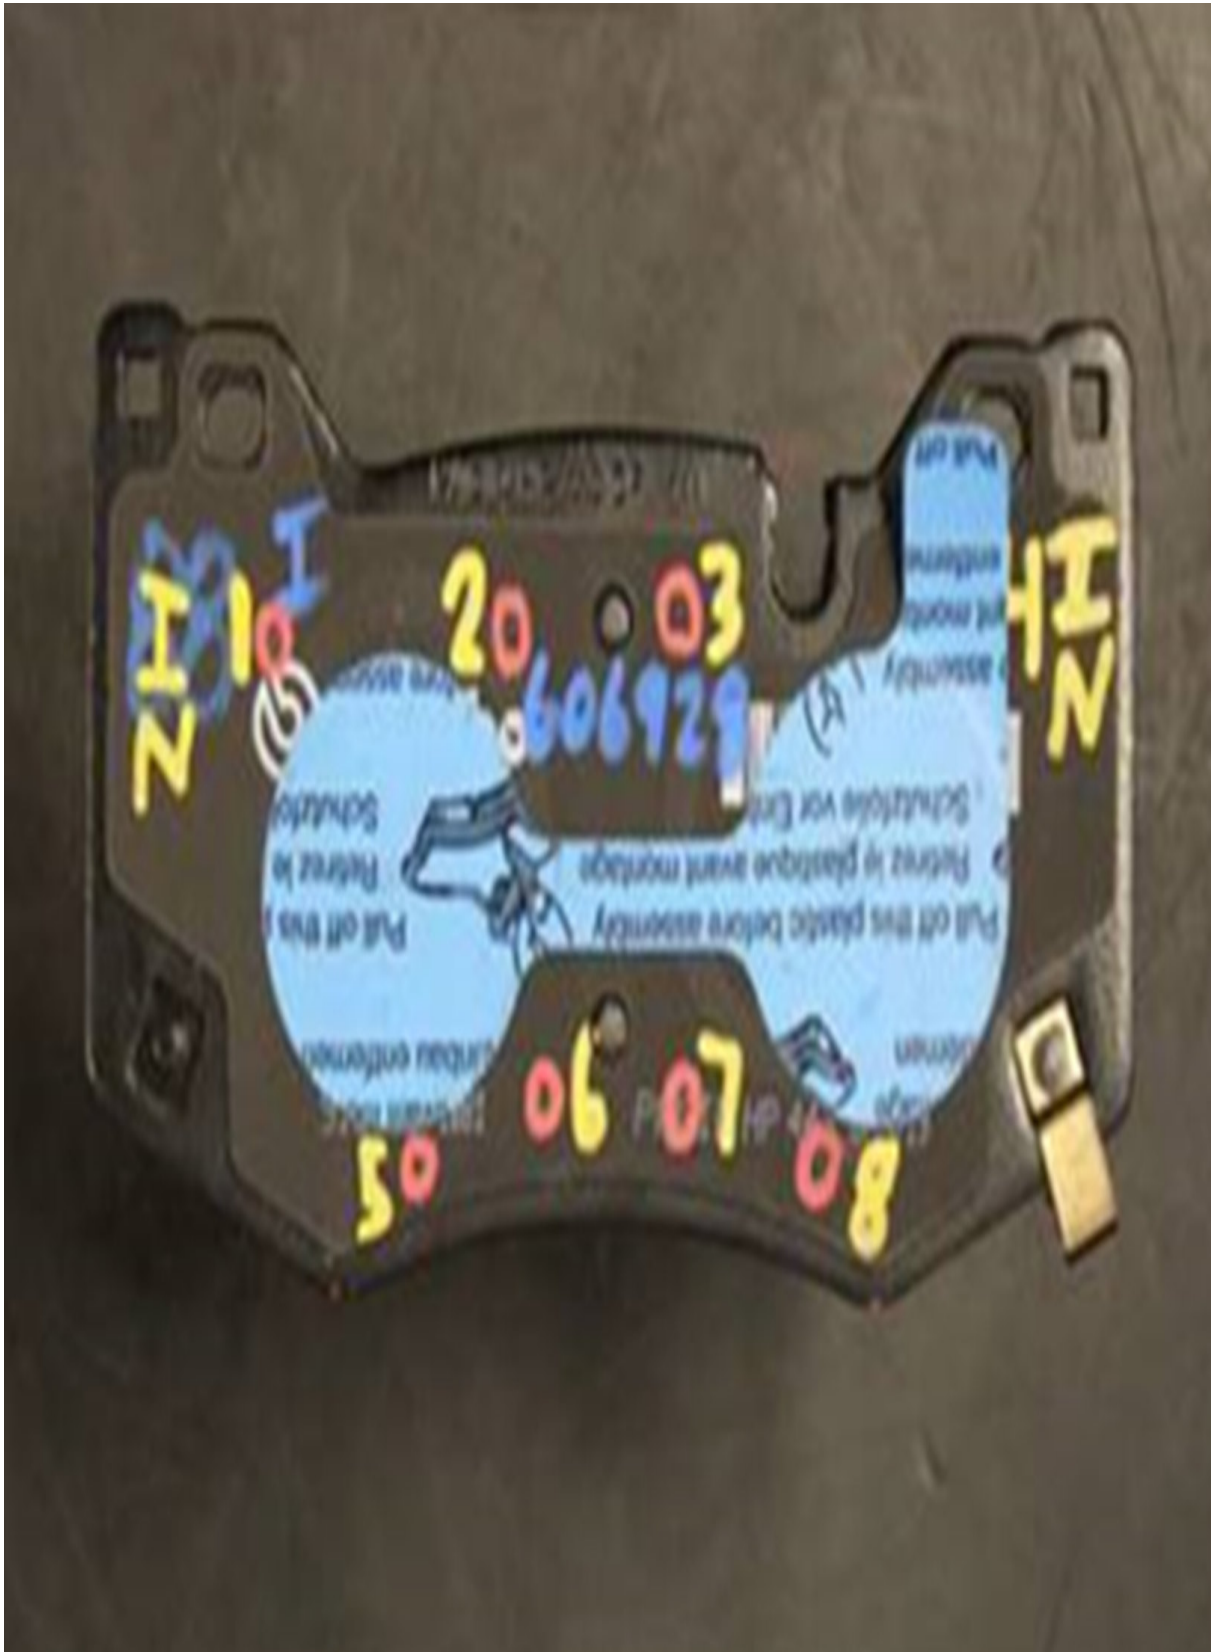
If the customer describes a brake noise coming from the vehicle, perform bulletin 17-NA-040 as described. When removing the front brake pads on a Z51-equipped vehicle, the servicing technician should notice that there is a piece of double-sided tape that secures the front brake pads firmly to the caliper pistons. See the photo below as an example. The blue area is this peel-and-stick double sided tape.

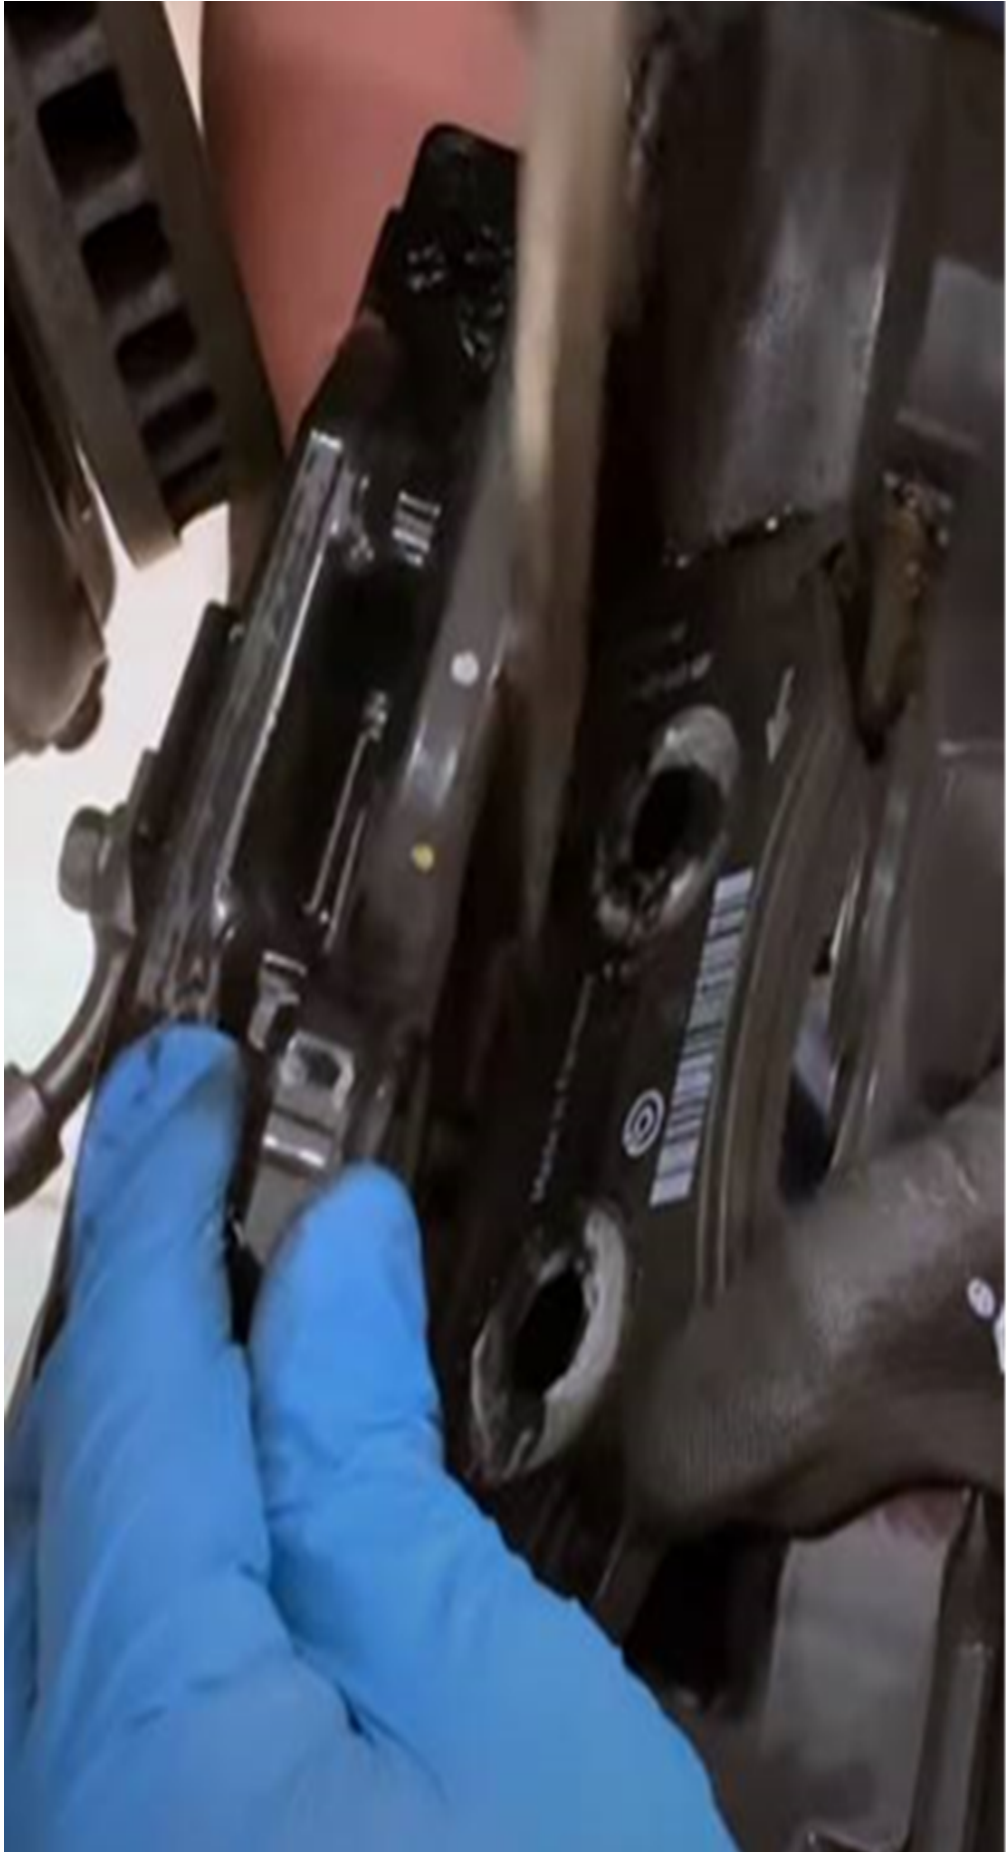
To apply the paste correctly, the pads must be removed from the calipers. See the photo below for an example of what the front brake pads look like once they have been separated from the caliper pistons.

This is normal when the front pads have been removed. When this has been done, remove as much of the remaining tape residue as possible. Then, apply the copper paste as directed in the bulletin. Once the copper paste has been applied correctly to the front brake pads, simply reinstall them into the calipers. There is no need to replace the front brake pads during this service because of the double-sided tape.

Important: At this point in reassembly, many technicians have a tendency to want to chamfer the edges of the brake pads slightly, in the hopes that this will eliminate or prevent future noises from occurring. This is not something that should be done, despite any direction to the contrary. "Taking the edge off" or chamfering the brake pads will not provide any noise benefit to the customer and it may actually create other issues with the brake system.
