# 1997 - 1999 Corvette: Service Bulletin: Loose or Missing Headlamp Door Bezel Plug

**Subject:** Loose or Missing Headlamp Door Bezel Plug (Install New Bezels and Plugs)

**Number:** 99-08-42-005

**Models:** 1997-99 Chevrolet Corvette

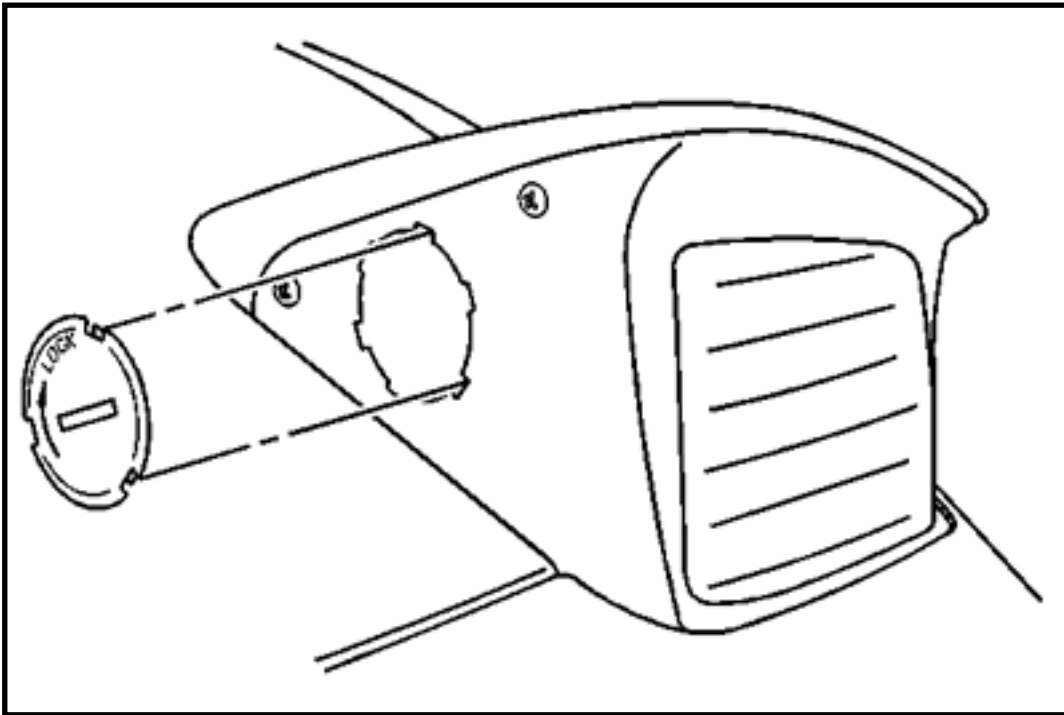
Some customers may comment that the plastic plug that covers the headlamp aiming adjustment screw on the inboard side of the headlamp door bezel is loose or missing.

Two different size plugs have been used in production. Early production 1997 vehicles used a plug with a diameter of 24 mm (15/16 in), while later 1997 vehicles and all 1998 and 1999 vehicles use a larger 54 mm (2 1/8 in) diameter plug. Both size plugs have been replaced by a new design plug and, therefore, will no longer be available.

Using the following service procedure, replace both the left and right headlamp bezels with the new design bezels that have a large NOTCHED hole. The notched hole is required for installing a new design NOTCHED plug.

1. Open the engine compartment hood.
2. Turn the headlamp switch to the ON position (the headlamp doors will open and the lamps will illuminate).
3. Turn the headlamp switch back to the PARK lamp setting (headlamp doors will remain open).
4. Remove and discard both the left and the right headlamp bezels and plugs, following the information in the Body & Accessories section of the appropriate Service Manual.
5. Install the new left and right headlamp bezels.
6. Align the notches on the new plug with the notches in the opening in the new headlamp bezel.
7. Using a quarter or a flat-bladed screwdriver, slowly rotate the plug in

the direction shown by the arrow on the outside of the plug until a click can be heard or felt.
