# 1990 - 1992 Corvette ZR-1: Service Bulletin: No Start Condition (Replace Starter)

**Subject:** NO START CONDITION (STARTER CORROSION-REPLACE STARTER)

**Model and Year:** 1990-1992 Corvette, Engine Code J (LT5)

**Bulletin Number:** 92-307-6 - (09/21/1992)

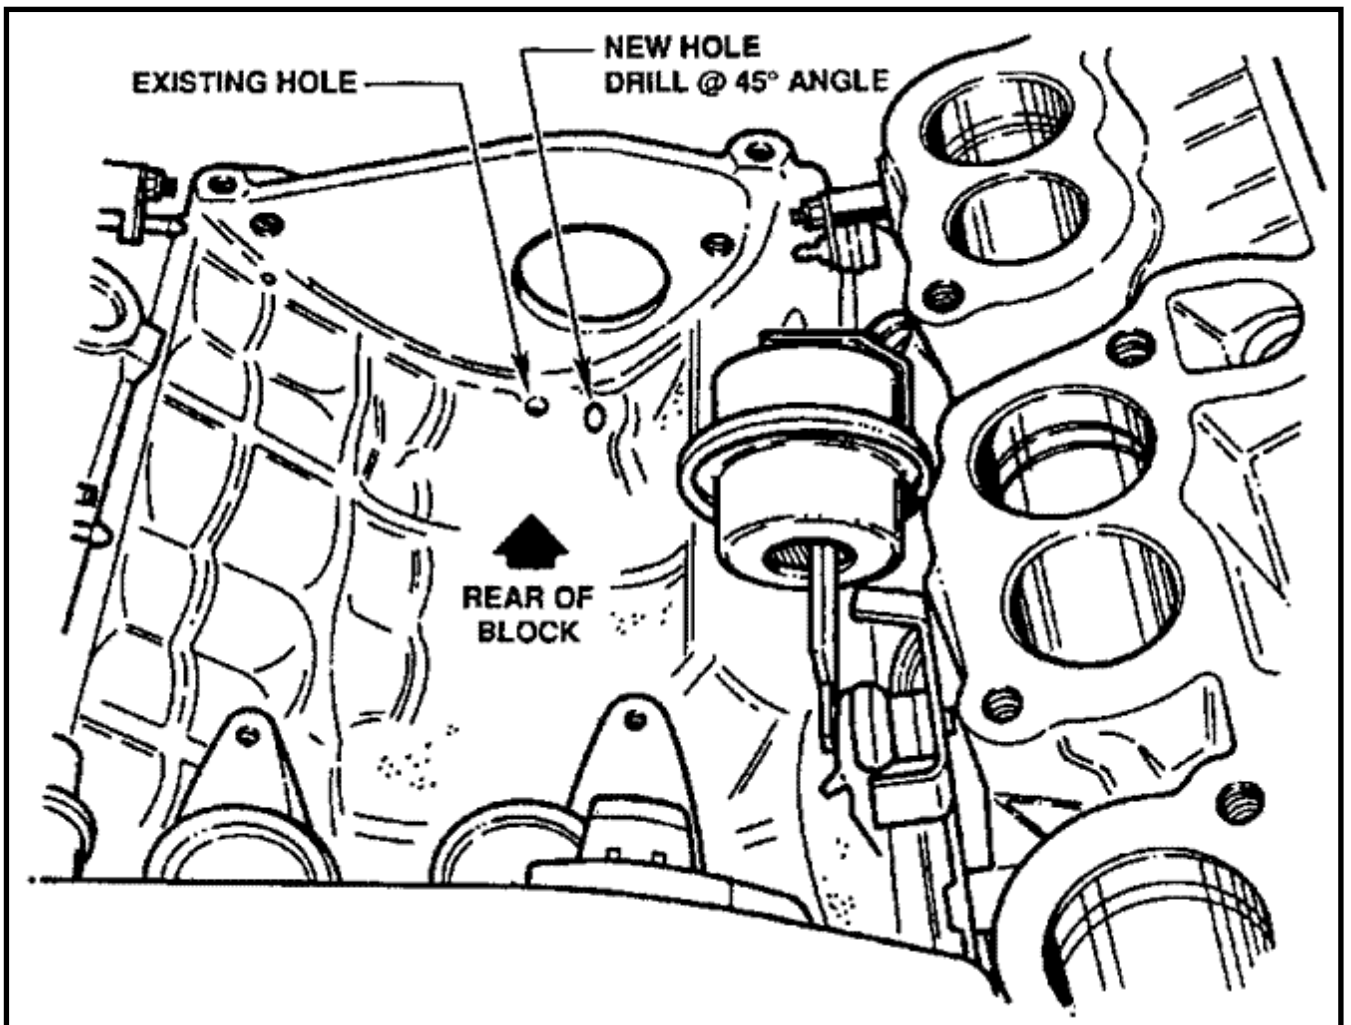
- 1 . Remove the old starter.
2. Clean any blockage in existing drain system.
3. Drill a 3/8" diameter hole through the engine "vee" to the back of the engine, allowing drainage (see Figure 1).

The starter on an LT5 engine is mounted in the engine "vee." A drain hole and drain tube are located at the rear of the engine valley. While washing the engine, debris may settle in the engine "vee" and block the drain system.
