1990 - 1992 Corvette ZR-1: Service Bulletin: No Start Condition (Replace Starter)

Subject: NO START CONDITION (STARTER CORROSION-REPLACE STARTER)

Model and Year: 1990-1992 Corvette, Engine Code J (LT5)

Bulletin Number: 92-307-6 - (09/21/1992)

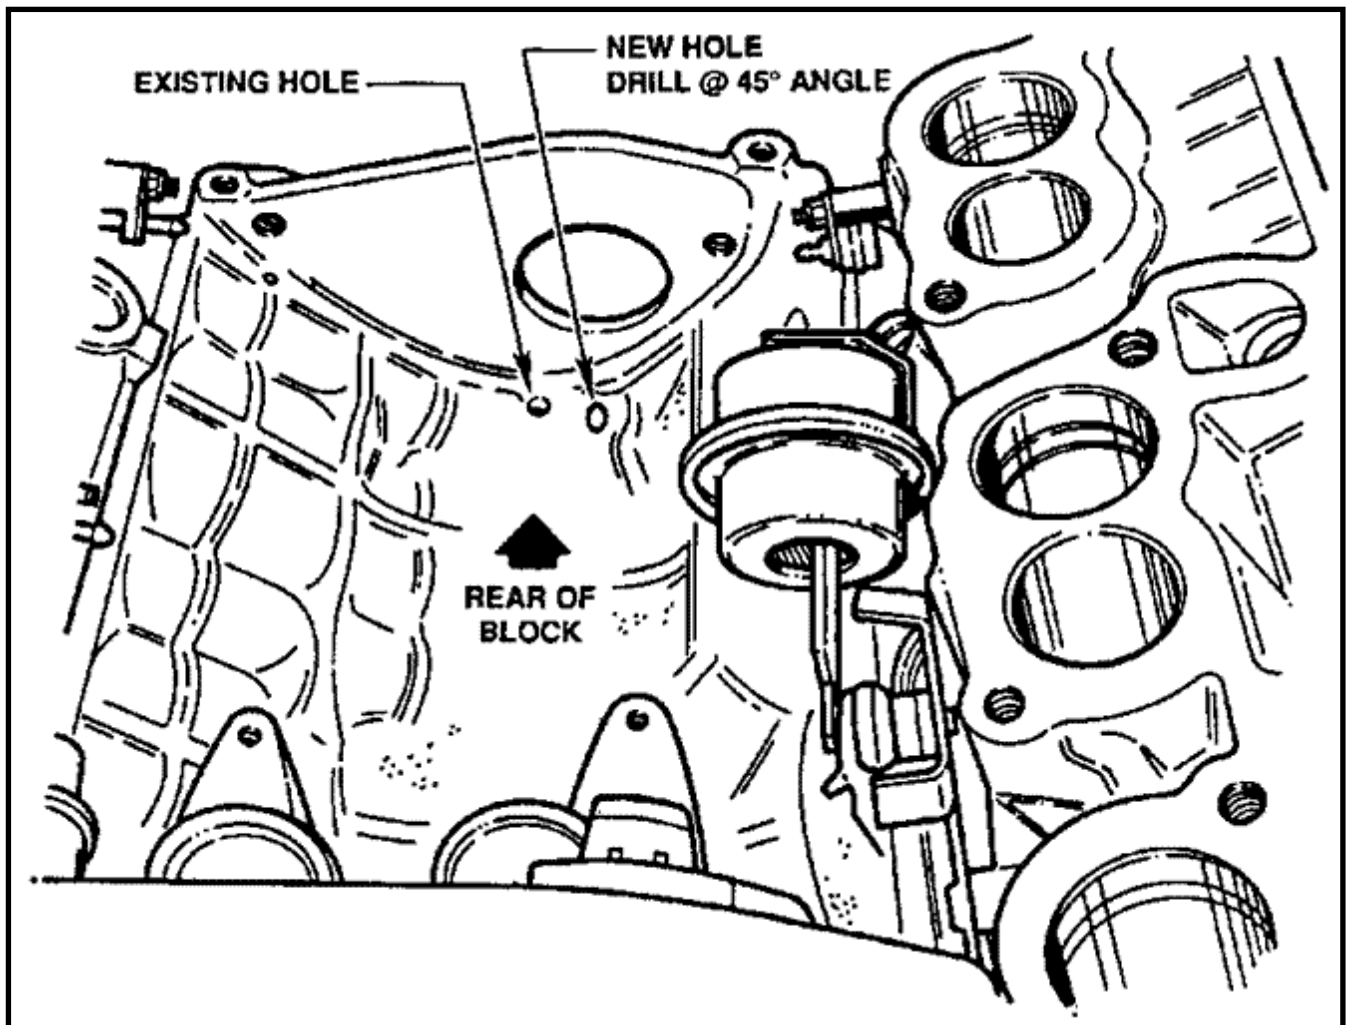
The starter on an LT5 engine is mounted in the engine "vee." A drain hole and drain tube are located at the rear of the engine valley. While washing the engine, debris may settle in the engine "vee" and block the drain system.

- 1 . Remove the old starter.
2. Clean any blockage in existing drain system.
3. Drill a 3/8" diameter hole through the engine "vee" to the back of the engine, allowing drainage (see Figure 1).
