1992 - 1996 Corvette: Technical Article: Rebuilding the LT1 Engine

Rebuilding the Chevrolet LT1 Engine, Doug Anderson,
Automotive Rebuilder, September 1999

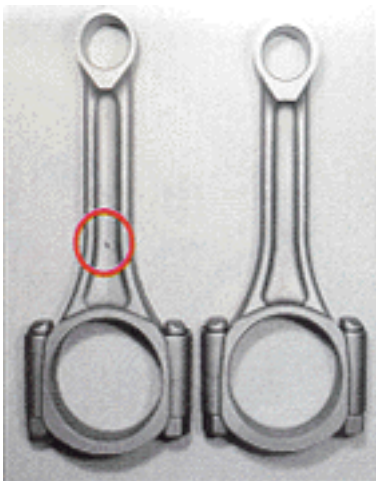
The rods for the 265 (left) are longer than the ones for the 350. They can be identified by the single, raised dot on the shank of the rod.

265 - The 265 rods are 0.240" longer than the ones in the 350. Both blocks are the same height, but the stroke for the 265 is 0.480" shorter, so the rods have to be longer to make up for half the difference. These rods can be identified by the single, raised dot on both sides of the shank.

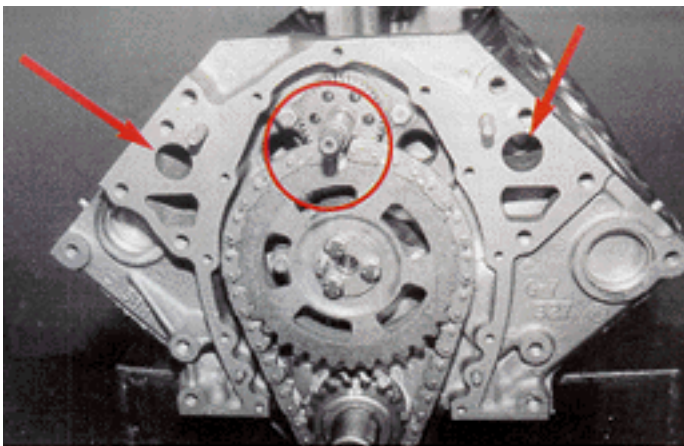
The front of the LT1 block is considerably different. Note the location of the coolant holes that direct the water to the heads and the shaft that drives the water pump.

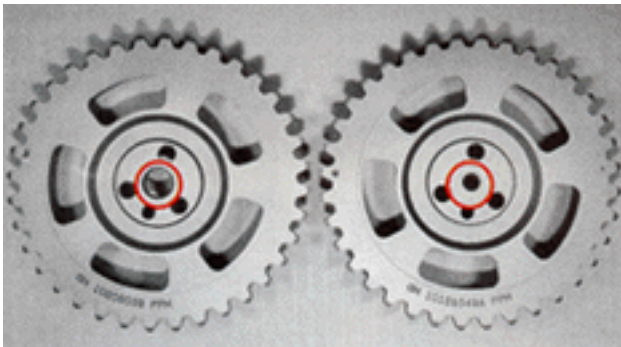
There were two cam gears used on these engines. The early ones (right) had a small hole with 16 splines for the distributor drive shaft while the later ones had a larger, unspined hole.

The original cam had a small, tapered hole in the center and a short dowel pin. It was used with the cam gear that had the small hole in the center with 16 splines in it. It was connected to the distributor with a short drive shaft that was splined on both ends. The cam gear is a GM p/n 10128349. This combination was used from 1992-'95 on the aluminum-headed motors.

The cam gear had a bigger hole and it didn't have the splines that were found in the early gear. The pilot shaft for the distributor extends through the hole in the cam gear and seats in the hole in the cam; the distributor is driven by the long dowel pin that sticks up through the cam gear. The cam gear is a GM p/n 10206039.

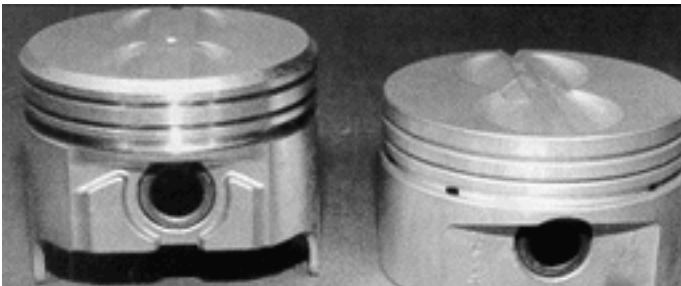
The piston for the 350 LT1 is a special, lightweight flat top with four valve reliefs. The piston for the 265 (left) looks like a smaller version of a 305.

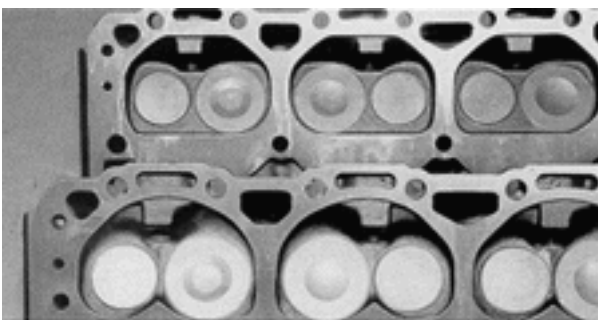
The chamber on the LT1 head (bottom) is much smaller and shaped different than the one for the regular Chevy 350.

All LT1 heads used small combustion chambers to get the higher compression ratios with flat top pistons; the 350s had a 10.5 to 1 ratio and the 265s had a 9.8 to 1 ratio.

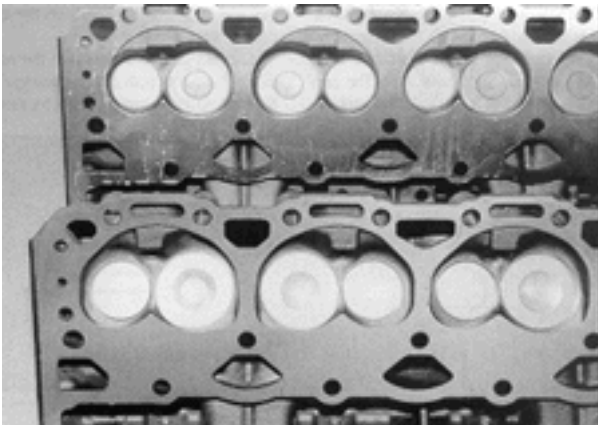
The chamber for the 265 (top) is shaped like the one for the 350 LT1, but it's even smaller.

265 IRON HEADS - The 265 had its own unique cast iron head with a 10208890 casting number. The chambers are smaller, so these heads cannot be interchanged with any of the 350 LT1 heads.

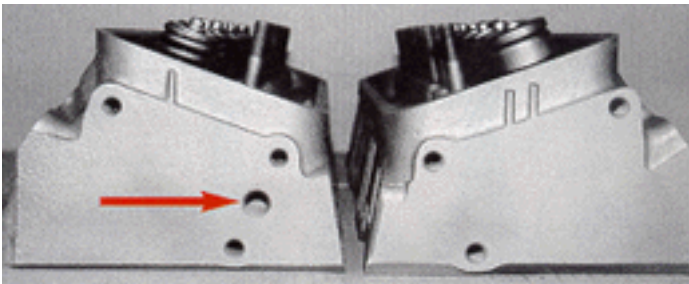
The LT1 heads have an extra hole on both ends. It must be plugged when it's on the front of either head.

There is an extra hole that goes into the water jacket on both ends of the heads. These should be plugged when they're in the front, but left open when they're on the back. There's an external coolant transfer line that connects the holes on the back side to a reservoir that vents the air and steam vapors that would be trapped in the head and cause hot spots.

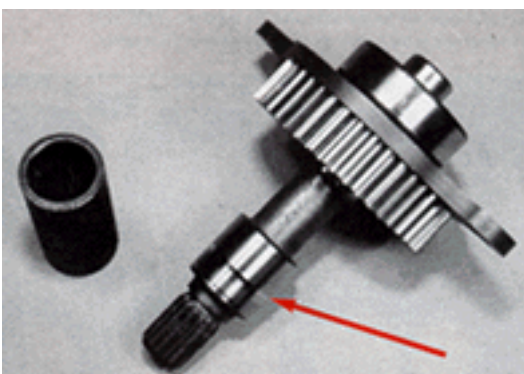
The water pump is driven by this gear and coupling. Make sure the bearing is good and that the seal surface isn't grooved before reusing it.

Be sure to check the seal surface on the geared shaft that drives the water pump. If it's grooved, it will leak and it will be your fault. New ones are available from GM (p/n 10219554) for around \$40. That's cheap insurance when you consider that the timing cover, chain and gears have to come off to replace it.

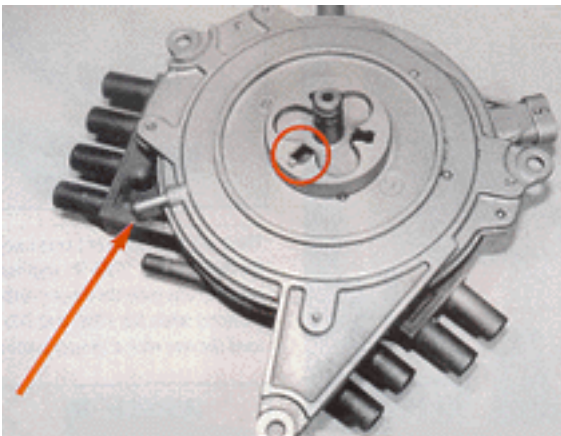
The late Optispark distributor is a sealed assembly that is vented to the intake. It is piloted by the stub shaft that centers in the cam and is driven by a long pin in the cam that engages a slot in the hub of the distributor.

GM had some problems with the early distributor due to both carbon tracking and moisture, so a new sealed distributor with a vacuum port was introduced on the iron-headed 265s and 350s in 1994 and used on all LT1s in 1995. The new distributor was located with a pilot shaft and driven by a pin, so both the cam and the gear were changed. The cam had a large, deep hole in the center for the pilot shaft and a longer dowel pin to drive the distributor.

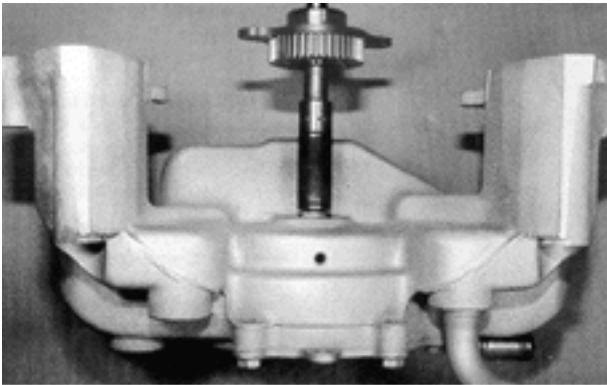
The water pump for the LT1 is gear driven off the cam.

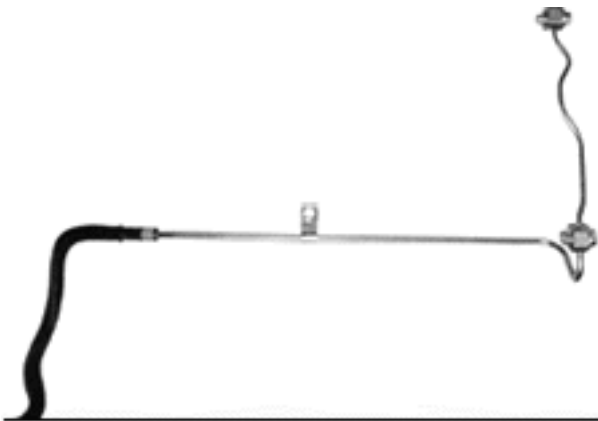
The holes in the back of the heads are connected to the reservoir with this manifold. It is needed to purge the air and steam vapors that would otherwise be trapped in the head.

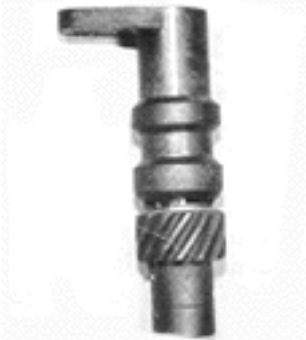
The oil pump is driven by a stub shaft that fits into the original distributor hole.

The LT1 powerplant uses the late model 350 oil pump with the 3/4" pickup tube. This should be fairly easy to identify.
