1992 - 1996 Corvette: Technical Article: Rebuilding the LT1 Engine

Rebuilding the Chevrolet LT1 Engine, Doug Anderson, Automotive Rebuilder, September 1999

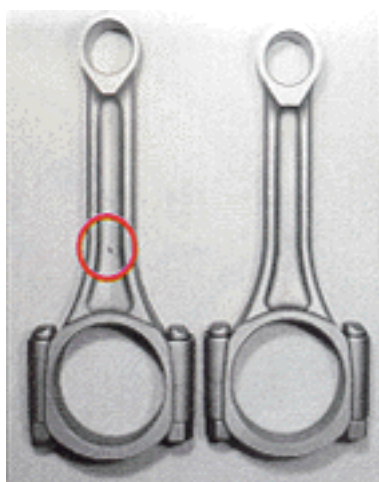
The rods for the 265 (left) are longer than the ones for the 350. They can be identified by the single, raised dot on the shank of the rod.

265 - The 265 rods are 0.240" longer than the ones in the 350. Both blocks are the same height, but the stroke for the 265 is 0.480" shorter, so the rods have to be longer to make up for half the difference. These rods can be identified by the single, raised dot on both sides of the shank.

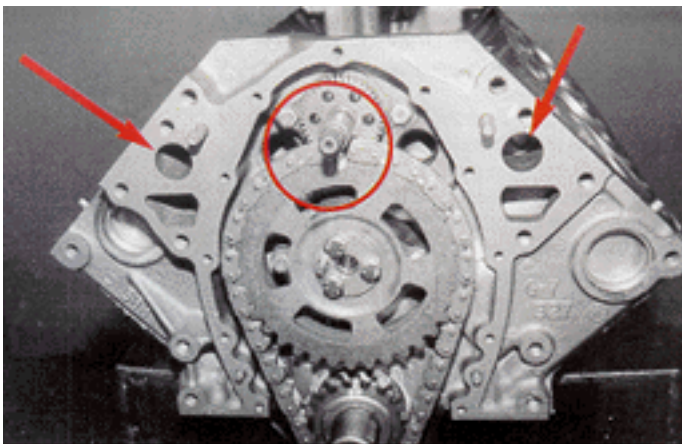
The front of the LT1 block is considerably different. Note the location of the coolant holes that direct the water to the heads and the shaft that drives the water pump.

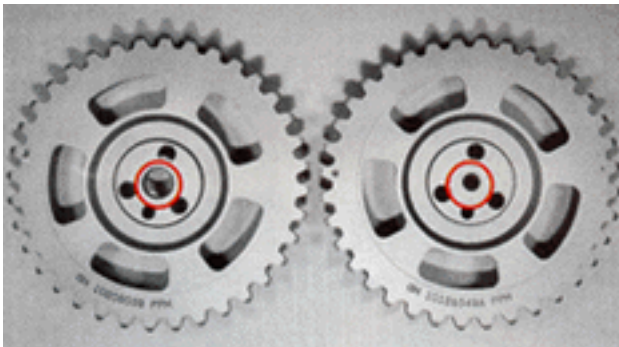
There were two cam gears used on these engines. The early ones (right) had a small hole with 16 splines for the distributor drive shaft while the later ones had a larger, unsplined hole.

The original cam had a small, tapered hole in the center and a short dowel pin. It was used with the cam gear that had the small hole in the center with 16 splines in it. It was connected to the distributor with a short drive shaft that was splined on both ends. The cam gear is a GM p/n 10128349. This combination was used from 1992-'95 on the aluminum-headed motors.

The cam gear had a bigger hole and it didn't have the splines that were found in the early gear. The pilot shaft for the distributor extends through the hole in the cam gear and seats in the hole in the cam; the distributor is driven by the long dowel pin that sticks up through the cam gear. The cam gear is a GM p/n 10206039.

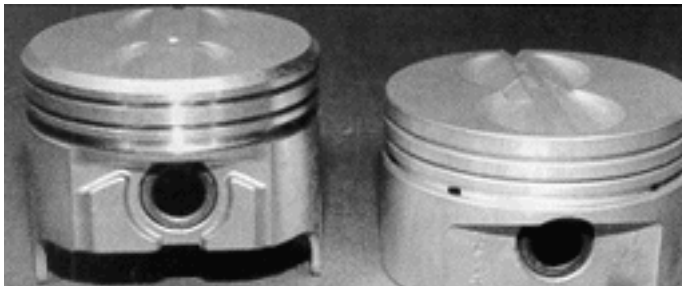
The piston for the 350 LT1 is a special, lightweight flat top with four valve reliefs. The piston for the 265 (left) looks like a smaller version of a 305.

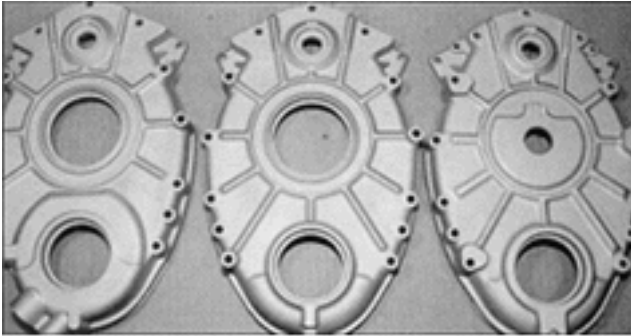
The original front cover (1992-'94) (right) had two small holes, one for the water pump drive and one for the distributor drive. The later one (1994-'95) had a large hole for the distributor. The latest one (1996-'97) (left) had another hole in the bottom corner for the crank position sensor.

The original cover had three holes, one for the crank, a small hole (@ 0.70") for the water pump drive and a second one for the small drive shaft for the distributor. It's a 10128289 casting.

The second front cover still had the small hole for the water pump shaft, but it had a much larger hole (@ 2.63") that sealed on the outside of the distributor housing itself. It's a 10214196 casting.

The second cover was modified again in 1996 to accommodate the crank position sensor that was located in the lower corner of the cover on the passenger side. This same cover was used for the few engines that were installed in 1997, too. It's a 12550032 casting.

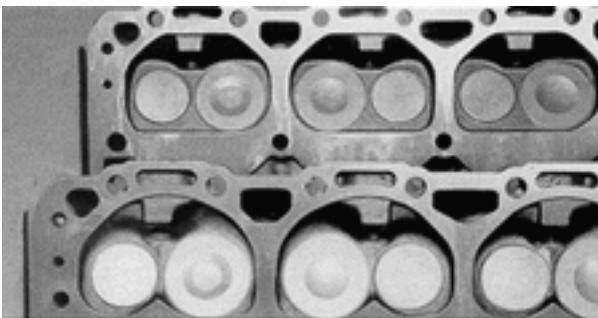
The chamber on the LT1 head (bottom) is much smaller and shaped different than the one for the regular Chevy 350.

All LT1 heads used small combustion chambers to get the higher compression ratios with flat top pistons; the 350s had a 10.5 to 1 ratio and the 265s had a 9.8 to 1 ratio.

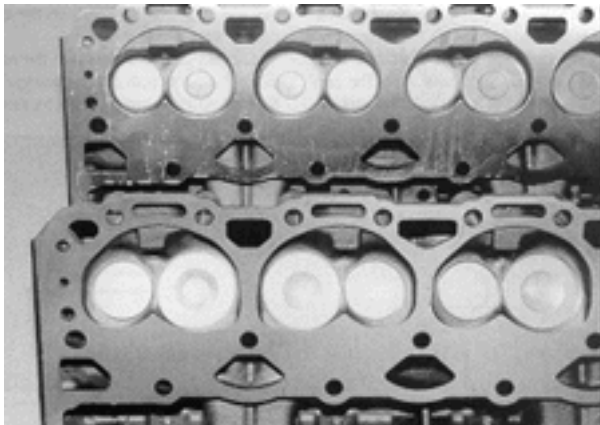
The chamber for the 265 (top) is shaped like the one for the 350 LT1, but it's even smaller.

265 IRON HEADS - The 265 had its own unique cast iron head with a 10208890 casting number. The chambers are smaller, so these heads cannot be interchanged with any of the 350 LT1 heads.

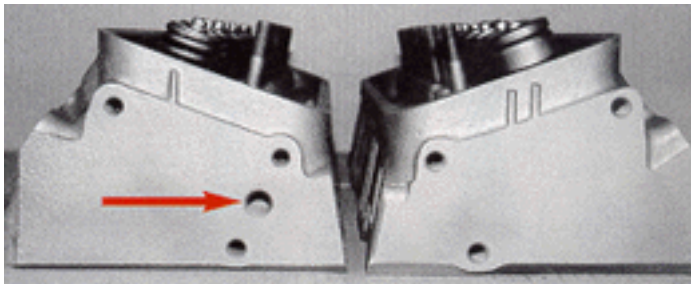
The LT1 heads have an extra hole on both ends. It must be plugged when it's on the front of either head.

There is an extra hole that goes into the water jacket on both ends of the heads. These should be plugged when they're in the front, but left open when they're on the back. There's an external coolant transfer line that connects the holes on the back side to a reservoir that vents the air and steam vapors that would be trapped in the head and cause hot spots.

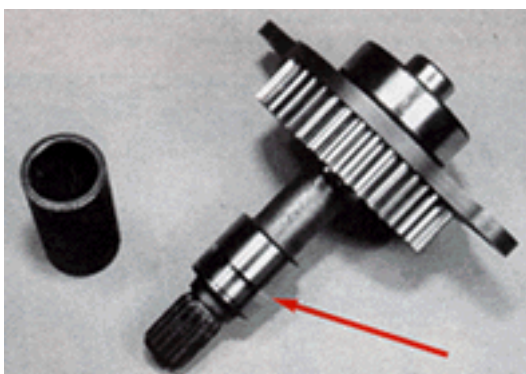
The water pump is driven by this gear and coupling. Make sure the bearing is good and that the seal surface isn't grooved before reusing it.

Be sure to check the seal surface on the geared shaft that drives the water pump. If it's grooved, it will leak and it will be your fault. New ones are available from GM (p/n 10219554) for around \$40. That's cheap insurance when you consider that the timing cover, chain and gears have to come off to replace it.

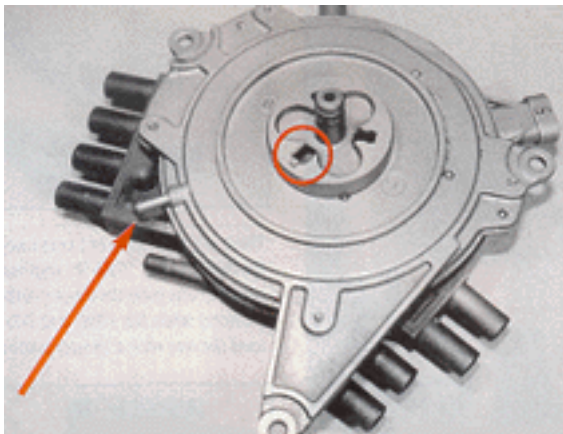
The late Optispark distributor is a sealed assembly that is vented to the intake. It is piloted by the stub shaft that centers in the cam and is driven by a long pin in the cam that engages a slot in the hub of the distributor.

GM had some problems with the early distributor due to both carbon tracking and moisture, so a new sealed distributor with a vacuum port was introduced on the iron-headed 265s and 350s in 1994 and used on all LT1s in 1995. The new distributor was located with a pilot shaft and driven by a pin, so both the cam and the gear were changed. The cam had a large, deep hole in the center for the pilot shaft and a longer dowel pin to drive the distributor.

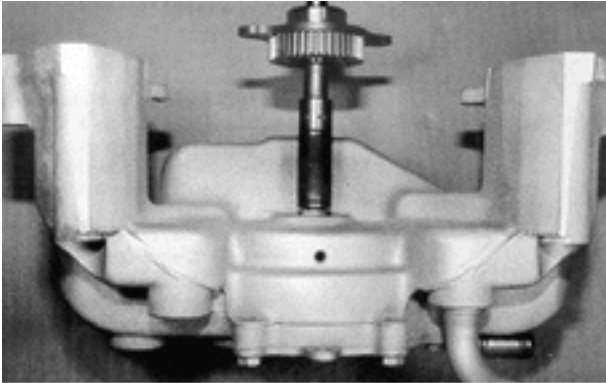
The water pump for the LT1 is gear driven off the cam.

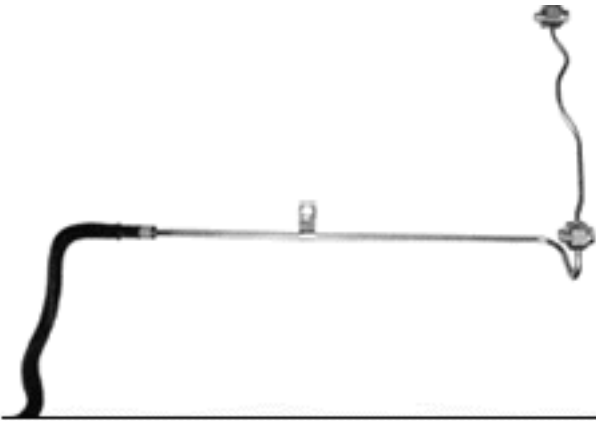
The holes in the back of the heads are connected to the reservoir with this manifold. It is needed to purge the air and steam vapors that would otherwise be trapped in the head.

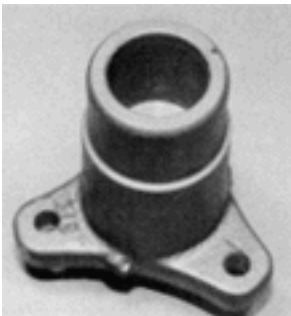
The balancer bolts onto the hub that is bolted to the crank. Note the lack of a keyway on the inside of the hub.

The balancer is a two-piece assembly with a pulley that bolts onto the hub. Separating the two made it easier to install the Optispark distributor on the assembly line and out in the field. The holes in the hub are offset, so the balancer only fits on it one way, but there's no keyway in the hub to index the hub on the crank. This shouldn't be a problem unless the damper was drilled at the factory to "trim" the final engine assembly.

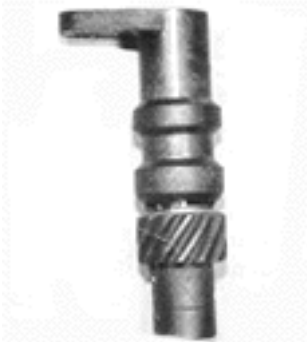
The oil pump is driven by a stub shaft that fits into the original distributor hole.

The LT1 powerplant uses the late model 350 oil pump with the 3/4" pickup tube. This should be fairly easy to identify.
