# 1988 - 1989 Corvette: Recall: Evaporative Emission Hoses

**Subject:** CAMPAIGN: EVAPORATIVE EMISSION HOSES

**Model and Year:** 1988-89 CHEVROLET CORVETTE

**Bulletin Number:** 89C25 - (08/23/1993)

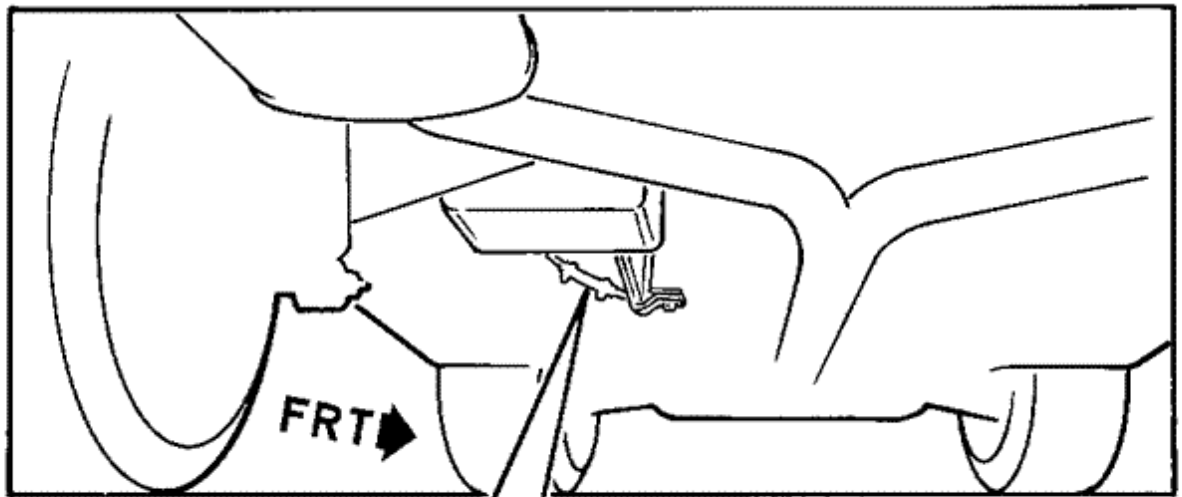
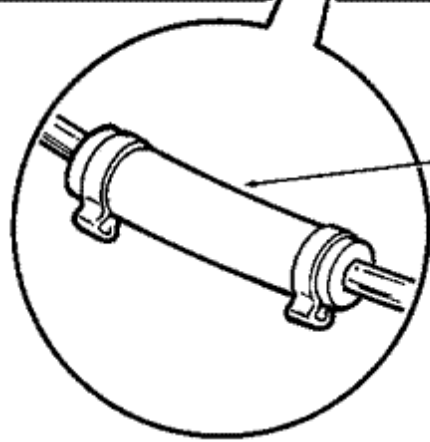
FIGURE 1

1. Raise vehicle.
2. Referring to Figure 1, locate rubber hose (approximately 2-9/16" long - 65mm) connecting fuel tank evaporative emission pipe to chassis fore-aft evaporative emission pipe.

HOSE MUST BE POSITIONED  
EQUALLY OVER BOTH PIPES

3. Remove both hose clamps and hose. Hose clamps and hose will not be reused.
4. Inspect pipes and bend if required to insure ends of pipes are in line with one another.

5. Install two (2) new clamps (P/N 01622744) and new hose (P/N 09442928) onto pipe ends. Insuring hose is positioned an equal distance over both ends. Position clamps onto hose and secure.

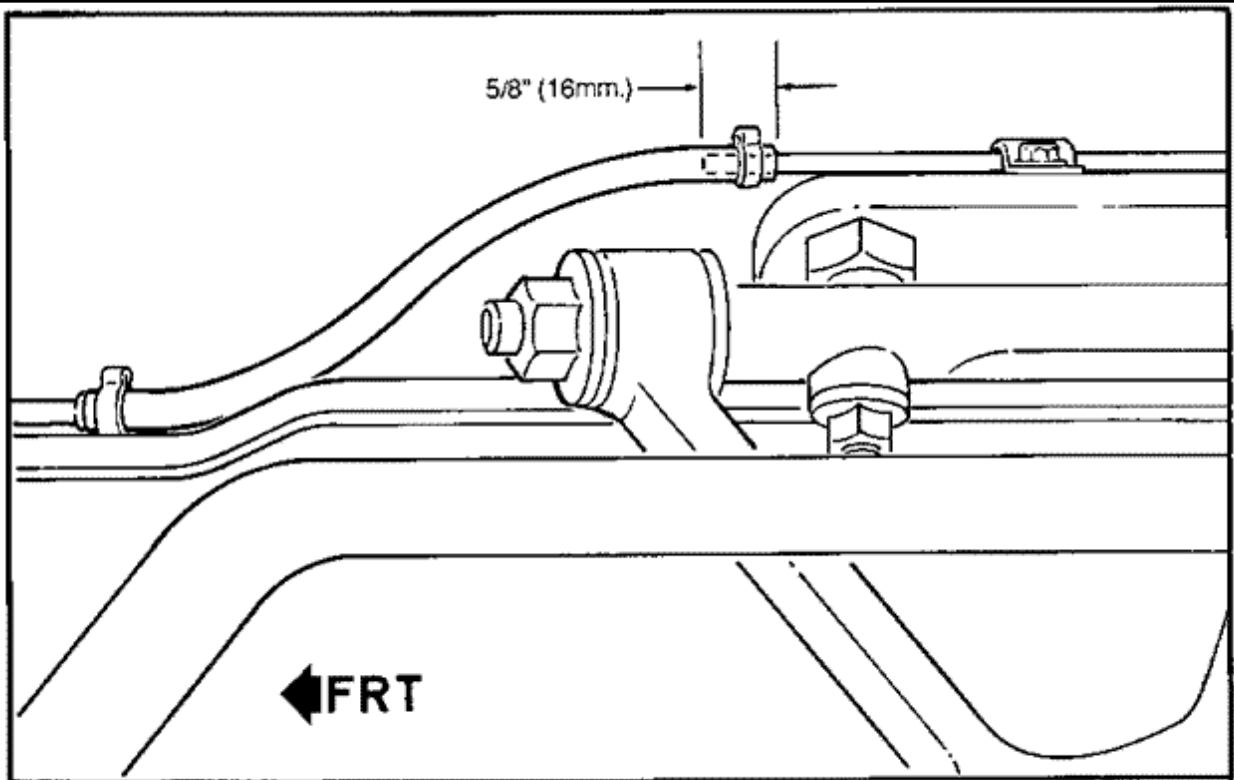
FIGURE 2

6. Lower vehicle.
7. Underhood, locate the evaporative emission hose connecting chassis fore/aft evaporative emission pipe to evaporative emission line shown in Figure 2.

8. Remove both hose clamps and hose. Hose clamps and hose will not be reused.
9. Install new large clamp (P/N 10028454) over nylon evaporative emission line, and install new small clamp (P/N 01622744) over chassis pipe.

10. Install larger end of new hose (P/N 10248651) over nylon evaporative emission line and install the opposite end approximately 1/2" over the fore/aft chassis pipe as illustrated in Figure 2.

**Notice: If hose appears taut when assembled as indicated above, repositioning of chassis fore/aft pipe may be required to alleviate condition.**

11. Position clamps onto hose and secure.
12. Install Campaign Identification Label.
