1987 - 1991 Corvette: Service Bulletin: 4L60 Low & Reverse Clutch New Plate Available

Subject: 4L60 LOW & REVERSE CLUTCH NEW WAVE PLATE IS AVAILABLE

Model and Year: 1987-91 CAPRICE, CAMARO, CORVETTE AND 1987-91 C/K, RN, S/T TRUCKS, G, M VANS AND 1990-91 L VAN WITH 4L60 AUTOMATIC TRANSMISSION

Bulletin Number: 91-186-7A - (01/29/1991)

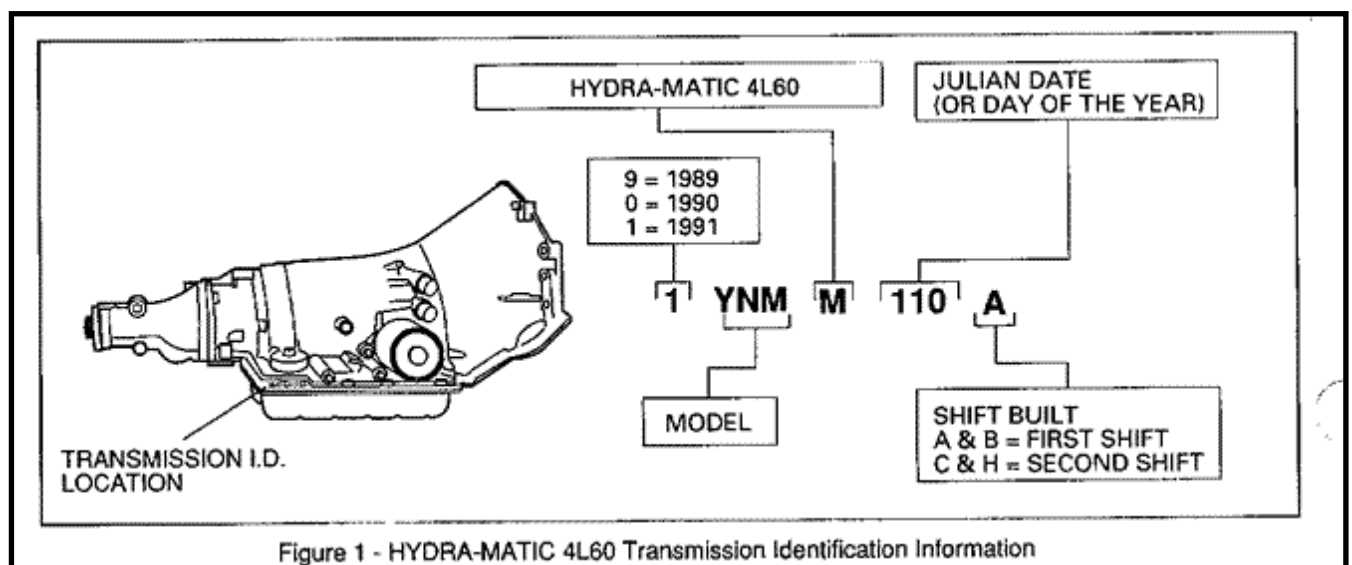
10 CASE, TRANSMISSION
682A PLATE, LO & REVERSE
CLUTCH (WAVED)

DATE OF PRODUCTION CHANGE: (Figure 1)

----- Beginning March 28, 1990 (Julian Date 087), all HYDRA-MATIC 4L60 transmissions were built using the new low and reverse clutch wave plate.

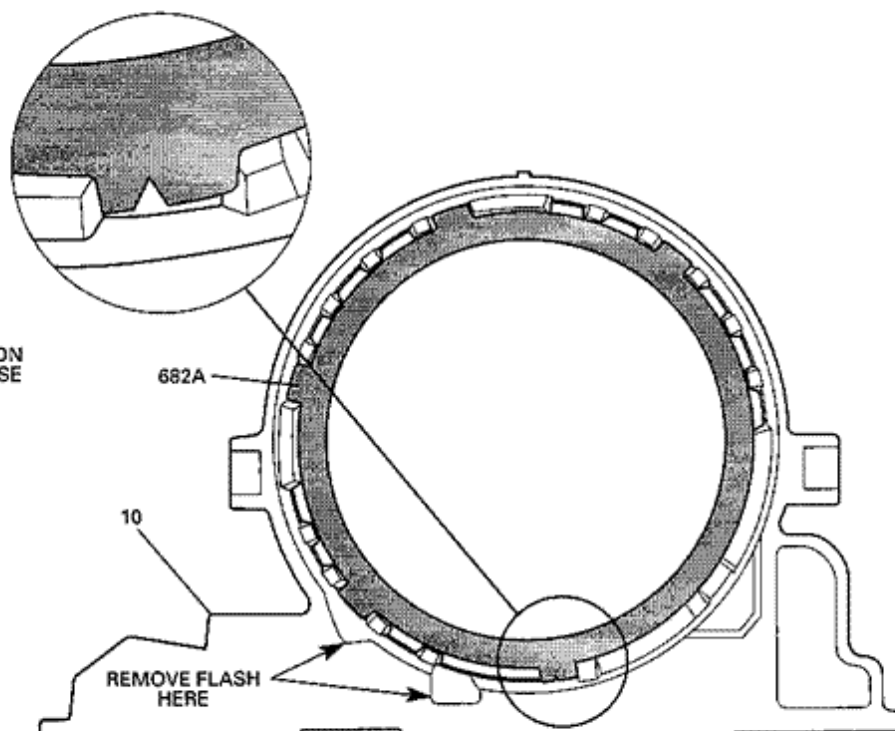
Figure 2 - Lo And Reverse Clutch Waved Plate

SERVICE INFORMATION: (Figure 2) ----- Low and Reverse Clutch failure can be caused by case casting flash interfering with clutch plate travel. A new wave plate is now available which will alleviate this condition. This new plate can be used to service any Hydra-matic 4L60 transmission produced after February 9, 1987 (Julian Date 040).

When installing the new wave plate, check for any case flash that may be present in the low and reverse grooves, and use a metal file to remove. See Figure 2 for case location information.
