## 1992 Corvette: Service Bulletin: Hood Latch Striker Bolt

Subject: HOOD LATCH STRIKER BOLT (USE PAST MODEL

Model and Year: 1992 Corvettes, Prior to VIN Breakpoint N5100919

**Bulletin Number:** 92-43-10 - (11/07/1991)

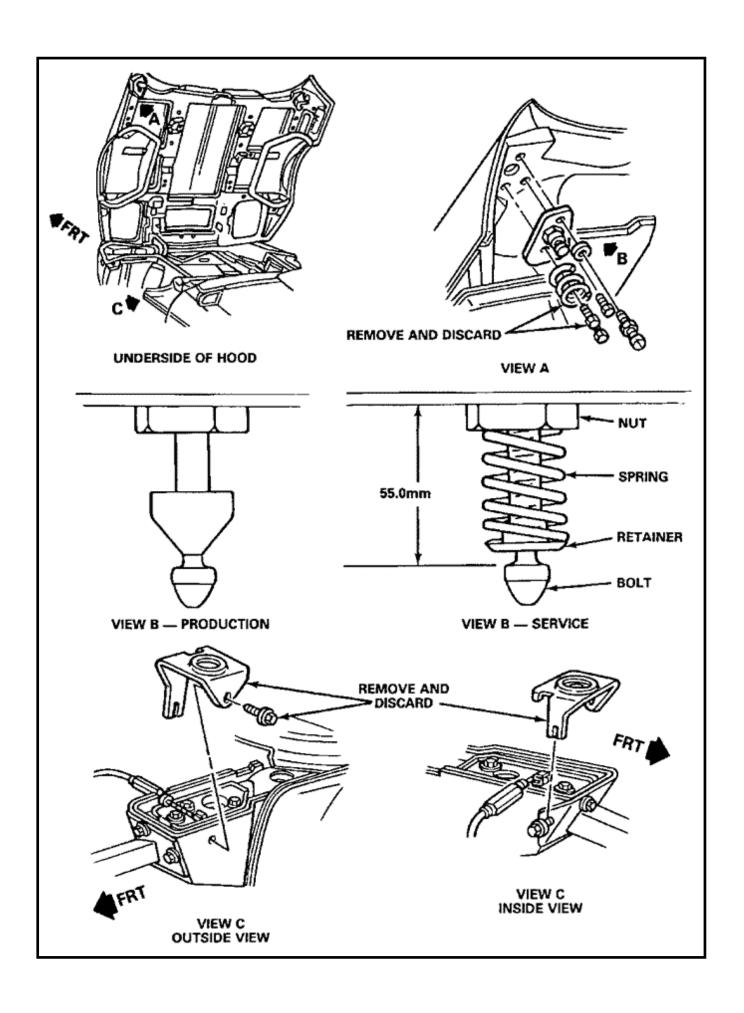
**Condition:** Early model 1992 Corvettes (prior to VIN breakpoint above) were built with unique hood latch striker bolts and pop up springs.

1. Raise hood to full open position. 2. Remove pop up spring and attaching bolt from bracket and discard (see View A). 3. Install new attaching bolt in position, tighten and torque to 27 N.m (20 lbs. ft.). 4. Loosen the locking nut on the striker latch bolt, remove bolt and nut from hood bracket, disassemble nut from bolt and save the nut for use on the new striker bolt. DISCARD THE ORIGINAL STRIKER BOLT. 5. Preassemble the new bolt, retainer, spring and original lock nut (see View B).

NOTE: The nut has a cavity on one side to act as spring seat.

6. Install the new striker bolt assembly to the bracket on hood, set initial

height as indicated on the illustration and tighten the locking nut. 7. Remove the outer attaching bolt for the spring seat (View C), loosen the inner attaching bolt and remove and discard the spring seat and outer attaching bolt. 8. Tighten the inner attaching bolt and torque to 25 N.m (18 lbs. ft.), see View C, inside View. 9. Carefully lower hood, check for latching and flushness conditions and adjust as required.

**Correction:** Parts Required- 14043052 - Spring 14043053 - Retainer 14084413 - Bolt, Hd. Pri. Lch. 11508269 - Bolt, M8 X 1.25 X 30
