# 1986 - 1987 Corvette: Service Bulletin: Convertible Top Number 5 Bow Weatherstrip Loose

**Subject:** Convertible Top Number 5 Bow Weatherstrip Loose

**Bulletin Number:** 87-148, Number 10

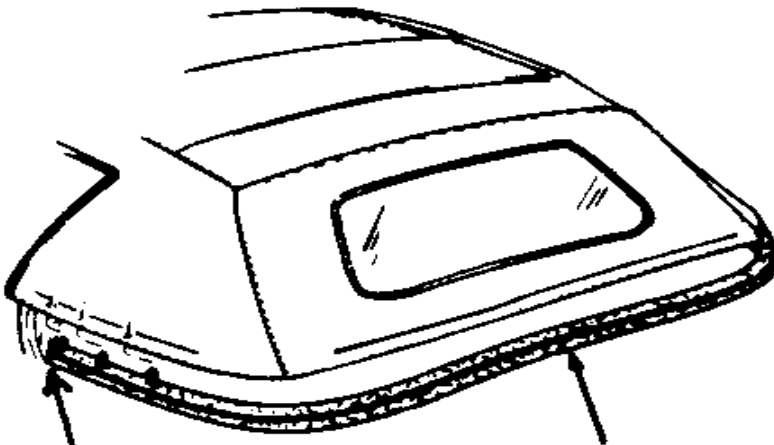
NUMBER 5 BOW WEATHERSTRIP

Comments have been reported that on some Corvette convertibles, the number 5 bow weatherstrip pulls loose from the bow at the front ends. Effective with start of 1987 production, the source used an adhesive which eliminated this problem on 1987 vehicles.

FRONT ENDS OF WEATHERSTRIP  
PULL LOOSE AND FOLD BACK.  
MAKE SURE ADHESIVE IS APPLIED  
ALL THE WAY TO THE FRONT END OF WEATHERSTRIP.

Field repairs can be accomplished by gluing the weatherstrip ends down with 3M weatherstrip adhesive, P/N 08011, or P/N 12345096-7 weatherstrip adhesive. (See illustration). Before applying adhesive wipe the weatherstrip with alcohol or all purpose adhesive cleaner to remove any mold release compound. Care should be taken to make sure the adhesive is applied all the way to the extreme forward ends of the weatherstrip. Also, be sure the plastic nails are installed properly. If the weatherstrip is damaged, it will have to be replaced.
