# 1999 - 2011 Corvette: GM TechLink: Head-Up Display Conditions

**Source:** GM Techlink

**Subject:** Head-Up Display Conditions

**Models:** 1999 - 2011 Chevrolet Corvette

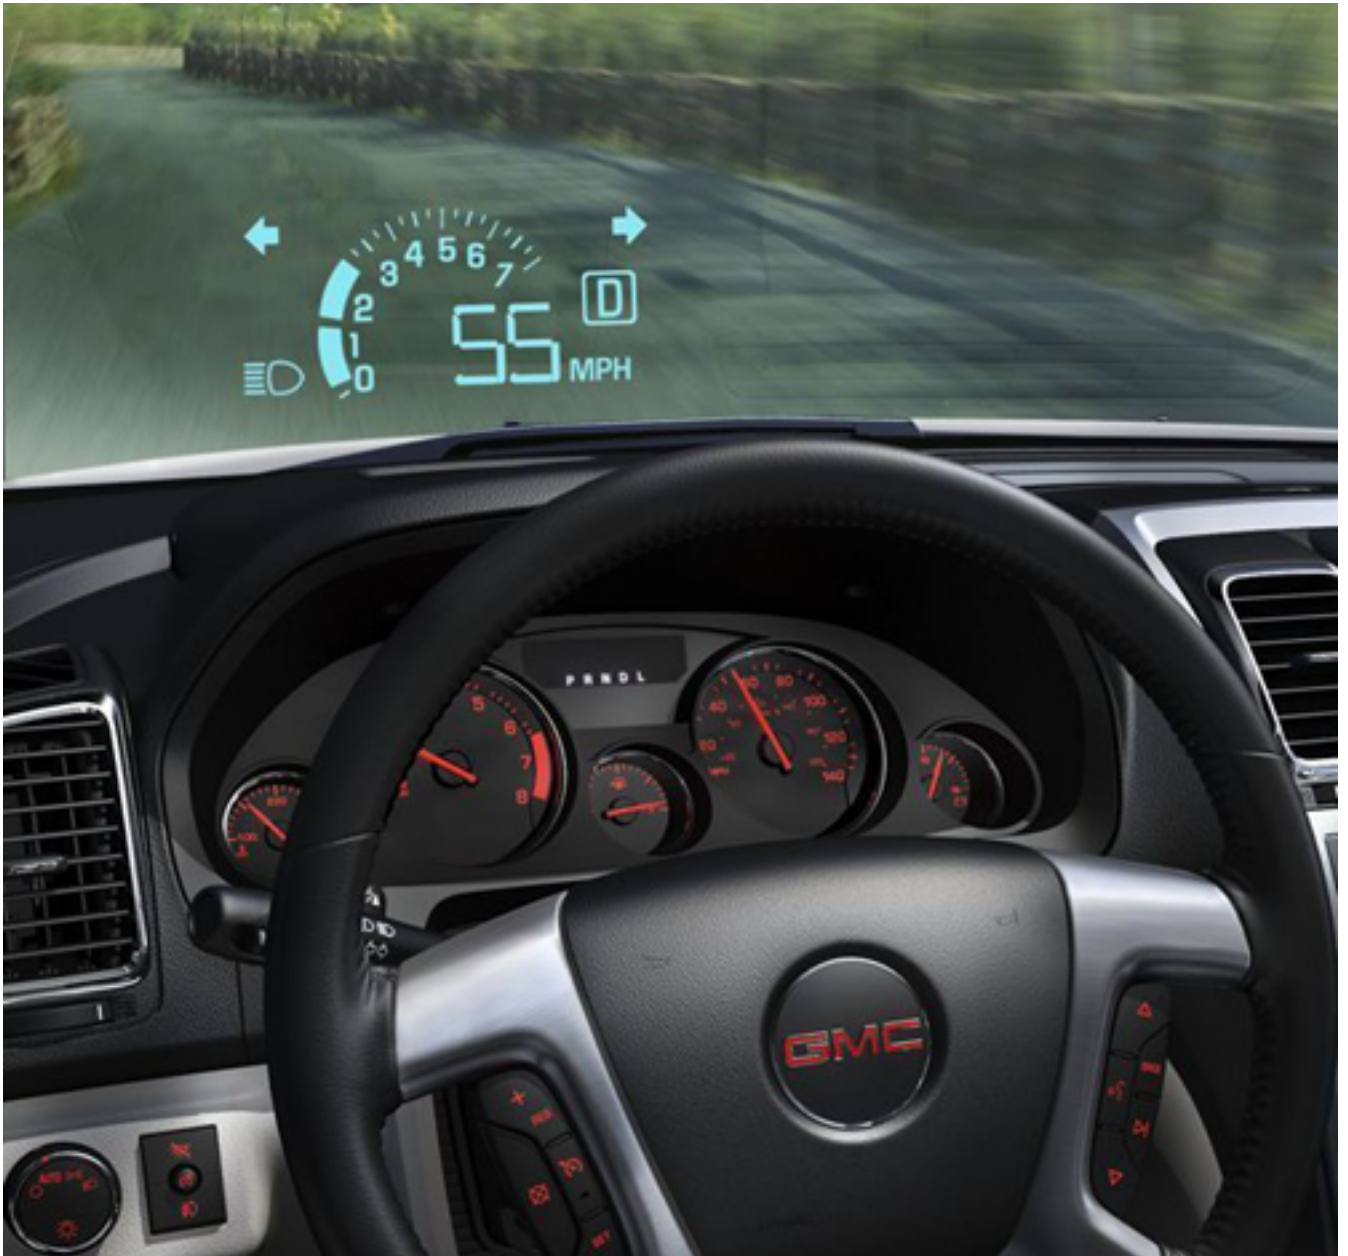
Fig. 9

A Head-Up Display (HUD) (Fig. 9) is available on the 1999-2005 Park Avenue, 2010-2011 Lacrosse, 2004-2009 XLR, 2005-2011 STS, 1999-2011 Corvette, 2011-Camaro, 2007-2011 Acadia, 1999-2005 Bonneville, and 1999-2008 Grand Prix.
