1982 - 1991 Corvette: Service Bulletin: Checking Connector Terminal Contact - Metri-Pack

Subject: CHECKING CONNECTOR TERMINAL CONTACT - METRI - PACK

Model and Year: 1982-91 PASSENGER CARS AND TRUCKS

Bulletin Number: 91-85-8A - (09/21/1990)

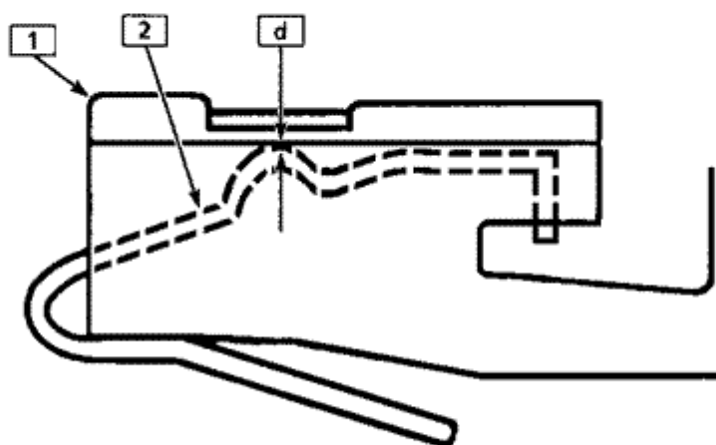
$d = 0$, GOOD TERMINAL CONTACT

-
- 1** TYPICAL METRI-PACK 150/280/480/630 SERIES FEMALE TERMINAL
(150 SERIES PUSH-TO-SEAT SHOWN)
 - 2** CONTACT TANG
 - d** AMOUNT OF DEFORMATION

to the female terminal contact tang, can result in poor terminal contact, see Figure 1, causing an open or intermittently open circuit.

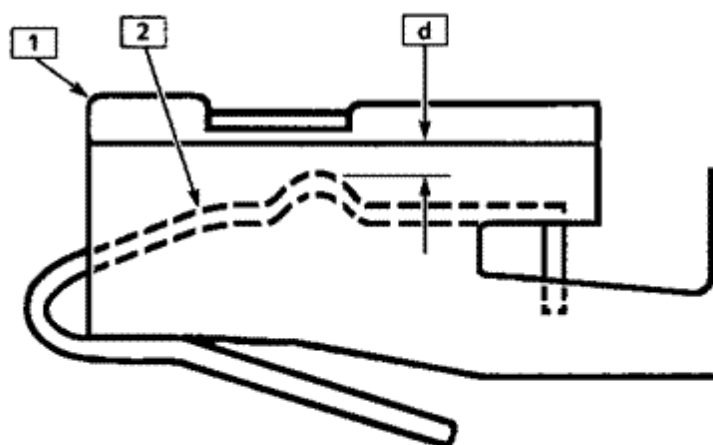
Figure 1 - Deformation of a typical Metri-Pack 150/280/480/630 series female terminal.

$d > 0$, POOR TERMINAL CONTACT

Deformation is caused by probing the mating side of a connector terminal without the proper adapter, improperly joining the connector halves or repeatedly separating and joining the connector halves. Deformation, usually

3. Using an equivalent male terminal from the Terminal Repair Kit J 38125-2, check the retention force of the female terminal in question by inserting and removing the male terminal to the female terminal in the connector body. Good terminal contact will require a certain amount of force to separate the terminals.

4. Using an equivalent female terminal from the Terminal Repair Kit J 38125-2, compare the retention force of this terminal to the female terminal in question by joining and separating the male terminal to the good female terminal, and then joining and separating the male terminal to the female terminal in question. If the retention force is significantly different between the two female terminals, replace the female terminal in question, refer to Terminal Repair Kit J 38125-2.
