1976 - 1990 Corvette: Service Bulletin: New On-Vehicle Service Procedure to Remove Rear Case or Extension Bushing

Subject: NEW ON-VEHICLE SERV. PROCEDURE REMOVE REAR CASE OR EXT. BUSH

Model and Year: 1976-90 B, F, G, Y CARS & 1976-90 C, G, K, L, M, R, S, T, V TRUCKS WITH THM 200-4R, THM 200-C, THM 200 & 4L60/THM 700R4 AUTOMATIC TRANSMISSION

Bulletin Number: 90-162-7A - (01/30/1990)

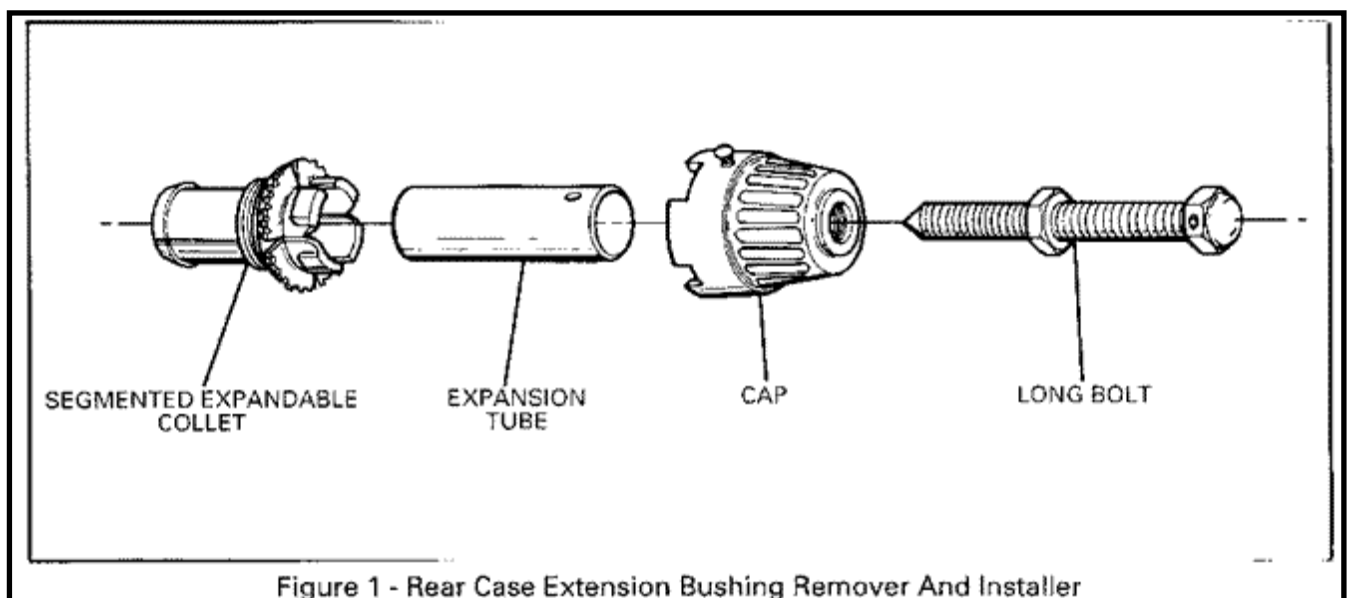
1. DISCONNECT PROPSHAFT FROM REAR OF TRANSMISSION
2. PRY OUT REAR CASE SEAL

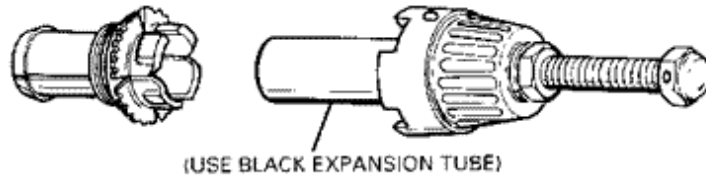
3. ASSEMBLE TOOL

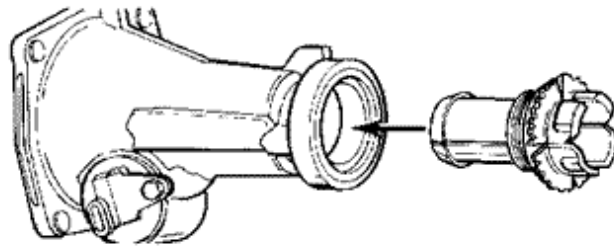
4. INSERT COLLET INTO TRANSMISSION

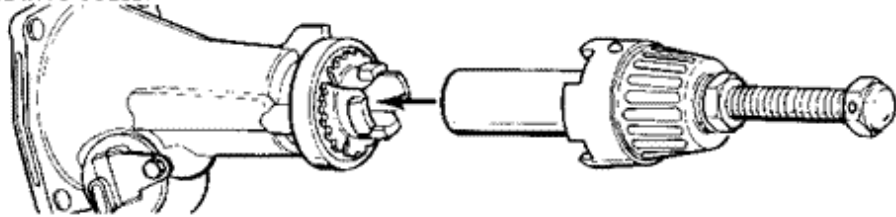
5. SLIDE EXPANSION TUBE INTO COLLET

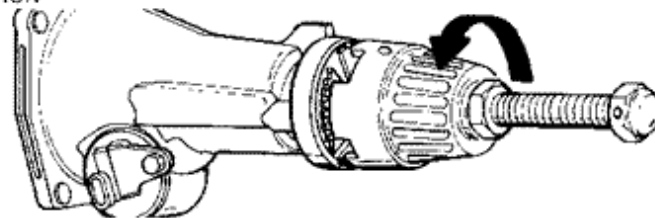
6. TURN CAP TO LOCK INTO POSITION

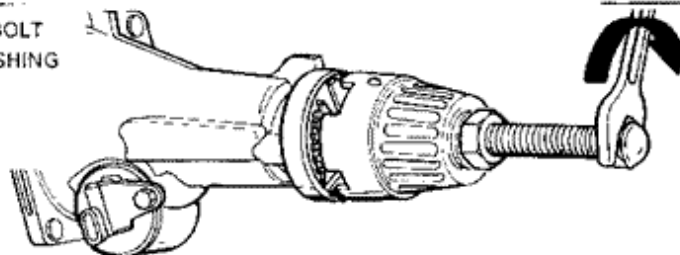
7. USE 15/16" WRENCH TO TURN BOLT CLOCKWISE AND REMOVE BUSHING

1. Disconnect propshaft from rear of transmission.
2. Remove rear case seal.
3. Assemble tool as shown in Figure 2.
4. Insert collet into rear opening of transmission case.
5. Slide expansion tube into segmented collet.
6. Turn cap to lock collet into position.
7. Use a 15/16" end wrench and turn bolt clockwise to remove bushing.
8. Remove J 38119 with collet attached.

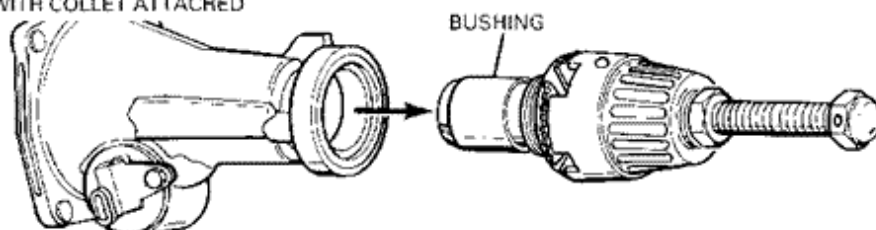
Figure 2 - Bushing Removal Procedure

8. PULL OUT J 38119 WITH COLLET ATTACHED

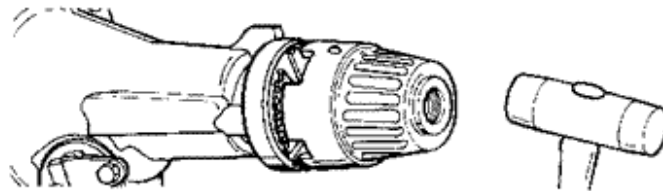
5. INSTALL J 38119 INTO TRANSMISSION WITH A PLASTIC HAMMER

1. Remove long bolt from cap of J 38119.
2. Place new bushing over segmented collet.
3. Slide black expansion tube into segments.
4. Turn cap to lock collet into place.
5. Install new bushing into transmission by driving J 38119 in firmly with a plastic hammer.
6. Turn cap to unlock collet.
7. Remove J 38119.
8. Remove collet.
9. Install rear case seal.
10. Connect propshaft to rear of transmission.

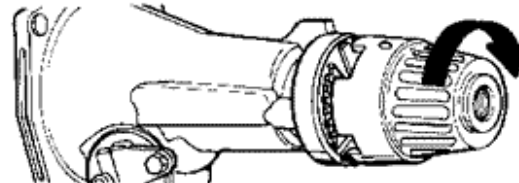
6. TURN CAP TO UNLOCK COLLET

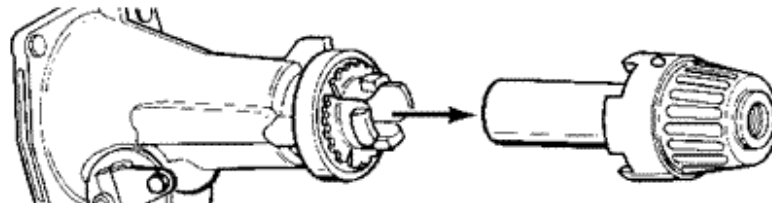
7. PULL OUT J 38119

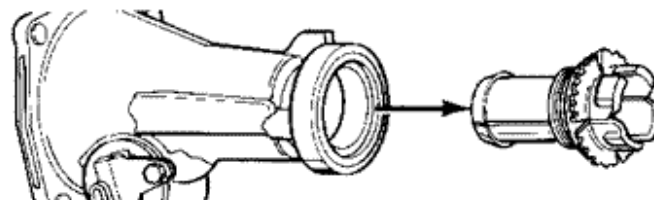
Figure 3 - Bushing Installation Procedure

8. REMOVE COLLET
