1976 - 1990 Corvette: Service Bulletin: New On-Vehicle Service Procedure to Remove Rear Case or Extension Bushing

Subject: NEW ON-VEHICLE SERV. PROCEDURE REMOVE REAR CASE OR EXT. BUSH

Model and Year: 1976-90 B, F, G, Y CARS & 1976-90 C, G, K, L, M, R, S, T, V TRUCKS WITH THM 200-4R, THM 200-C, THM 200 & 4L60/THM 700R4 AUTOMATIC TRANSMISSION

Bulletin Number: 90-162-7A - (01/30/1990)

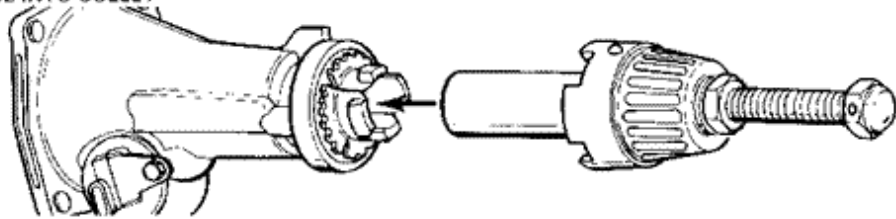
5. SLIDE EXPANSION TUBE INTO COLLET

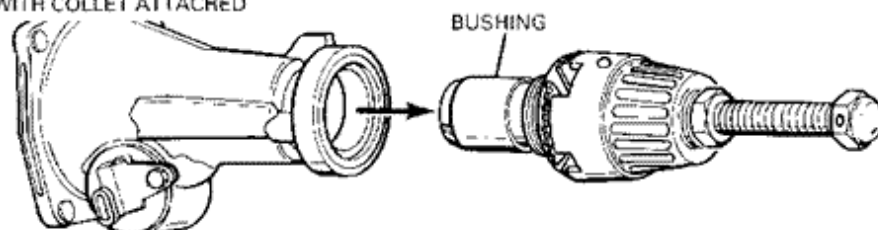
Figure 2 - Bushing Removal Procedure

8. PULL OUT J 38119 WITH COLLET ATTACHED

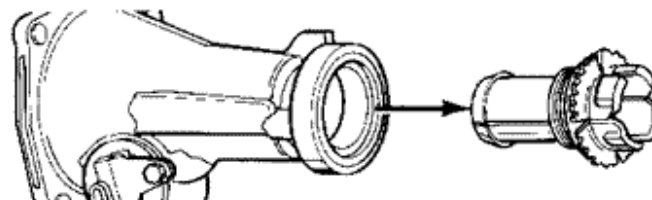
Figure 3 - Bushing Installation Procedure

8. REMOVE COLLET
