1984 Corvette: Service Bulletin: No Heat - A/C Control Unit

Source: Chevrolet Dealer Service Technical Bulletin

Bulletin Number: 83-T-70, Number Ia

Date: August, 1983

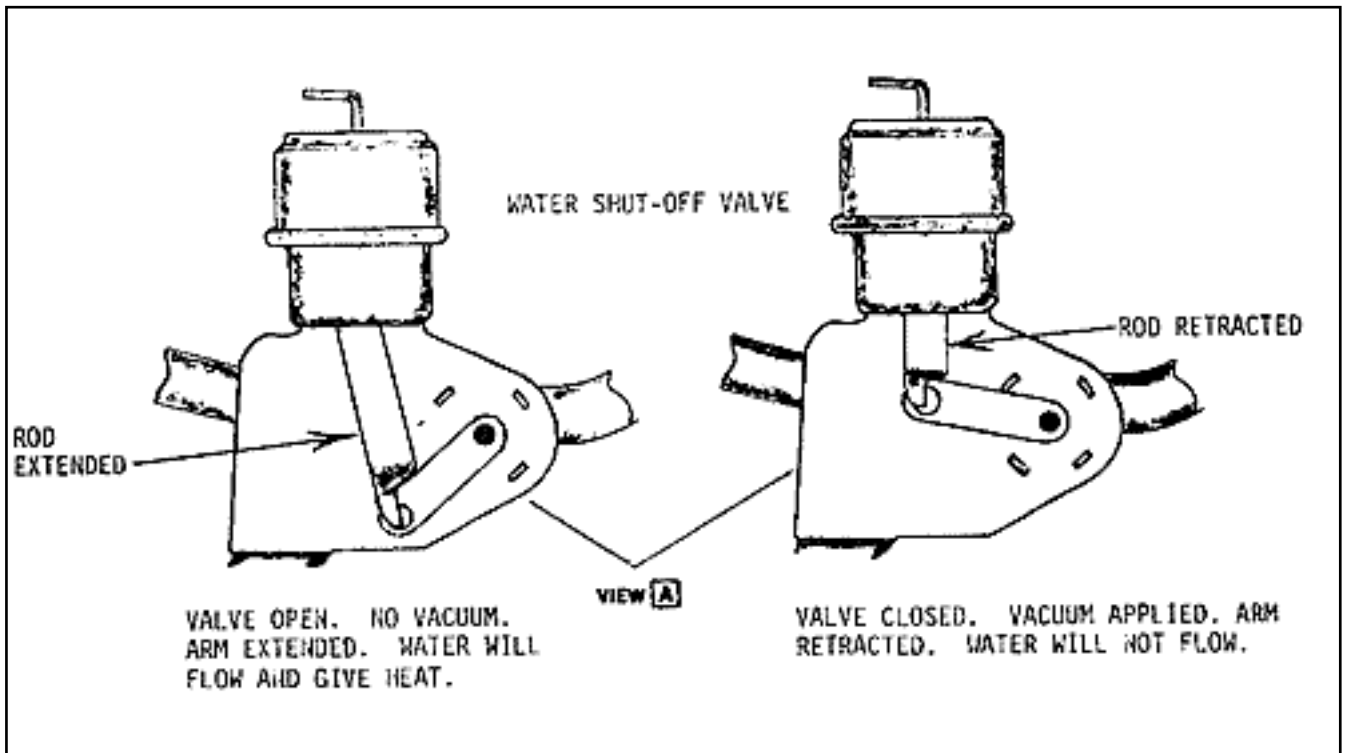
The vacuum switch in the A/C control unit controls a water shut off valve on the evaporator blower assembly. This valve should be closed with the temperature selector lever in the full cold position and open with the lever in any other position. Water will not flow through the heater core when the valve is closed (vacuum applied). Note that the valve actuating rod will be extended when the valve is open and retracted when closed (refer to sketch).

1. Observe the operation of the valve on the blower assembly while the temperature selector lever is moved from "cold" to "hot" position. The engine must be running to supply vacuum and should be at operating temperature.
2. If the valve opens (rod extended) when the temperature selector lever is moved to the "hot" position and heat output does not occur, the condition is not directly related to this particular control unit problem and should be further diagnosed, as described in Chevrolet Service Manual, Section 1.

3. If the valve does not open (rod retracted) remove the vacuum line from the valve. If this causes the valve to open and results in heat output, refer to Step 4.
4. Leave the vacuum line off the valve and seal off the end of the line to prevent a vacuum leak. (This can be done by fabricating a rubber plug or equivalent.) Secure the loose line to the harness with a band strap.
5. The vehicle can be operated with this line disconnected from the valve with no adverse effect to the A/C system.
