# 1975 Corvette: Service News: Shipping Block Removal - 1975 Corvettes Shipped Via Rail

**Subject:** Shipping Block Removal - 1975 Corvettes Shipped Via Rail

**Model and Year:** 1975 Corvette

**Date:** October 1974, Volume 46, Issue Number 10

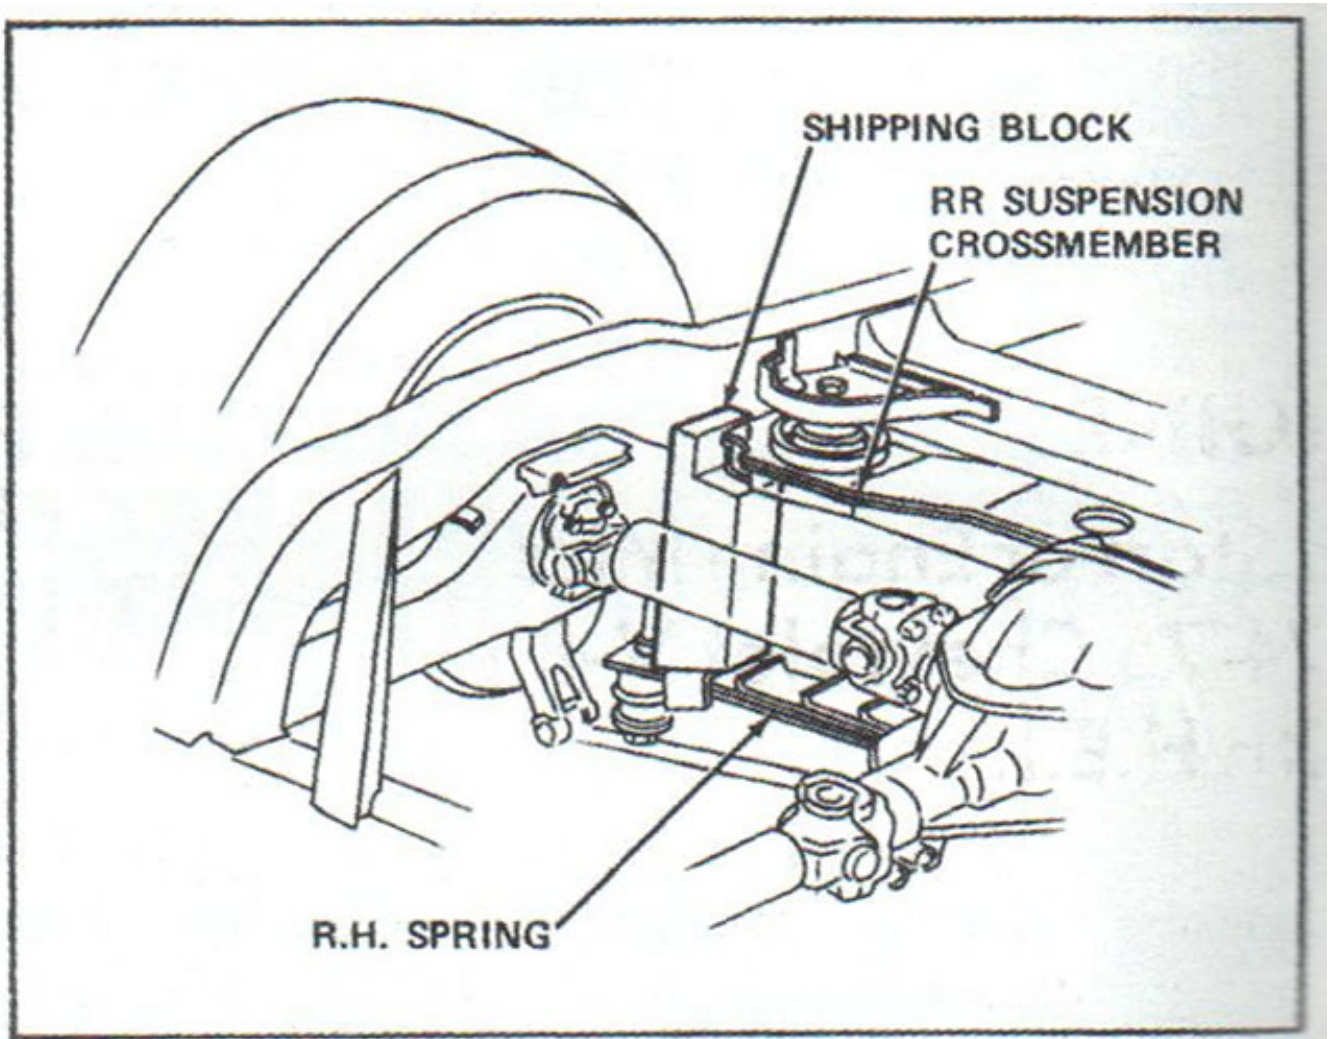
In order to provide a means of protection against damage to the catalytic converter while in transit, all 1975 Chevrolet Corvettes shipped via rail transportation will have a 10 inch shipping block installed between the right rear frame crossmember and the rear leaf spring assembly.

**Fig. 1—Shipping Block Location**

It will become necessary to remove the shipping block prior to delivery to the customer. Removal of the block can best be accomplished by jacking the right rear corner of the vehicle in a manner that will allow the suspension to "hang", tilting the shipping block rearward and removing. See Figure 1 for block location.
