1964 Corvette: Service Bulletin: Directional Signal Switch Service

Model Year: 1964 All Series Except Corvette and Comfortilt Wheel
Subject: Directional Signal Switch Service
Source: Chevrolet - Central Office - Technical Service Bulletin
Bulletin No: DR #693, Section XII
Date: September 8, 1964

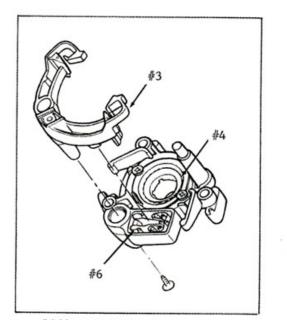
1964 CHEVELLE ONLY

DESCRIPTION AND PART NUMBERS	1000 SERIES	CHEVY II	10-30 TRUCK	50-80 TRUCK	CORVETTE	CHEVELLE	CORVAIR 95	CHEVY VAN
1.	CANCELLING CAM (Not shown) 3813945 382931	x	x	Exc. D.D.			x		
	3831338		X		X				X
	3841844					X.			
2.	3857036 SWITCH ASSEMBLY (All parts shown)							X	
	910746	х	x	x		x		x	x
	910372 (383033 Optional)			1			X		
	910582			20-30 D.D.	х				
3.	ACTUATING PLATE								
	5955189	X	X	X	X	X		X	X
4.	5955238 UPPER MAST JACKET BEARING						X		
4.	5955201	x	x	x	x	x		x	x
	383871						X		
5.	HORN CONTACT RING								
	5955202	Х	X	X		X		X	X
6.	CONTACTOR KIT (Spring Unit) 5955856	x	x	x	x	x	x	x	x
