# 2014 - 2015 Corvette: Service News: Rough Idle or Vibration

**Subject:** Rough Idle or Vibration

**Model and Year:** 2014 - 2015 Corvette with RPO LT1 Engine

**Source:** Chevrolet Service News

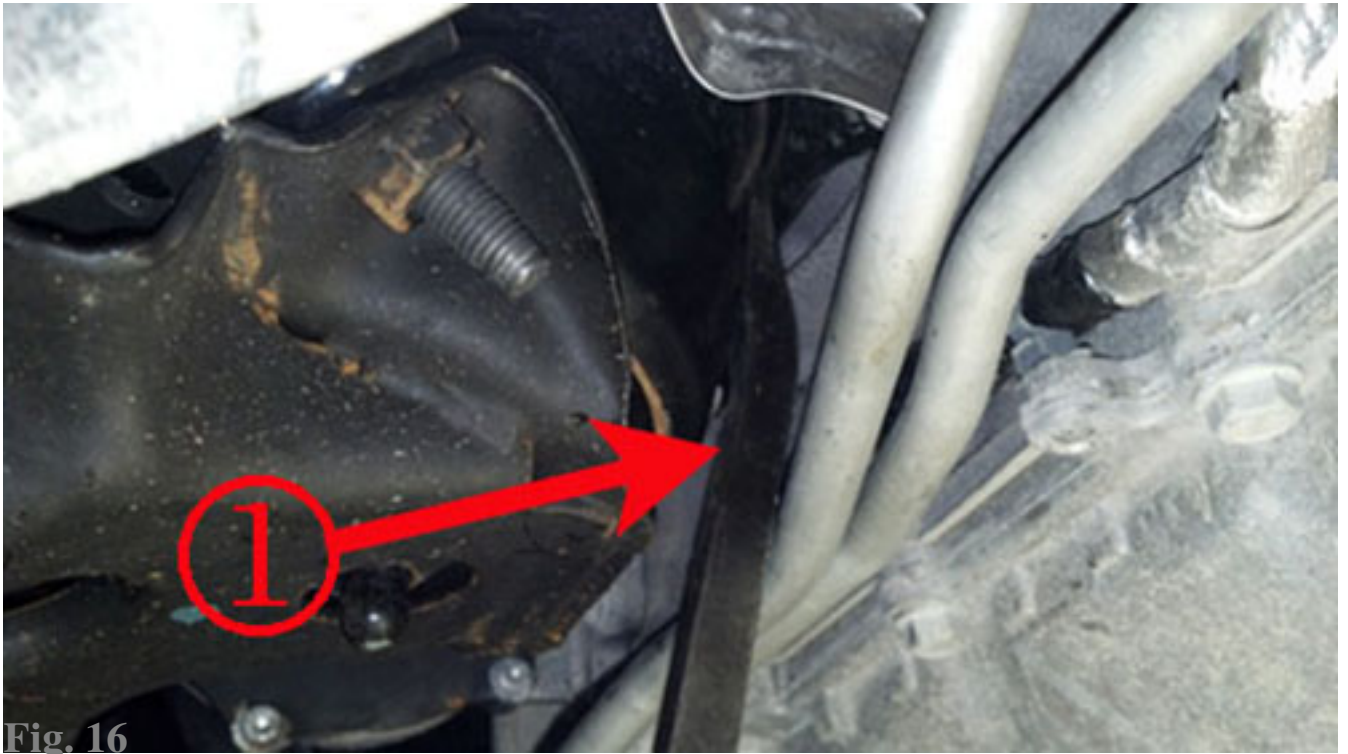
Fig. 16

2. Lift the engine slightly to take the load off the mounts.
3. Use a pry bar to push the mount outboard as far as possible (about 1–1.5 mm) (Fig. 16, left engine mount; Fig. 17, right engine mount); torque the bolts while pushing the mount outboard.
